***CITY MARKET AND OLD CITY HALL***  
***Indianapolis, Indiana***

***OLD CITY HALL FACILITY ASSESSMENT AND CAPITAL PLANNING REPORT***

***JSH No.: 21060108***

***Date***  
***08/06/2021***

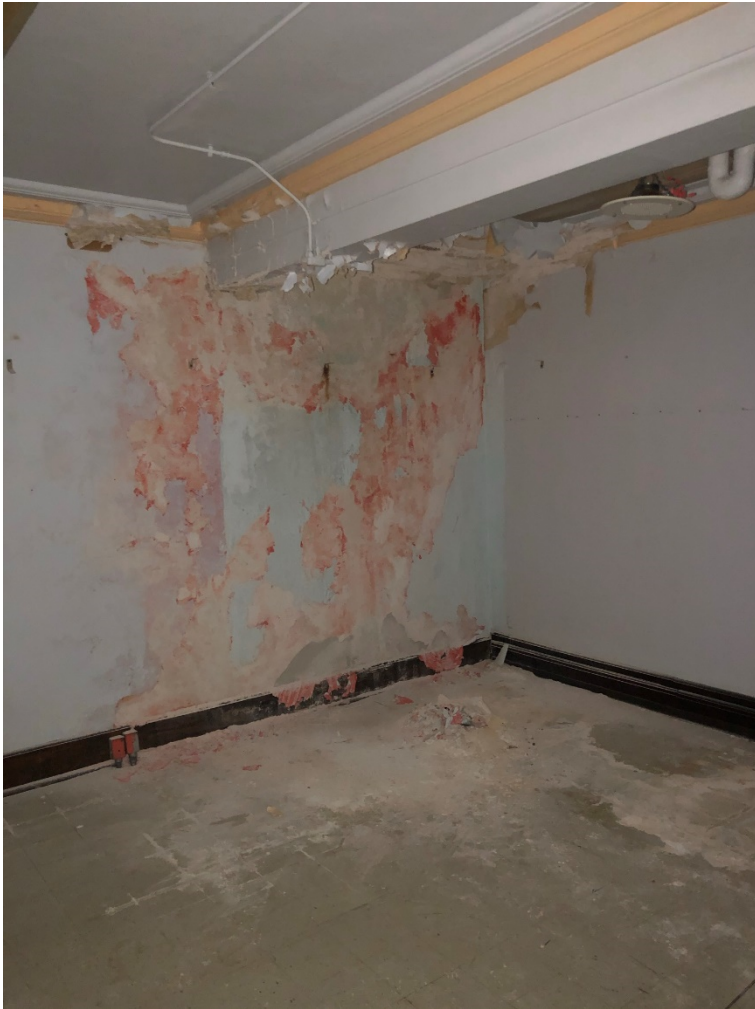
*Photo OCH - 4 - 5: Office east of council chamber. Original plaster ceiling and wall damaged by water leaks. Window openings blocked in and plastered.*

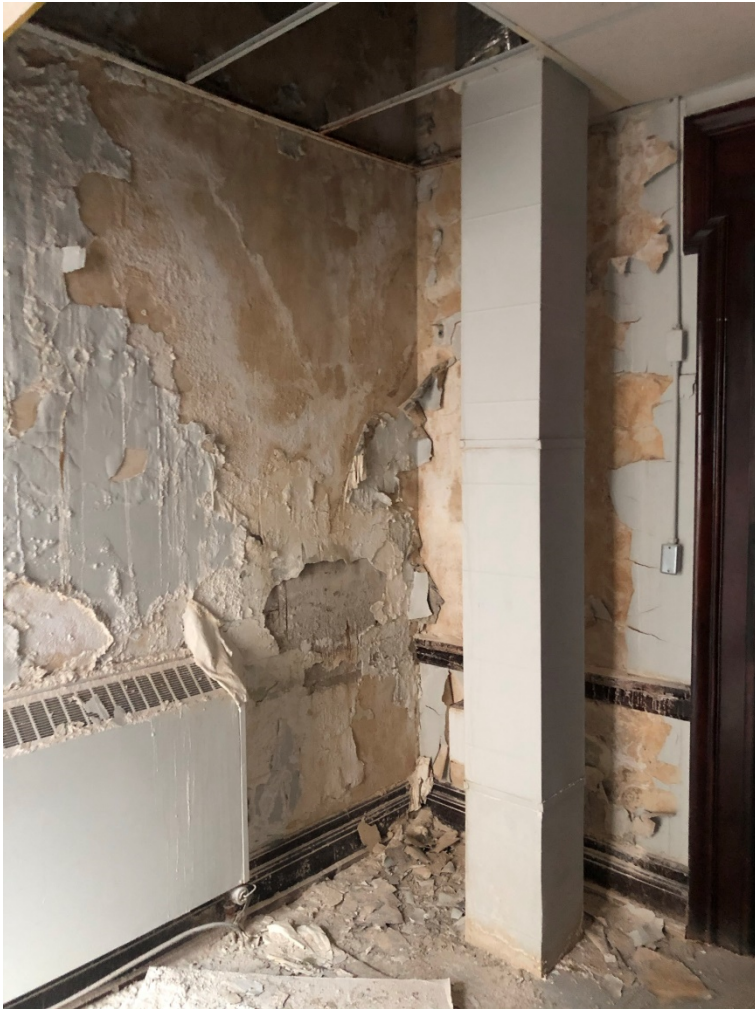
*Photo OCH - 4 - 6: Office east of rotunda. Dropped ceiling covering original plaster ceiling. Original plaster ceiling and wall damaged by water leaks. Window openings blocked in and plastered. Same room as Photo OCH-4-7.*

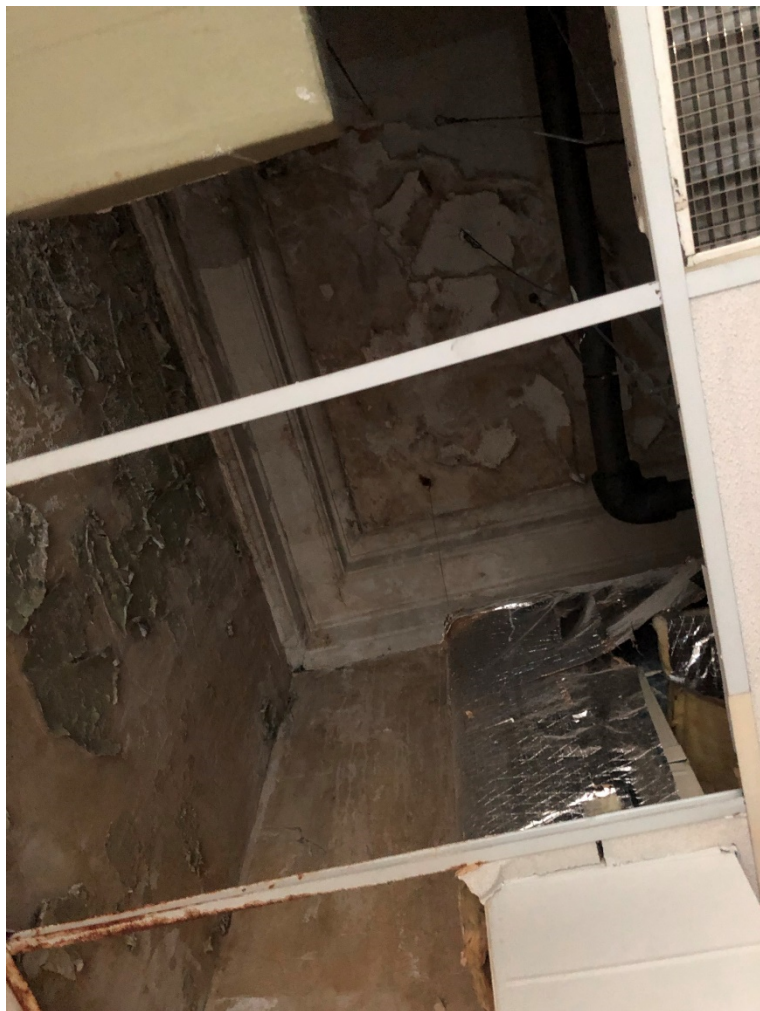
*Photo OCH - 4 - 7: Office east of rotunda. Dropped ceiling covering original plaster ceiling. Original plaster ceiling and wall damaged by water leaks. Window openings blocked in and plastered. Same room as Photo OCH-4-6.*

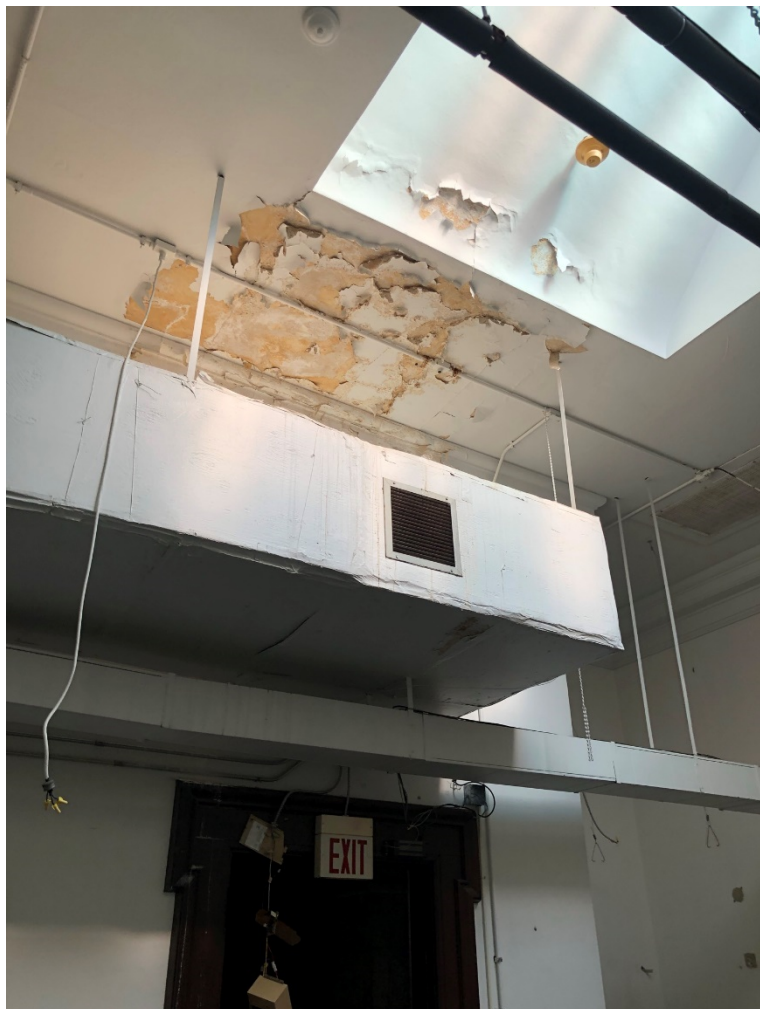
*Photo OCH - 4 - 8: Office east of rotunda. Original plaster ceiling and wall damaged by water leaks. Window openings blocked in and plastered. Same room as Photo OCH-4-9.*

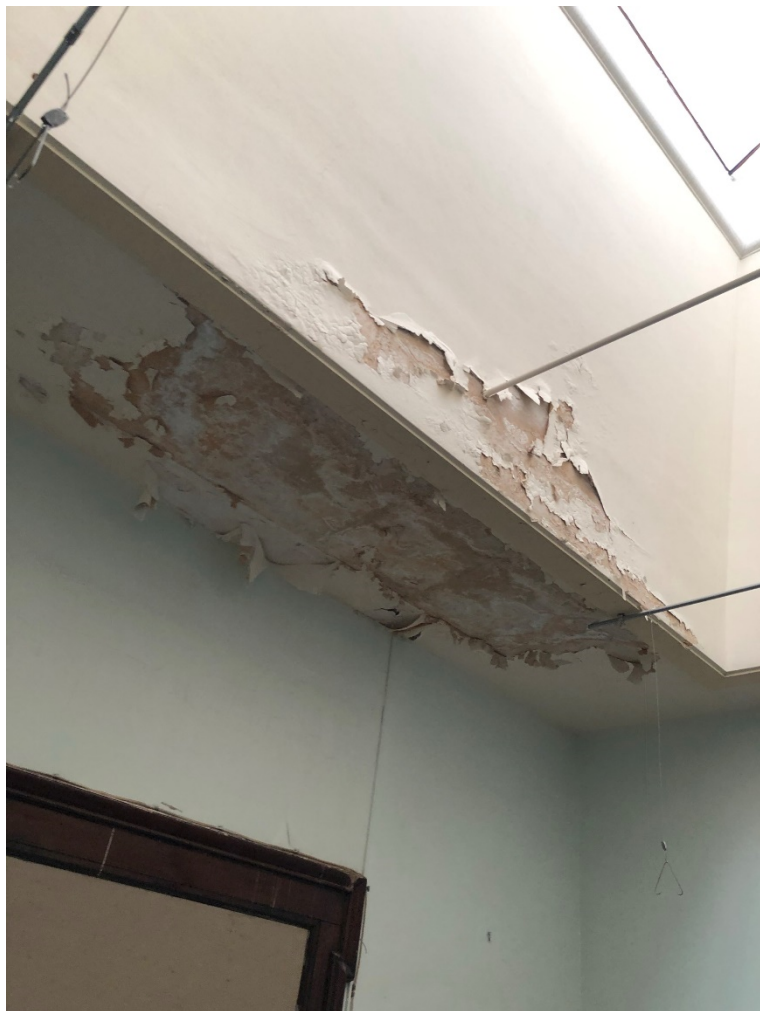
*Photo OCH - 4 - 11: Lobby north of rotunda. Original plaster ceiling and walls damaged by water leaks. Same room as Photo-OCH-4-11.*

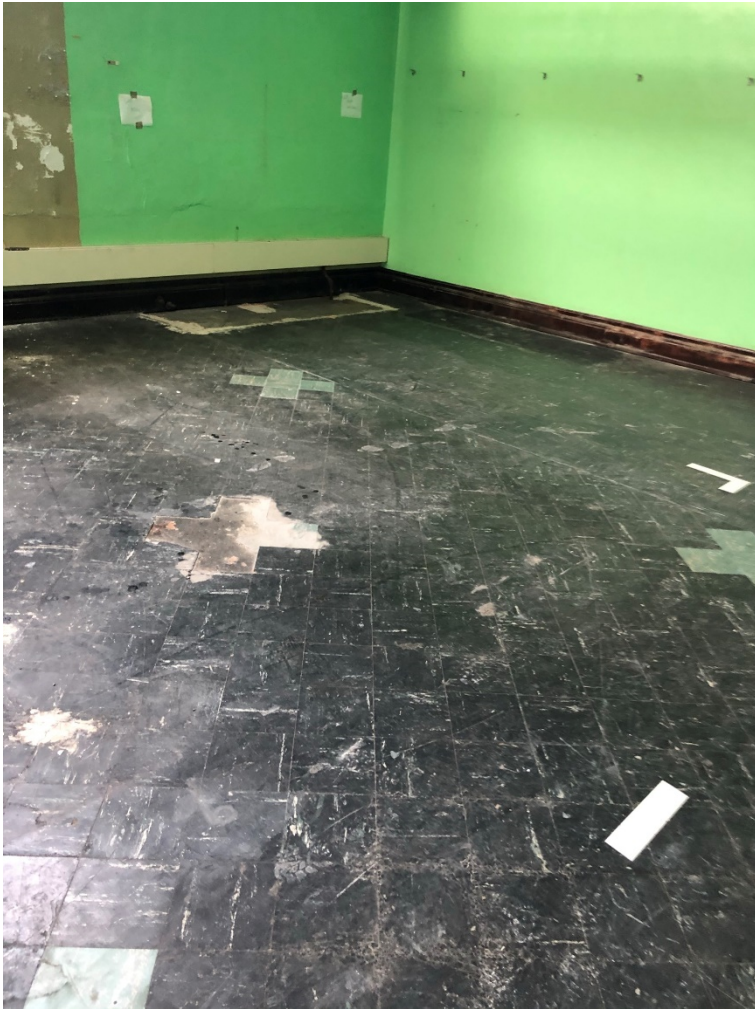
*Photo OCH - 4 - 14: Office north of rotunda. Damaged floor tile. Testing for hazardous materials required. Same room as OCH-4-14.*

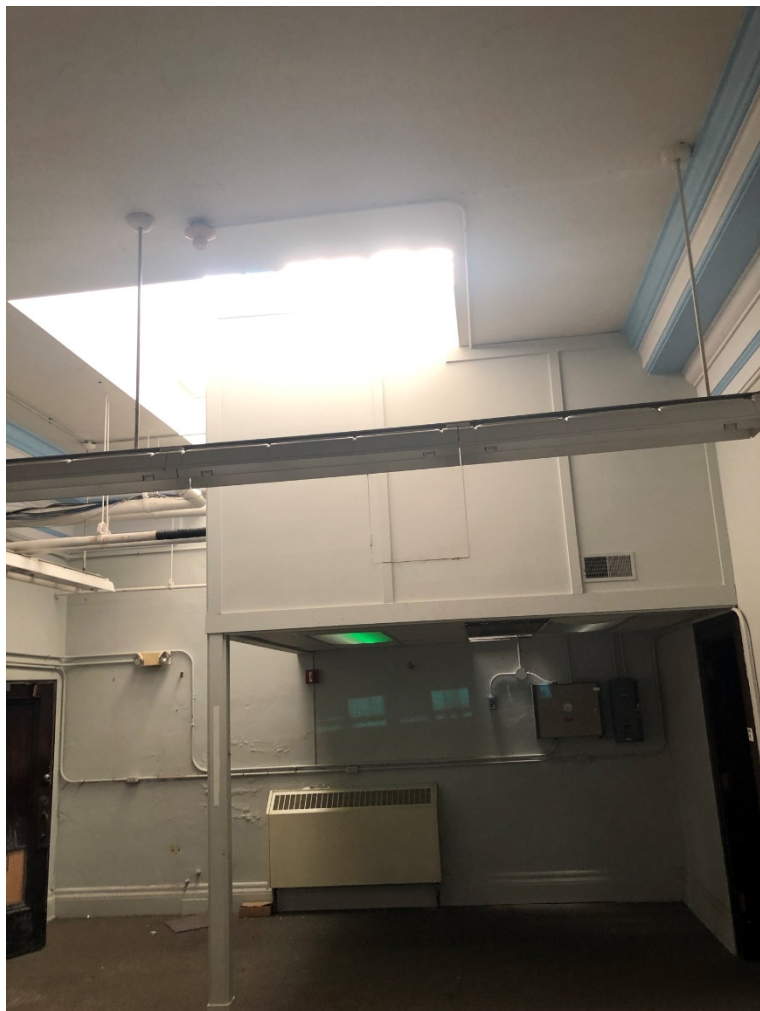
*Photo OCH - 4 - 15: Office east of north lobby. Mechanical mezzanine partially covering skylight. Windows openings blocked in and plastered. Same room as OCH-4-16.*

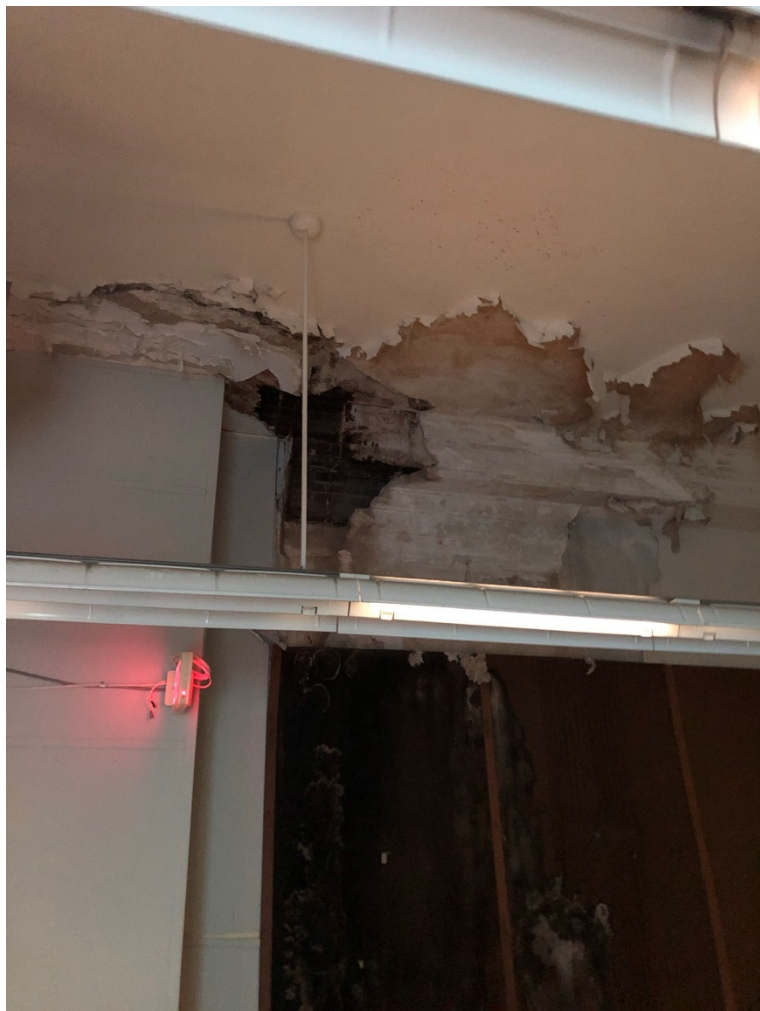
*Photo OCH - 4 - 16: Office in east of north lobby. Original plaster ceiling and walls damaged by water leaks. Windows openings blocked in and plastered. Same room as OCH-4-15.*

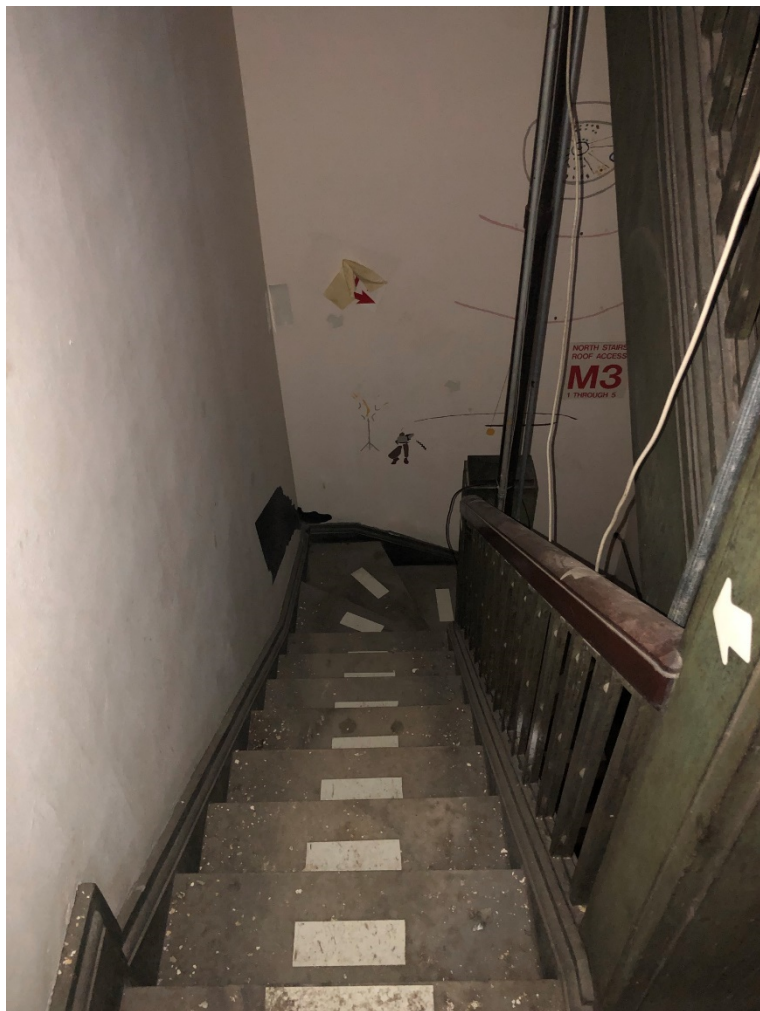
*Photo OCH - 4 - 17: North private stair view from 4<sup>th</sup> floor. Handrail only on one side.*

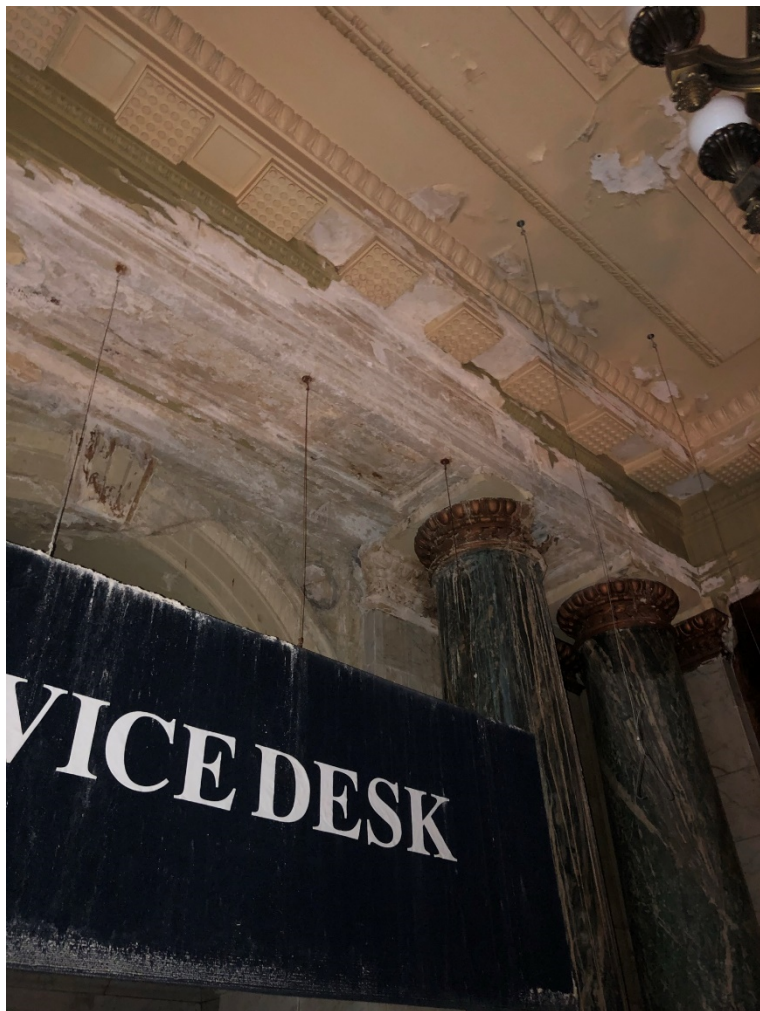
*Photo OCH - 4 - 22: Southeast corner of rotunda. Original plaster ceiling and walls damaged by water leaks.*

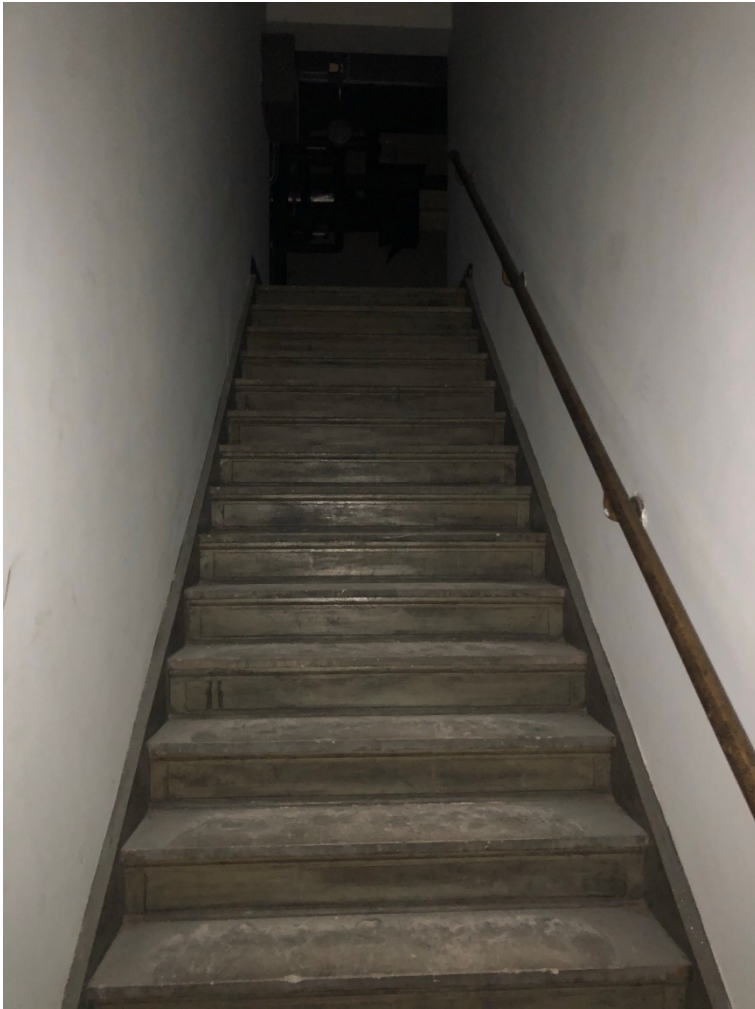
*Photo OCH - 4 - 23: East stairs to mezzanine overlooking council chambers. Handrail only on one side.*

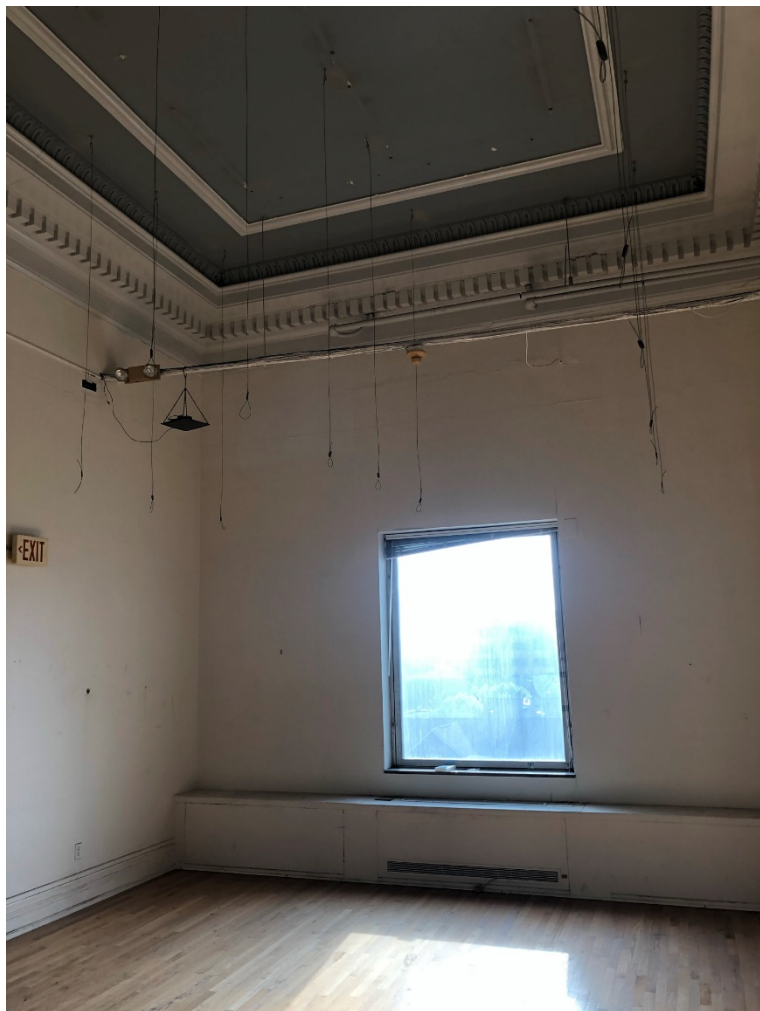
*Photo OCH - 3 - 2: Room east of north lobby. Original ceiling intact. Window is replacement and opening is partially blocked.*

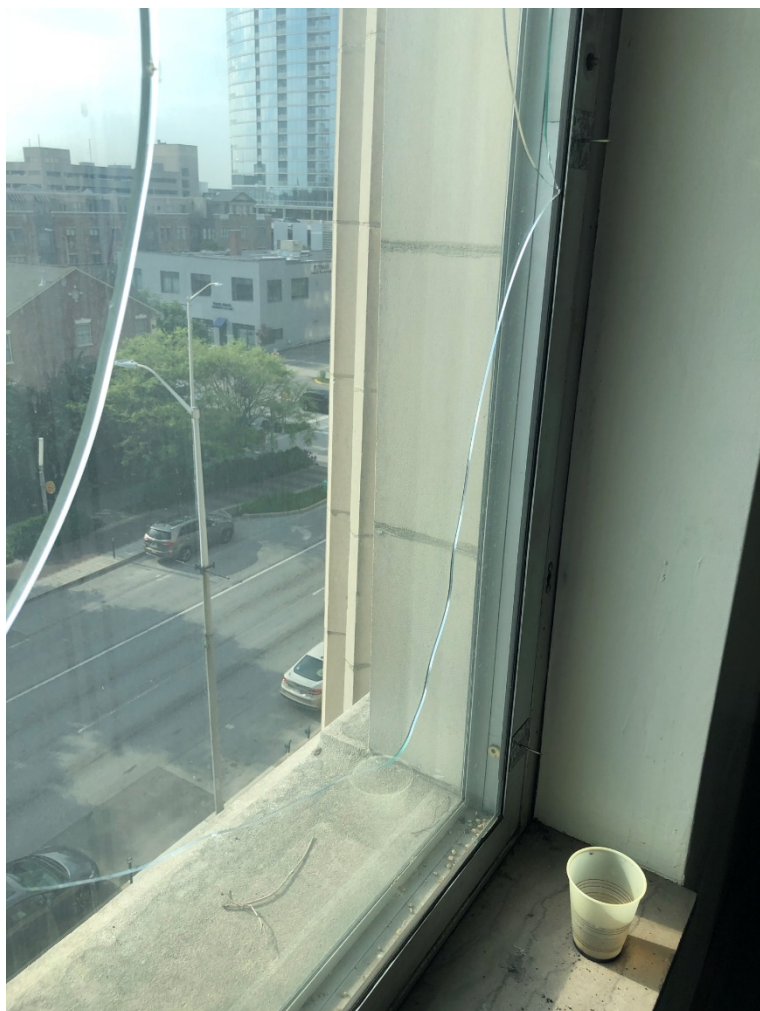
*Photo OCH - 3 - 3: Exterior window in room east of rotunda. Exterior pane broken. Same room as Photos OCH-3-4 through OCH-3-6.*

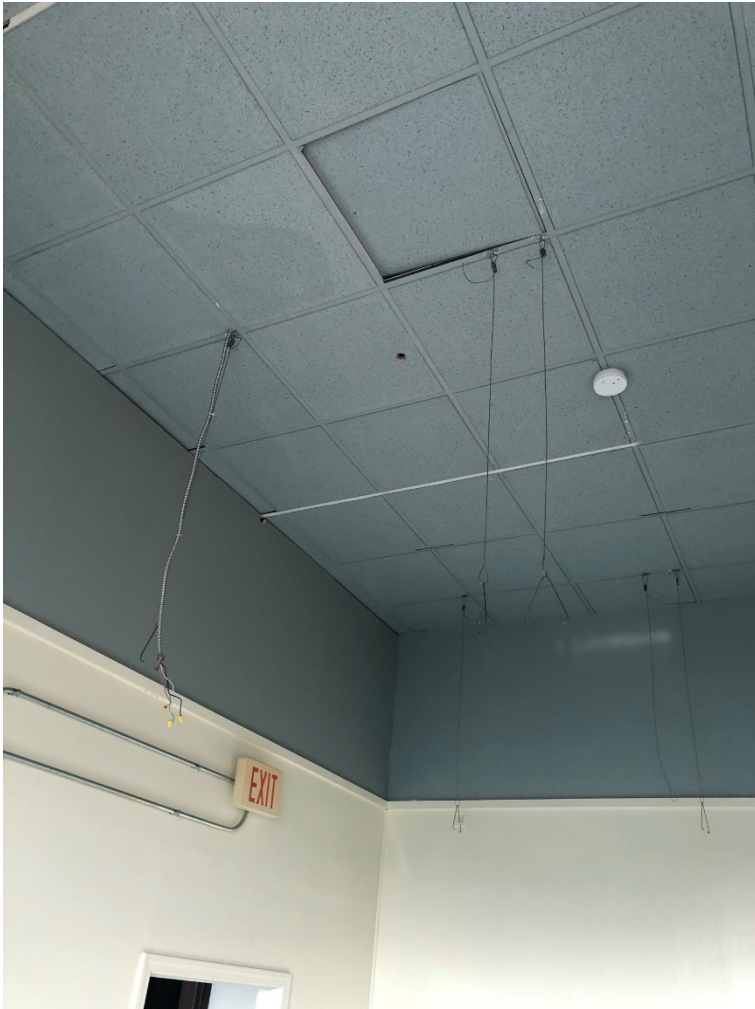
*Photo OCH - 3 - 4: Room east of rotunda. Dropped ceiling covers original plaster ceiling. Windows are replacement and openings are partially blocked. Same room as Photos OCH-3-3 through OCH-3-6.*

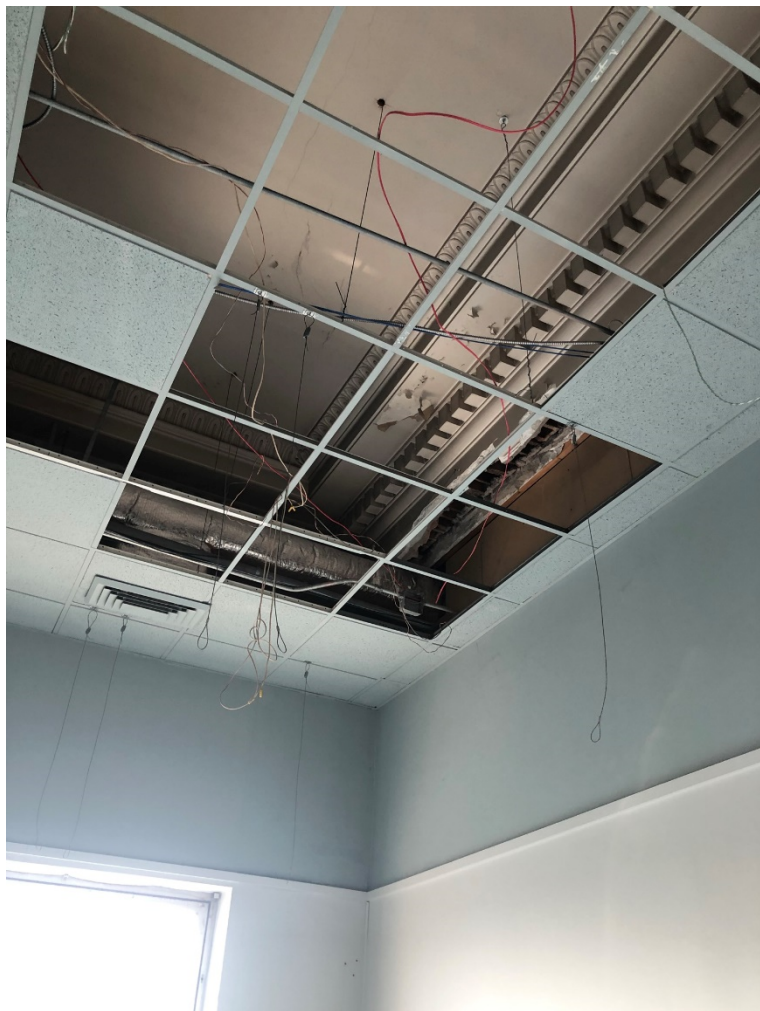
*Photo OCH - 3 - 5: Room east of rotunda. Dropped ceiling covers original plaster ceiling. Windows are replacement and openings are partially blocked. Same room as Photos OCH-3-3 through OCH-3-6.*

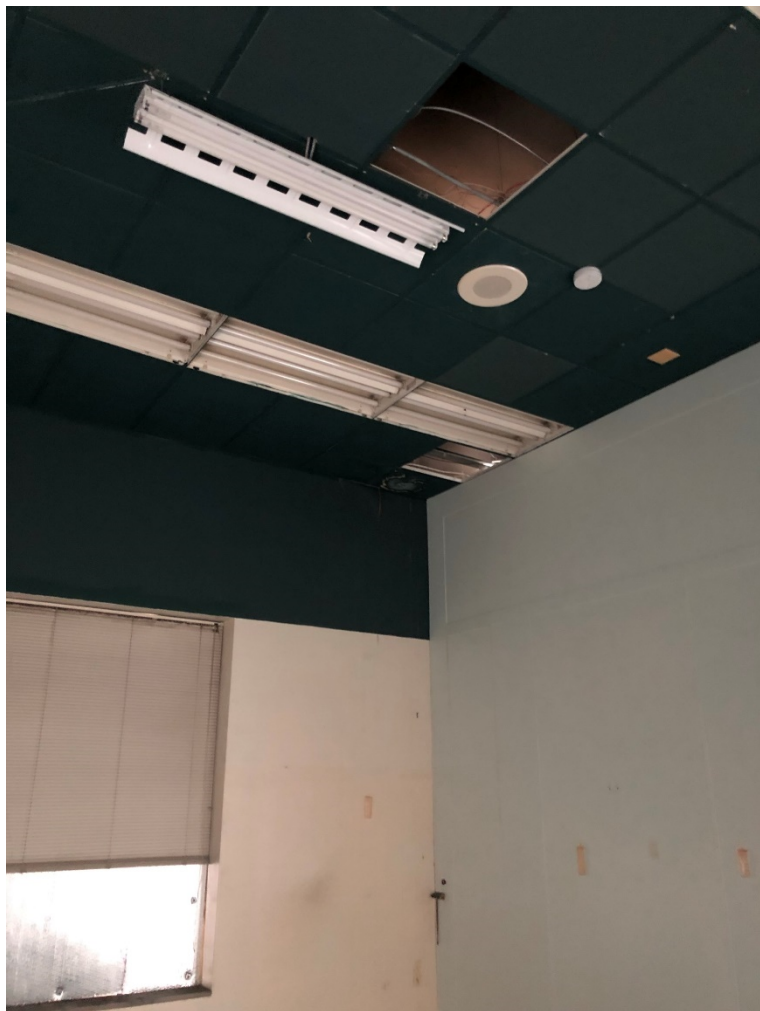
*Photo OCH - 3 - 6: Room east of rotunda. Dropped ceiling covers original plaster ceiling. Windows are replacement and openings are partially blocked. Same room as Photos OCH-3-3 through OCH-3-5.*

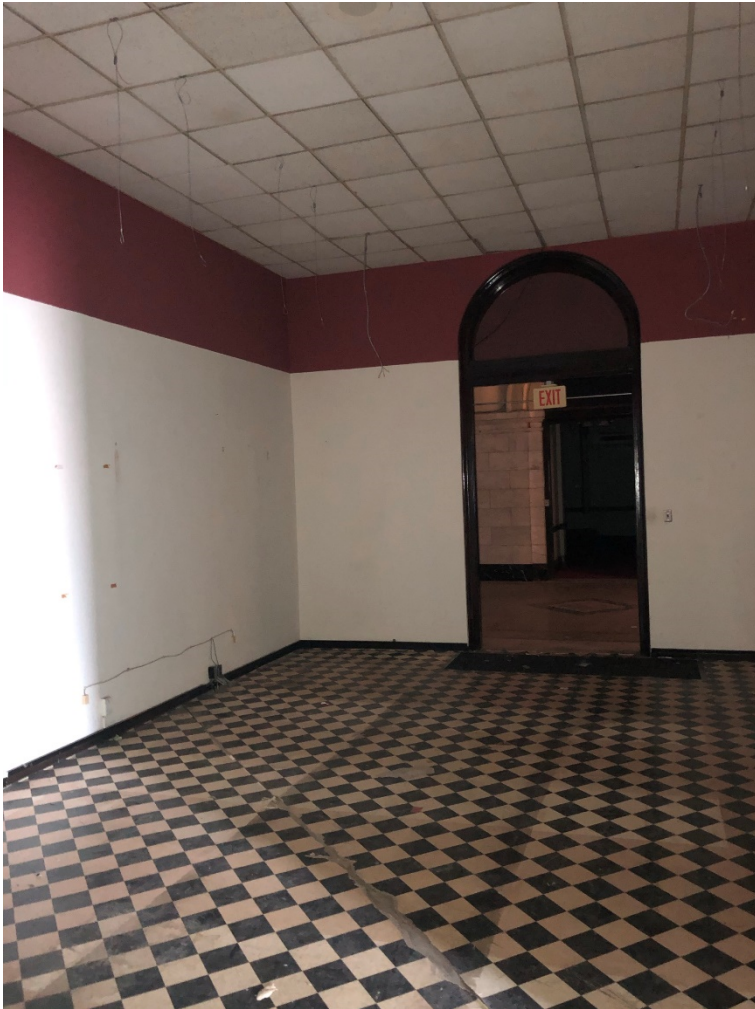
*Photo OCH - 3 - 7: Room east of the south lobby. Dropped ceiling covers original plaster ceiling. Damaged floor tile. Testing for hazardous materials required.*

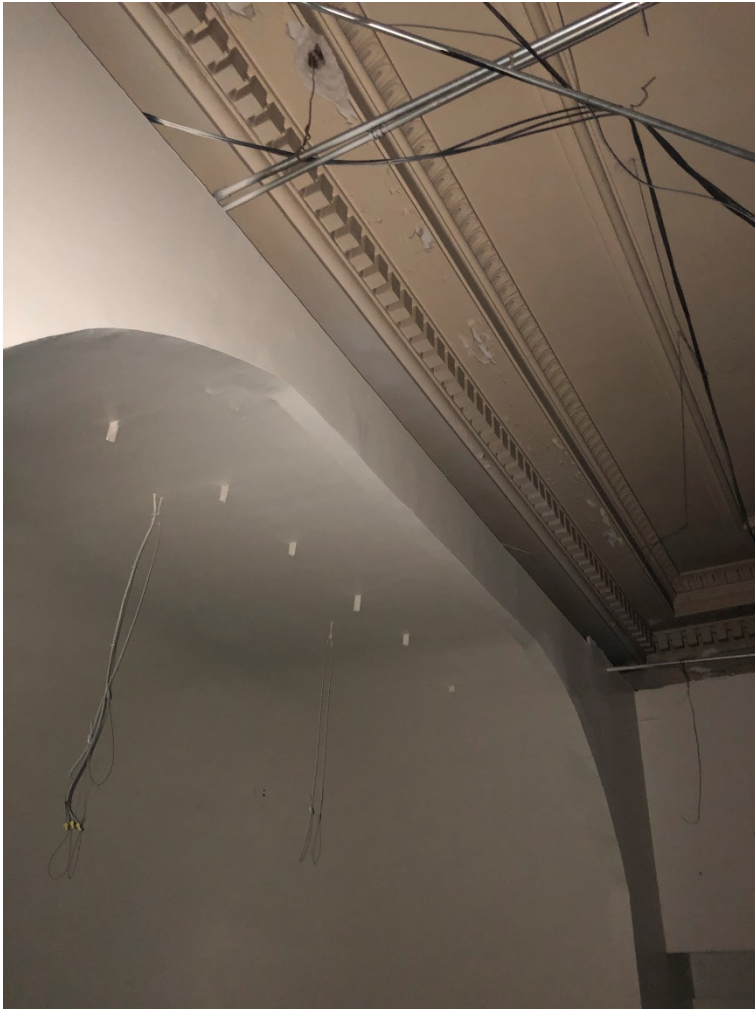
*Photo OCH - 3 - 8: Room south of south lobby. Original plaster ceiling partially exposed. Plaster walls are not original and cover original walls. Same room as OCH-3-9 and OCH-3-10.*

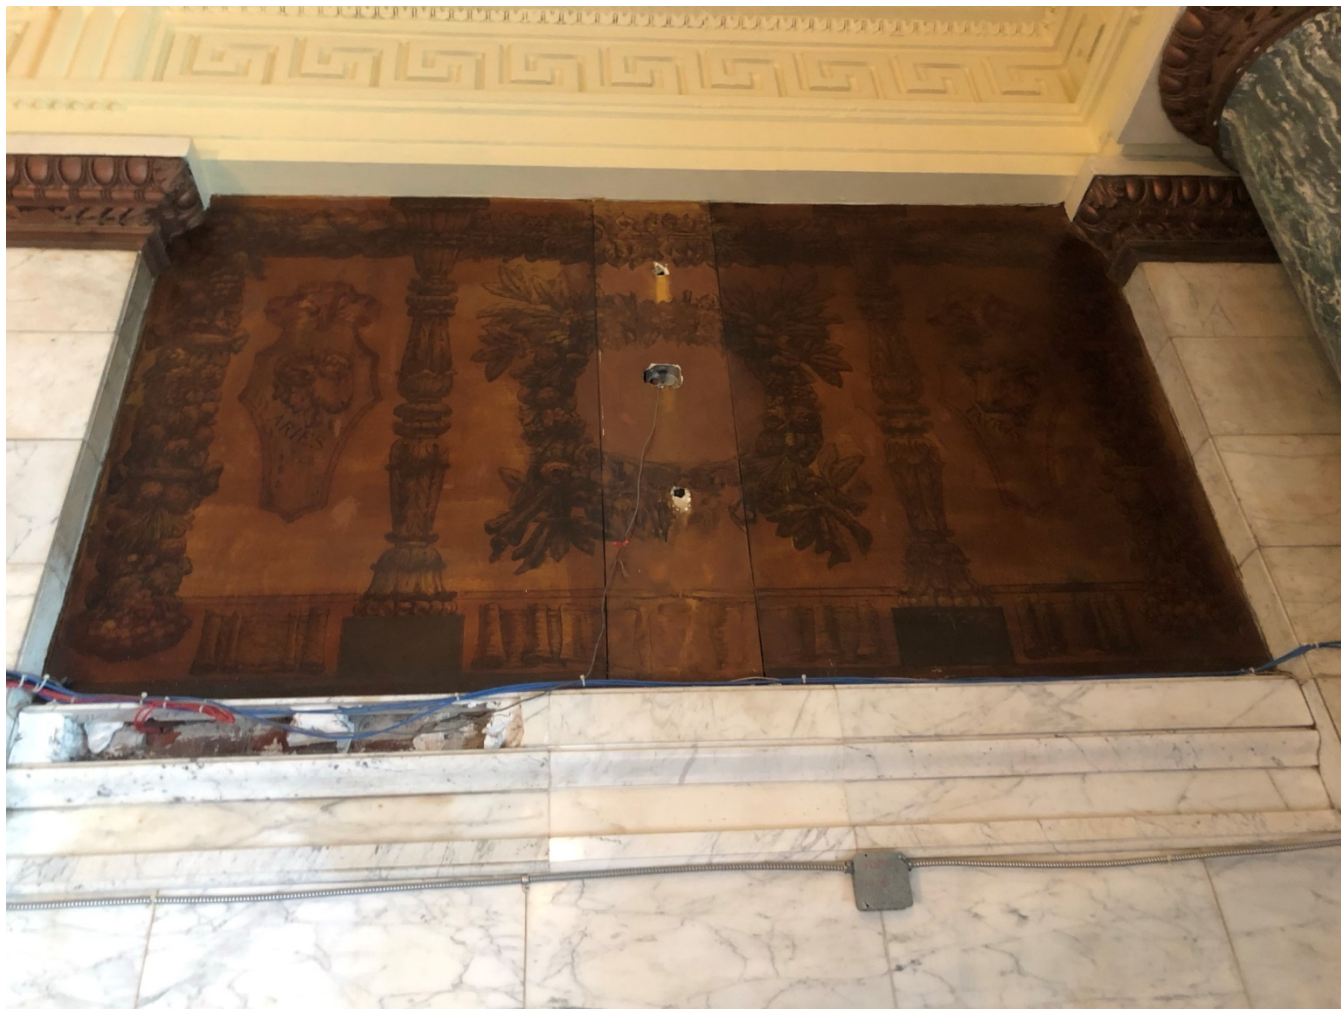
*Photo OCH - 3 - 15: Northeast corner of rotunda. Damaged artwork and marblework. Utility boxes and wrapped wiring surface mounted on marblework.*

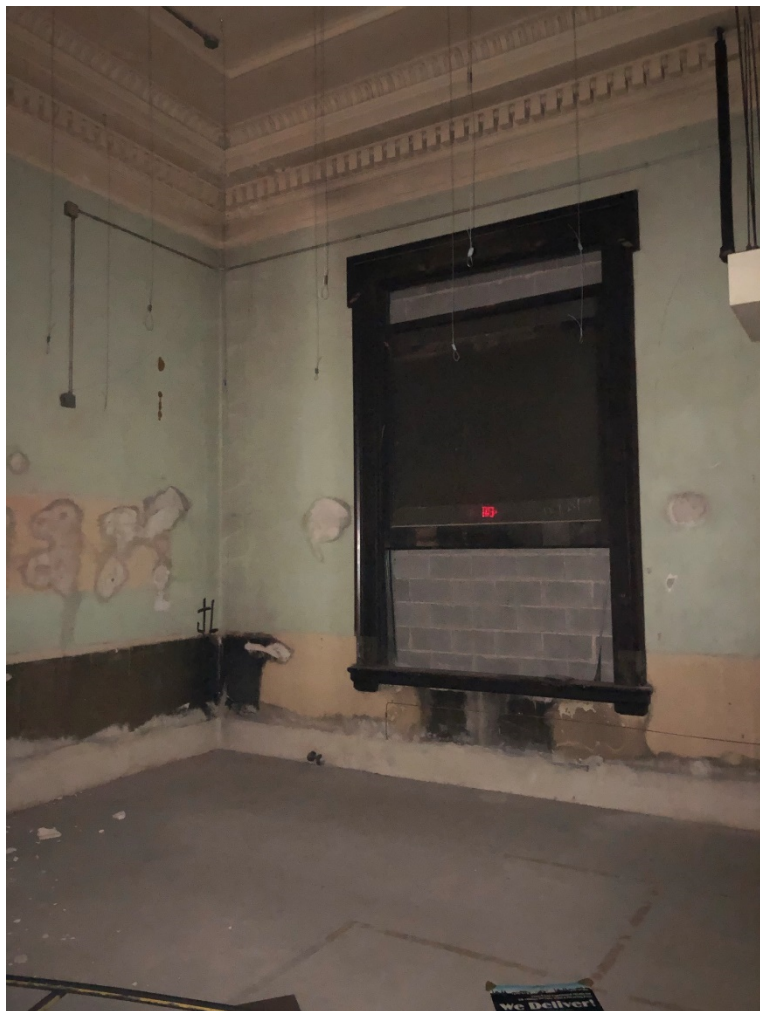
*Photo OCH - 3 - 16: Room west of north lobby. Original window removed and blocked. Adjacent to freight elevator.*

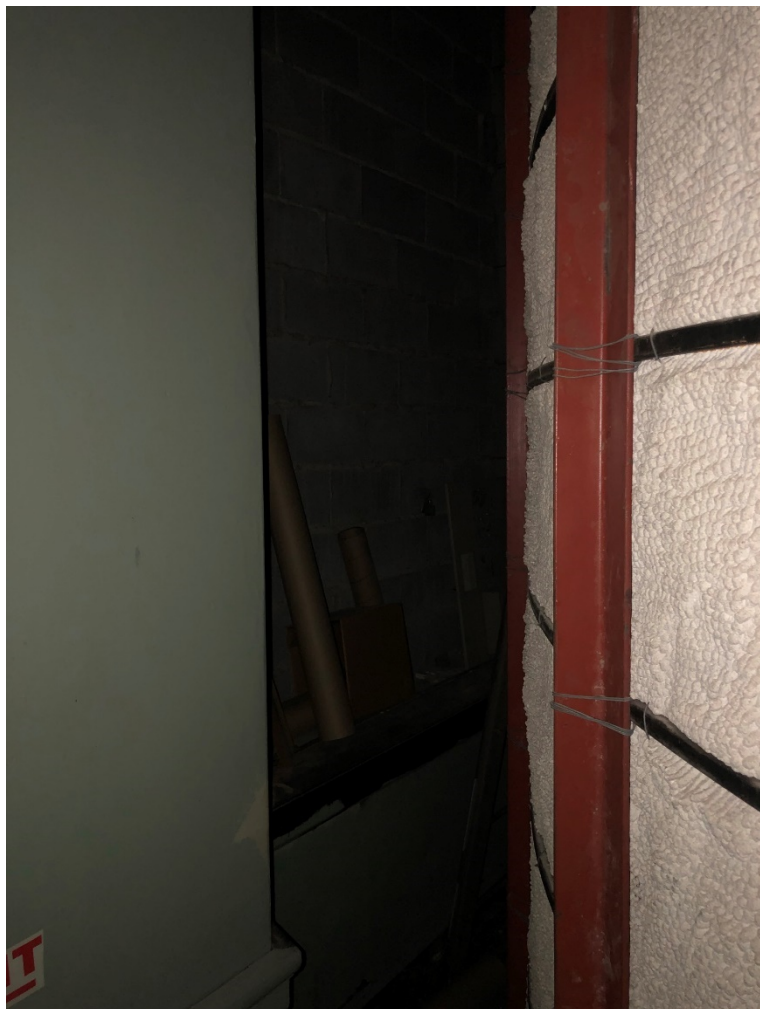
*Photo OCH - 3 - 19: Behind exhibit plaster walls installed in Room north of the north lobby. Typical condition found in rooms previously used for museum exhibit space.*

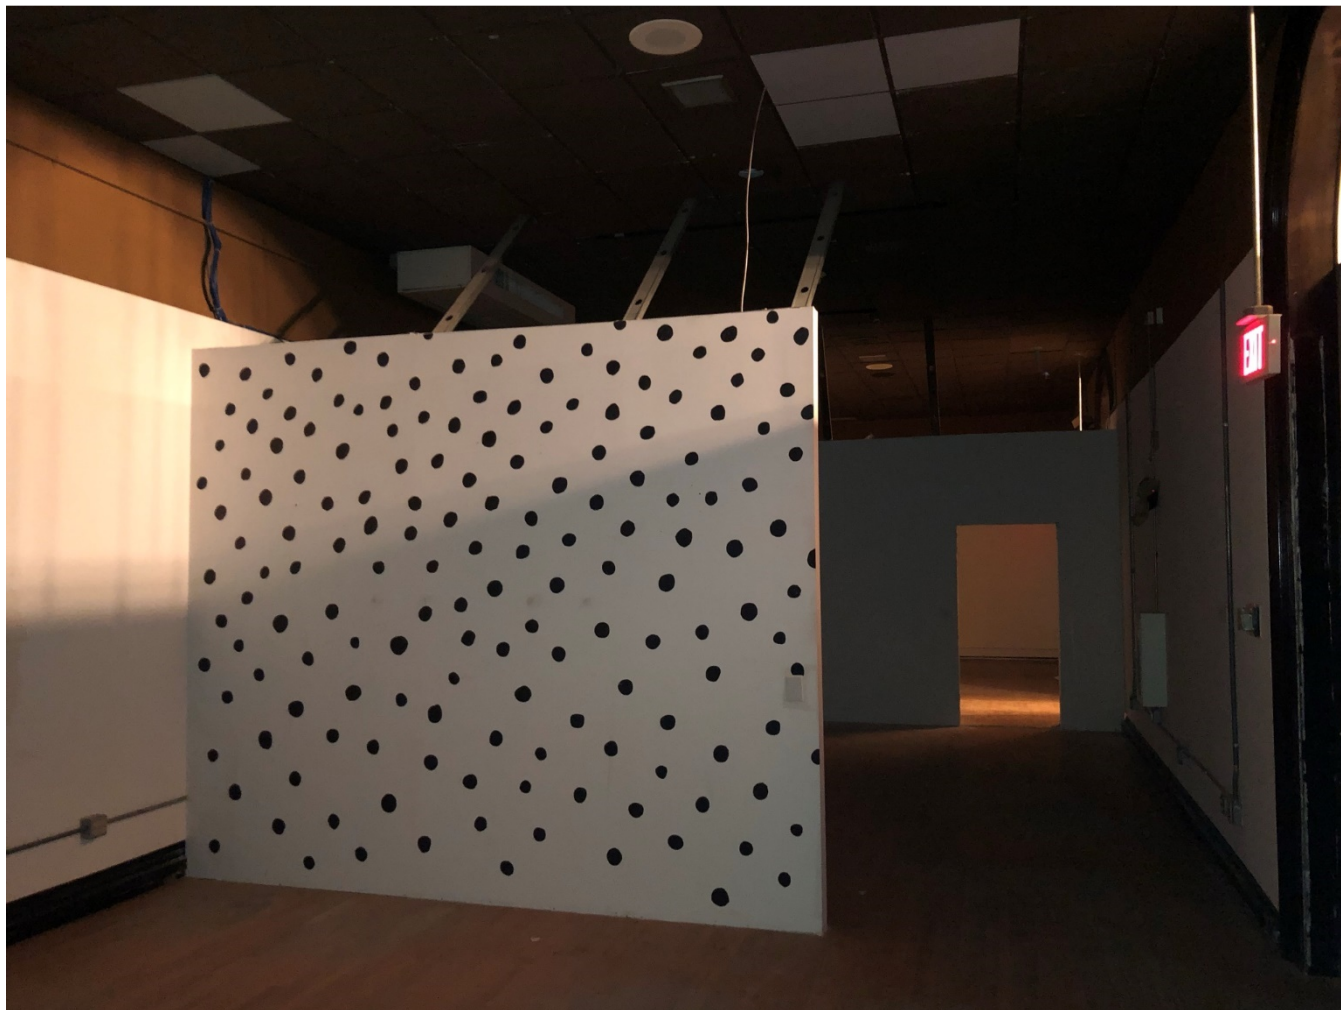
*Photo OCH - 2 - 1: Room east of rotunda. Dropped ceiling covers original plaster ceiling. Original windows removed and openings blocked and covered. Walls installed for exhibitions.*

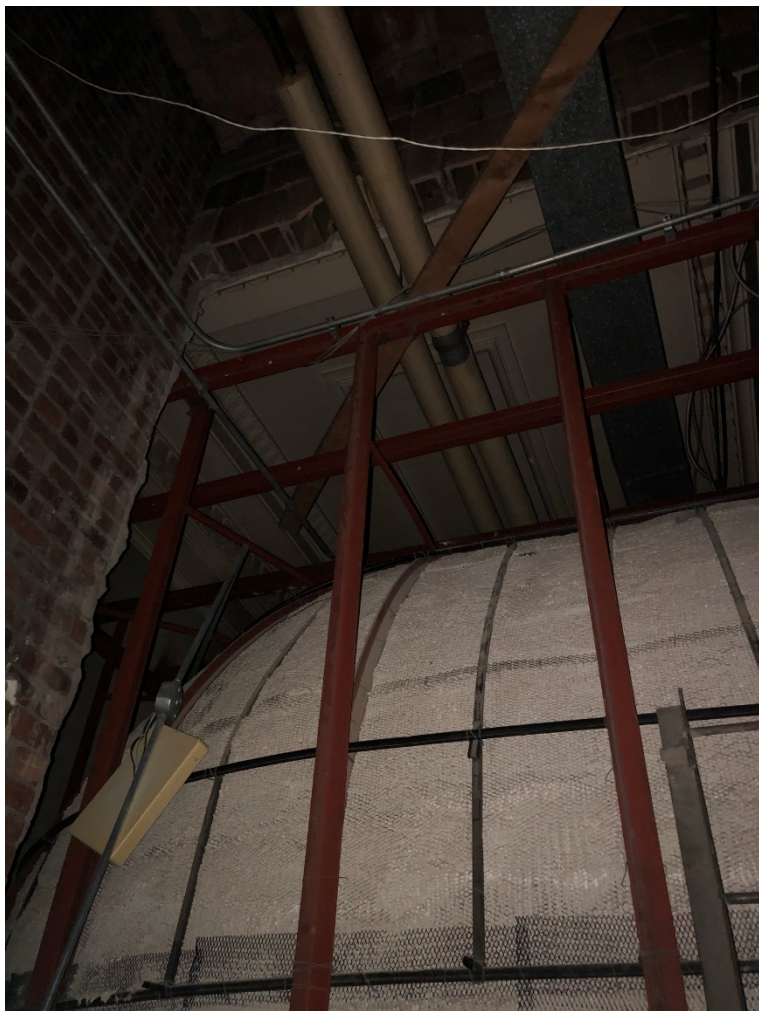
*Photo OCH - 2 - 6: Behind exhibit plaster walls installed in room south of the south lobby. Typical condition found in rooms previously used for museum exhibit space.*

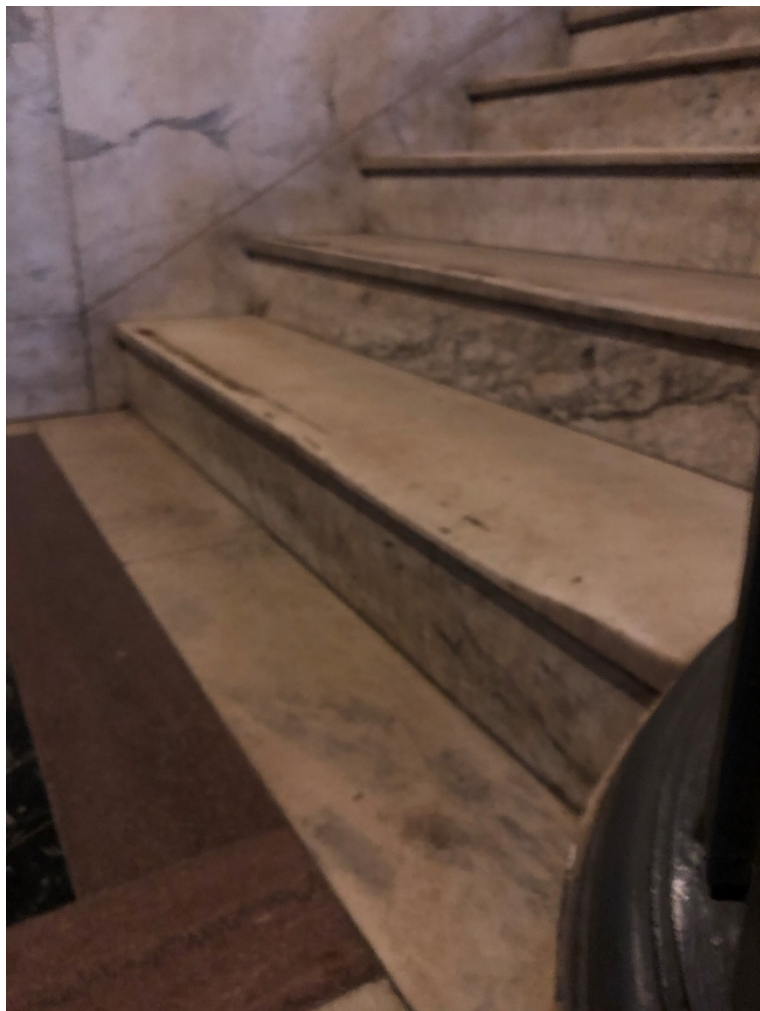
*Photo OCH - 1 - 4: North side of central stairs. Stairs leading to second floor. Significant wear on stair treads.*

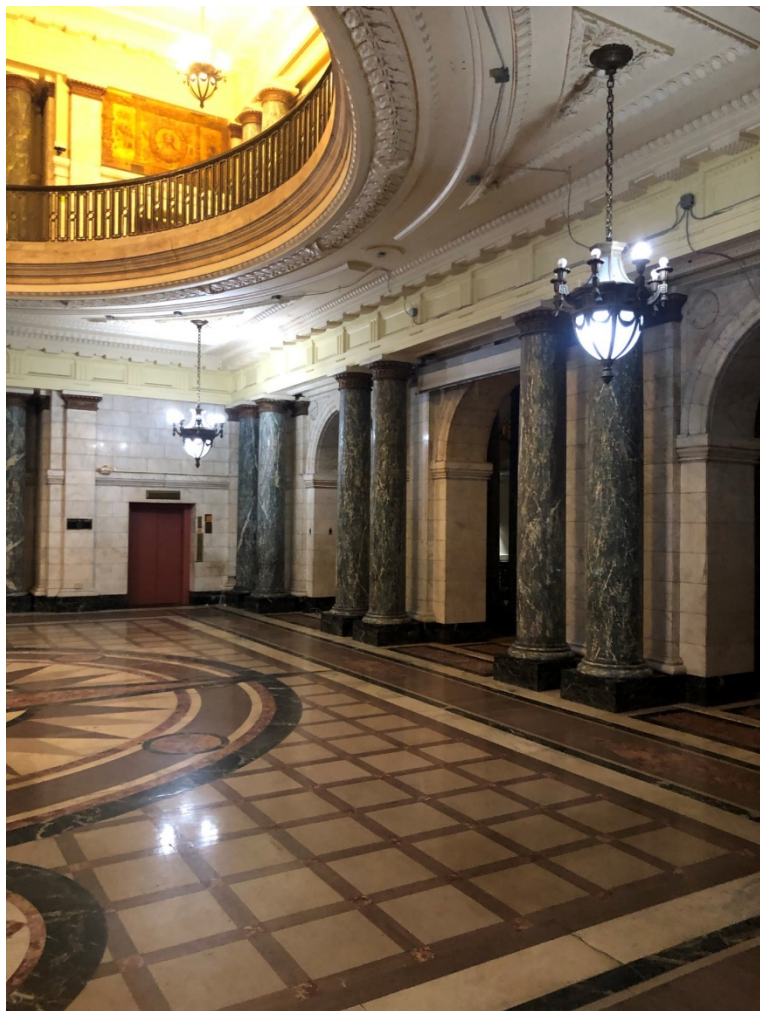
*Photo OCH - 1 - 5: Rotunda viewed from north end. Electrical conduits and metal wrapped wiring surface mounted on original plaster and marble.*

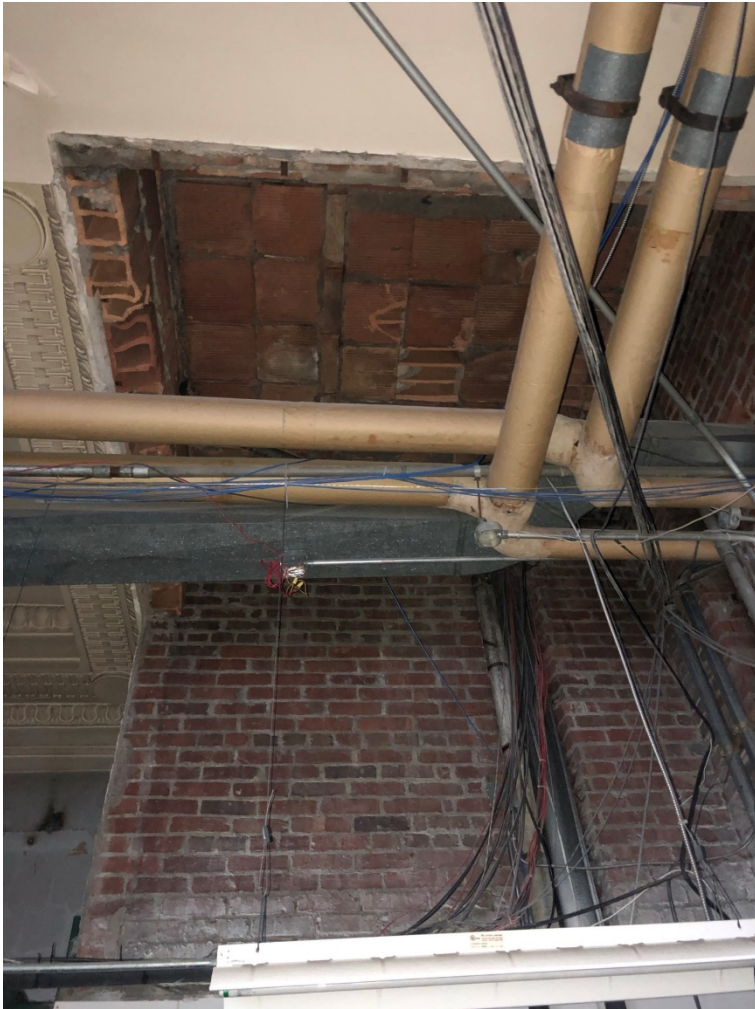
*Photo OCH - 1 - 9: East end of the room north of the north lobby. Example of plaster ceiling damage. Same room as photos OCH-1-7 and OCH-1-8.*

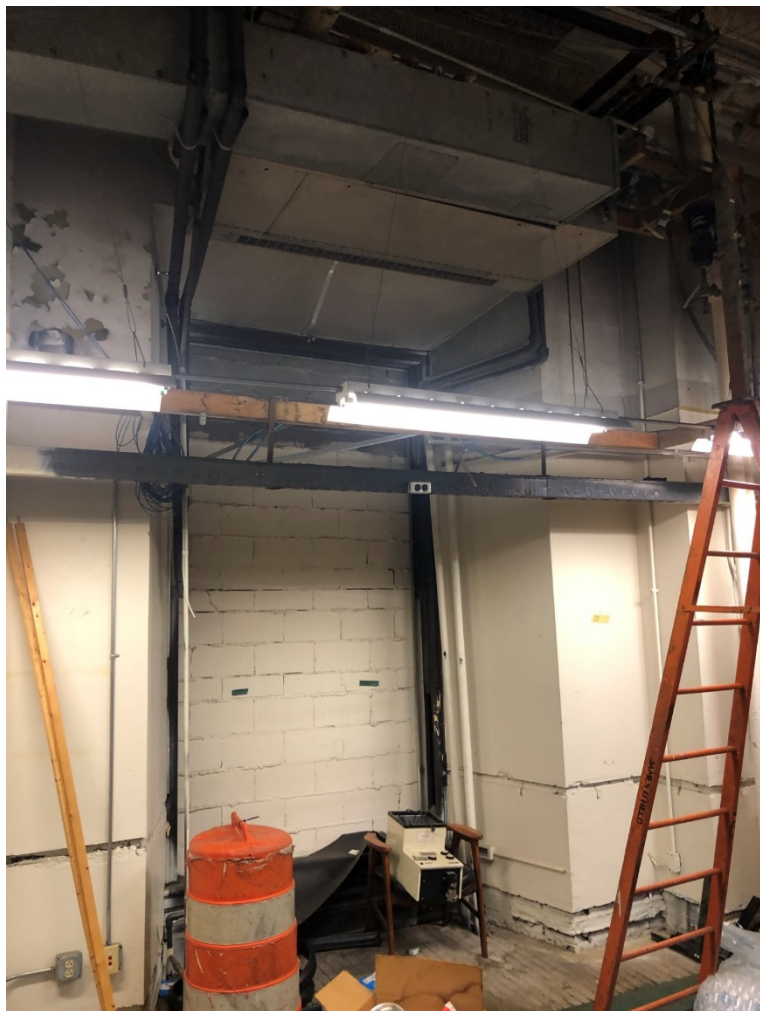
*Photo OCH - 1 - 10: Room east of north lobby. Original window removed and opening blocked. Mechanical system up against ceiling.*
