***CITY MARKET AND OLD CITY HALL***  
***Indianapolis, Indiana***

***OLD CITY HALL FACILITY ASSESSMENT AND CAPITAL PLANNING REPORT***

***JSH No.: 21060108***

***Date***  
***08/06/2021***

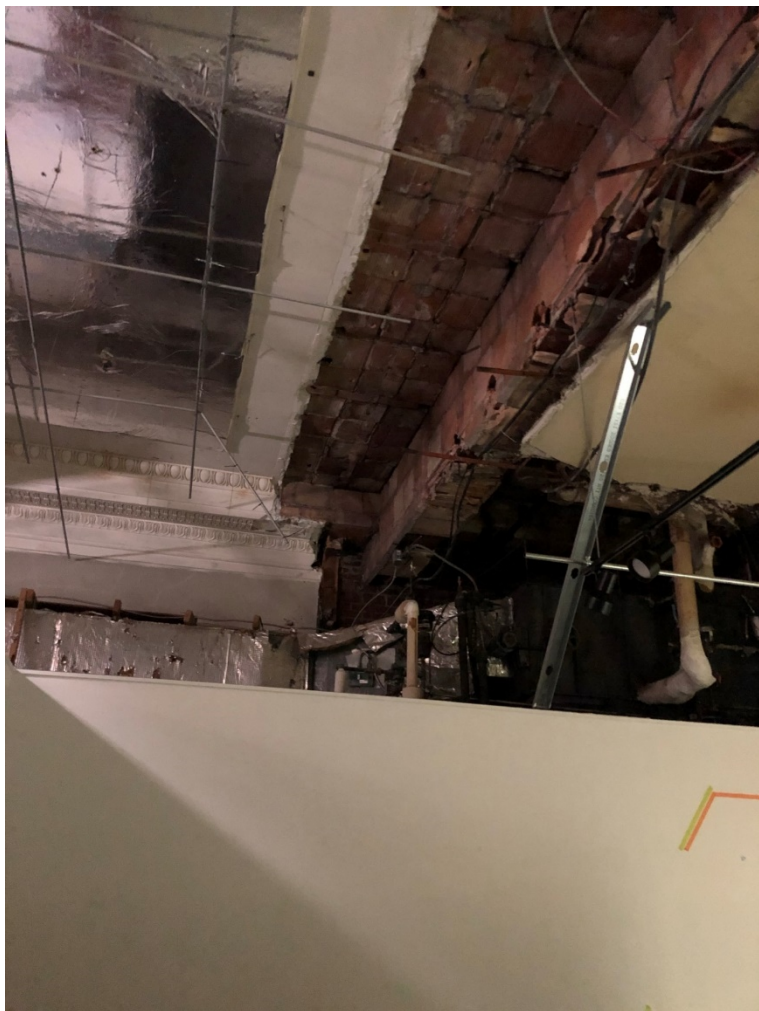
*Photo OCH - 1 - 16: Room south of the south lobby. Example of plaster ceiling damage. Same room as photo OCH-1-15.*

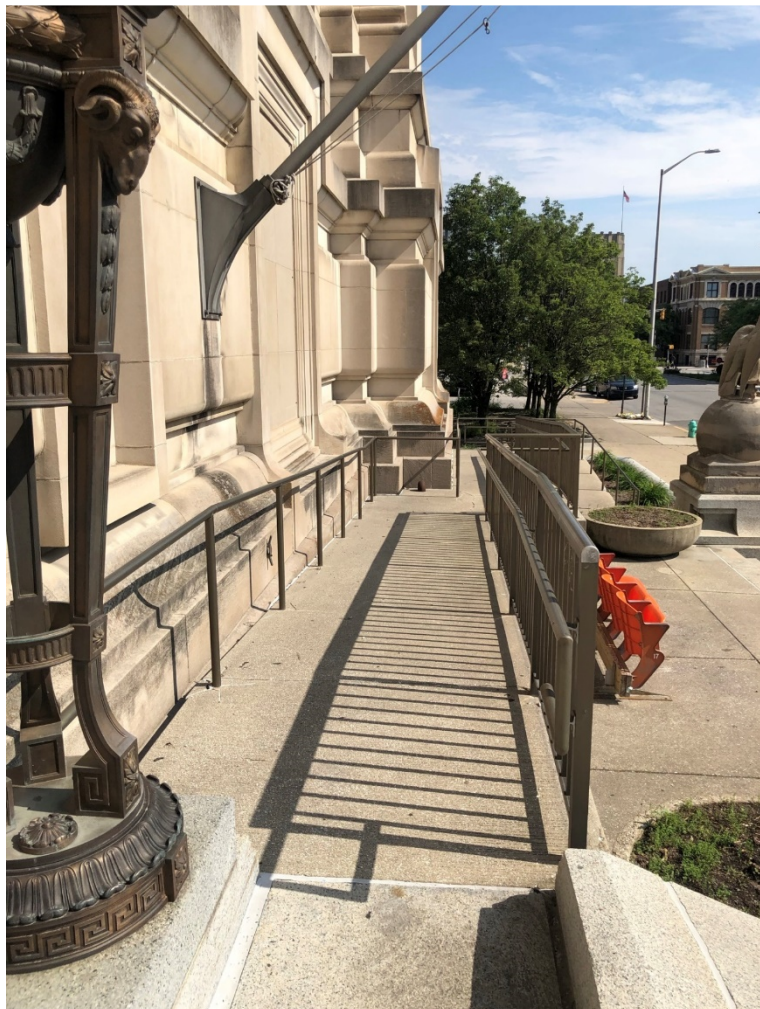
*Photo OCH - EXT - 1: Ramp from building entry to landing. Curb or barrier edge protection missing.*

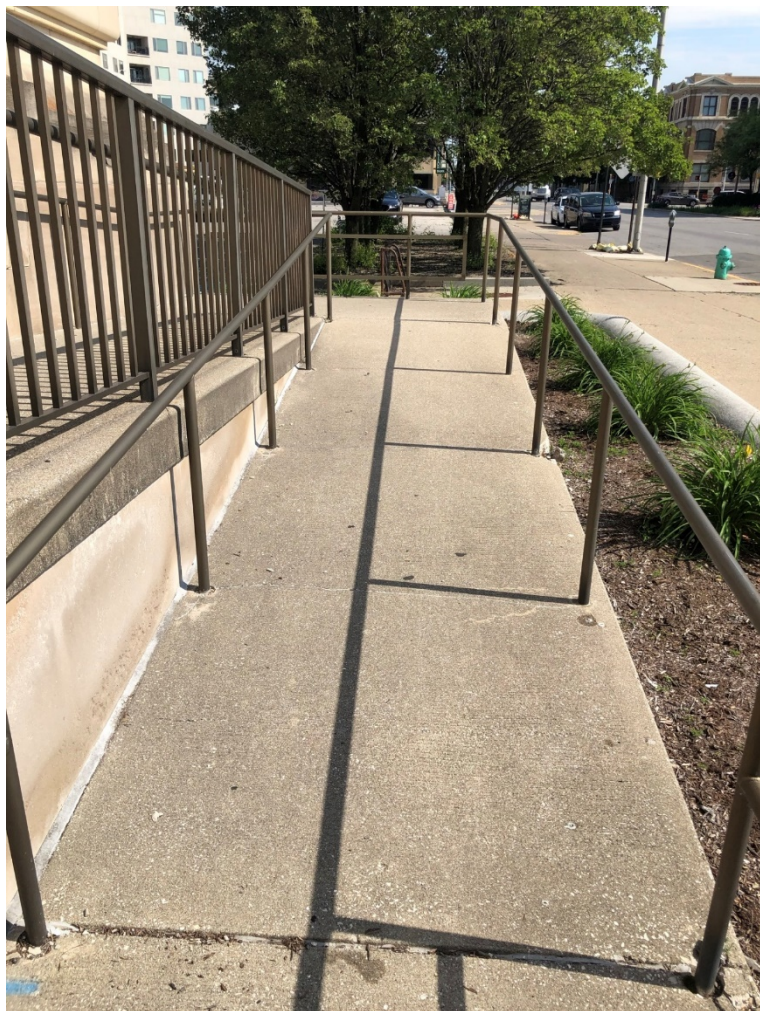
*Photo OCH - EXT - 2: Ramp from street level to landing. Curb or barrier edge missing.*

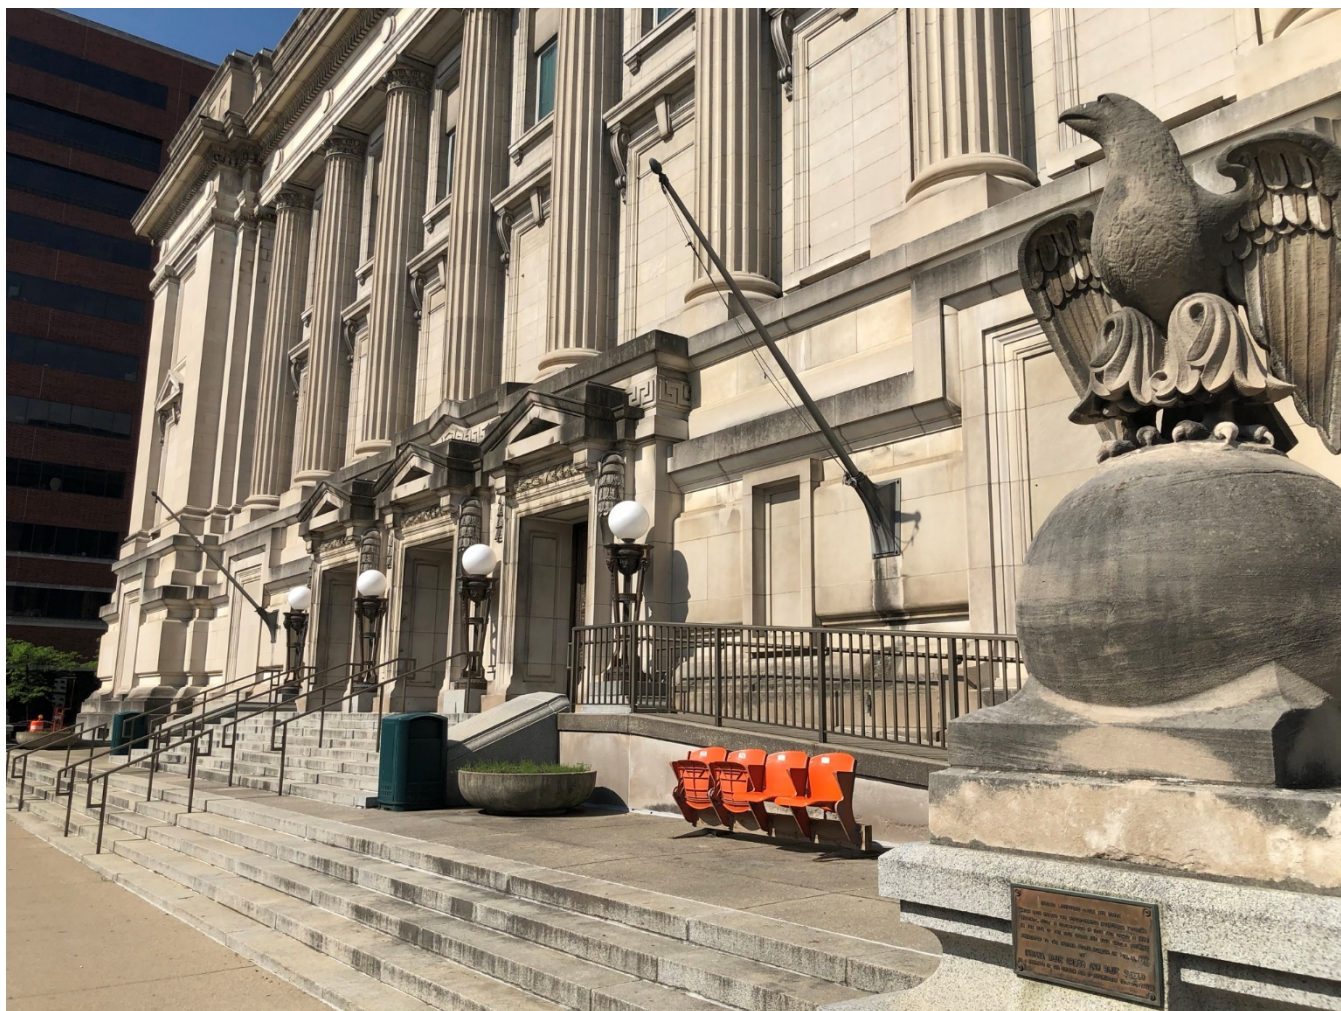
*Photo OCH - EXT - 3: East/front elevation. Multiple original windows removed and openings blocked.*

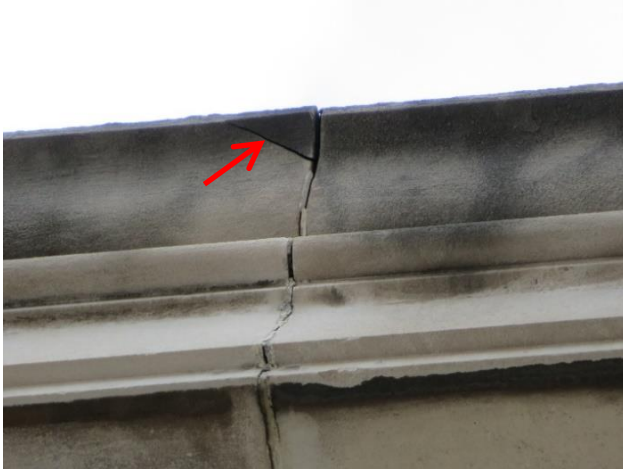
adjacent materials which are relieved by displacement, cracking, or spalling, particularly in limestone. Presuming the nail-in type wedge anchors were consistently installed along the length of the cornice, additional spalling and cracking of the cornice limestone units is expected to occur unless the anchors are removed.

Figure 11. Incipient Spall at cornice along east facade.

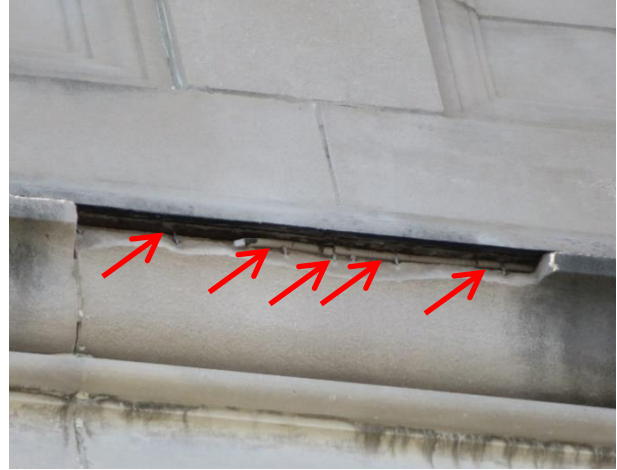
Figure 12. Spalled limestone cornice unit with metal anchors visible at fractured surface (red arrows)

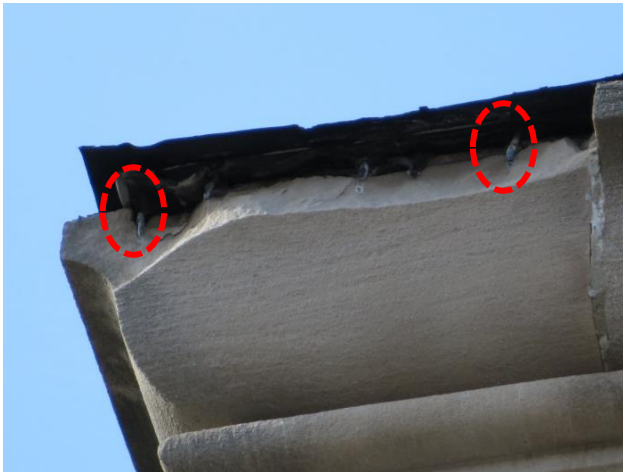
Figure 13. Wedge anchors visible at cornice spall location near northeast corner

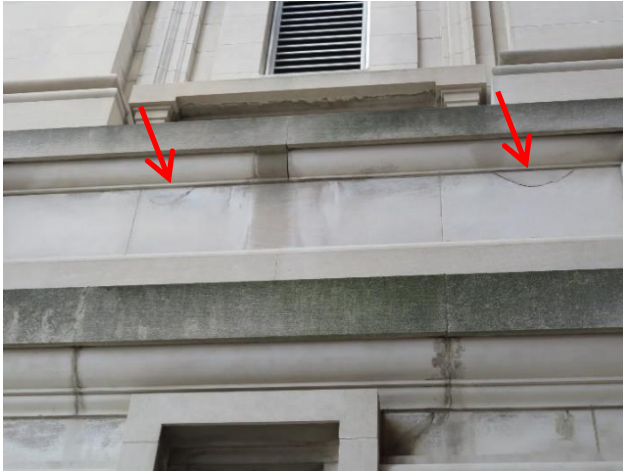
As stated previously, corrosion of mild steel can cause stresses and result in distress of adjacent confining materials such as limestone. Mild steel strap anchors were commonly utilized at the time the OCH was constructed to anchor stone back to the substrate. When the corrosion of the anchors causes spalls in the limestone on the exterior or interior side of the stone at the anchor, the lateral load carrying capacity of the anchor kerf in the limestone is reduced from its original condition. Mild steel strap anchors likely anchor most of the exterior limestone units on the building back to the substrate. Over time additional spalls could develop from corrosion of the mild steel strap anchors. Further up-close evaluation and monitoring of the limestone facade is necessary to determine if less visually prominent incipient spalls exist.

Figure 14. Two incipient limestone spalls at the west facade.

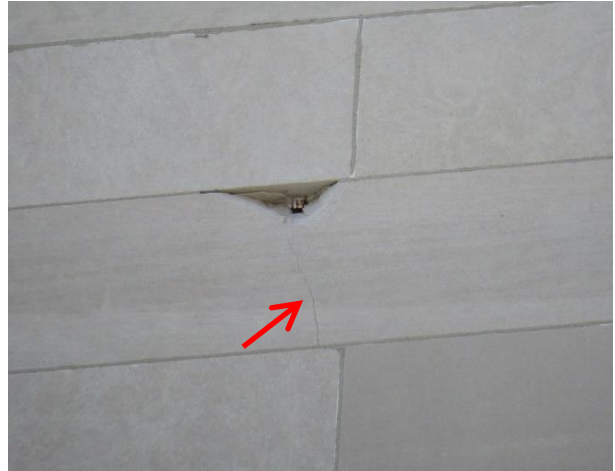
Figure 15. Spalled limestone at metal anchor showing corrosion on anchor. A crack also extends from this spall (red arrow)

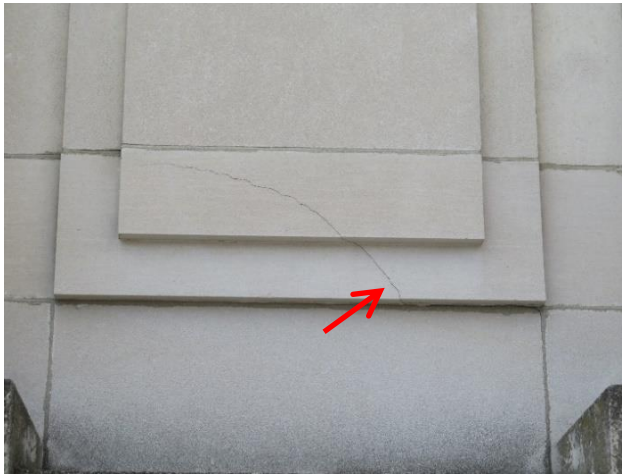
Discussion: The causes of the various cracked limestone units observed remains unknown and further up-close evaluation and inspection openings would be necessary to determine the causes and appropriate repairs. The causes for cracked limestone units should be determined prior to developing treatment methods to ensure underlying causes are mitigated to prevent future distress. Cracked limestone units could be caused by a number of factors including corrosion of embedded mild steel elements (e.g., strap anchors or structural framing), unaccommodated thermal expansion and contraction, or unaccommodated differential movement of the building.

Figure 17. Cracked limestone unit on north facade.

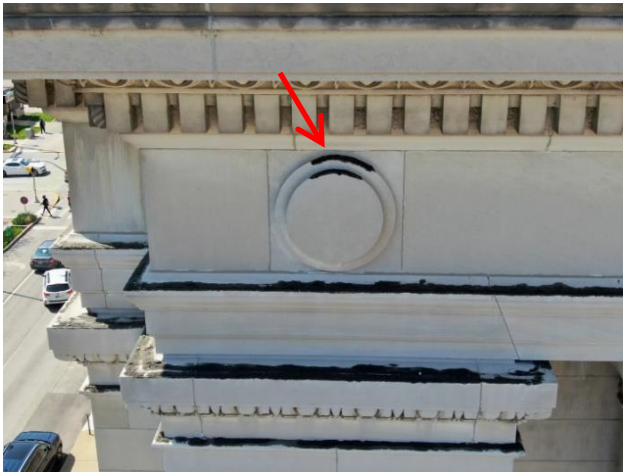
Figure 20. Unknown black material on horizontal limestone surfaces at north facade.

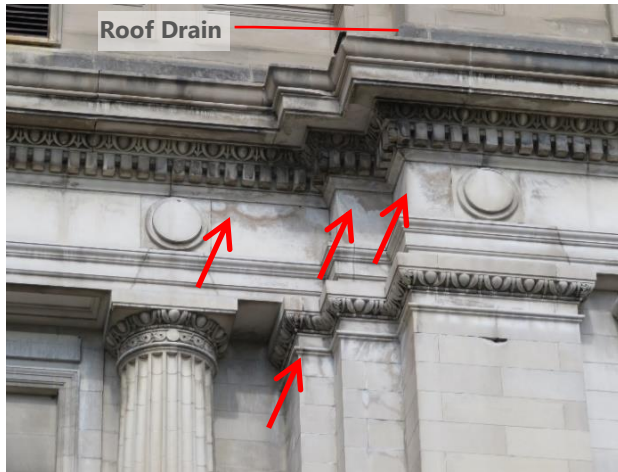
Figure 24. Water staining and efflorescence below cornice at northeast re-entrant corner.

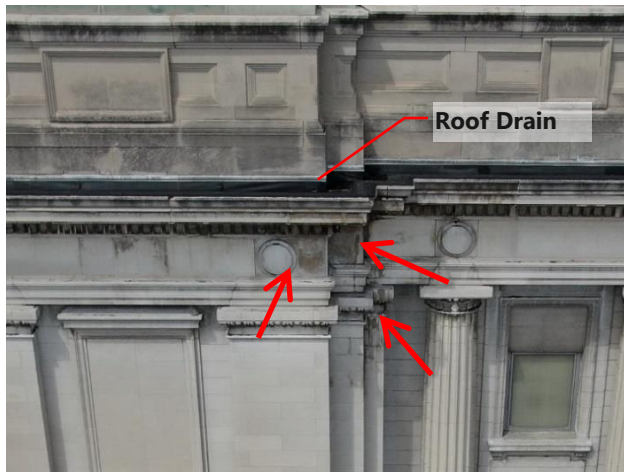
Figure 25. Water staining below the cornice at southeast re-entrant corner.

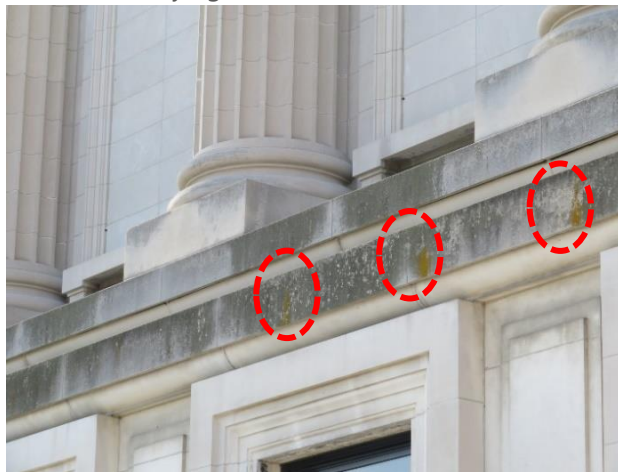
Figure 26. Atmospheric staining on vertical surface of north facade. Biological growth within stained areas is shown by red dashed ellipses.

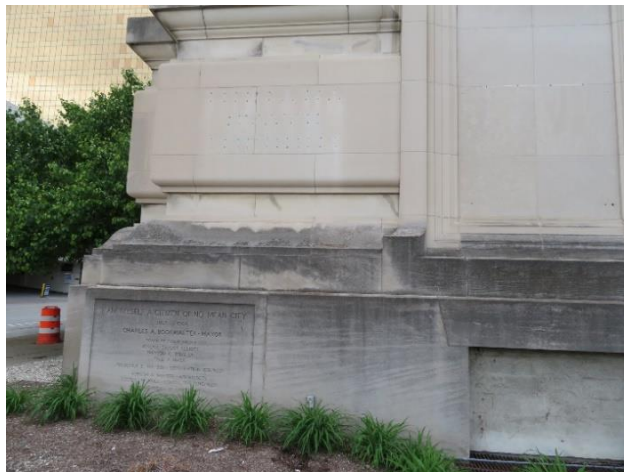
Figure 27. Atmospheric staining near base of wall.

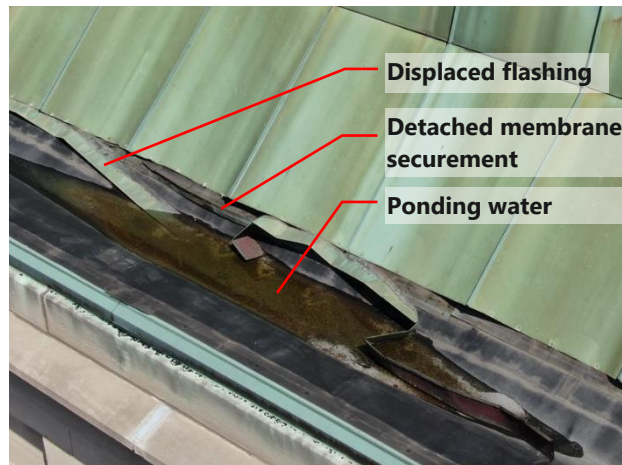
Figure 46. Detached copper flashing and metal roof membrane securement along the south edge of Roof Area 2.

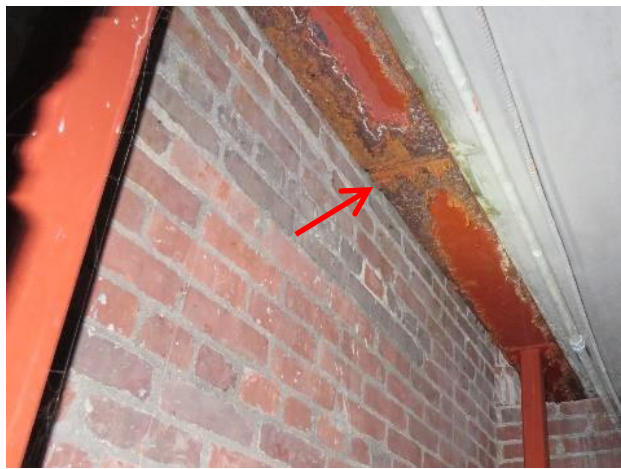
Figure 59. Surface corrosion on supplemental steel framing below vaulted sidewalk.

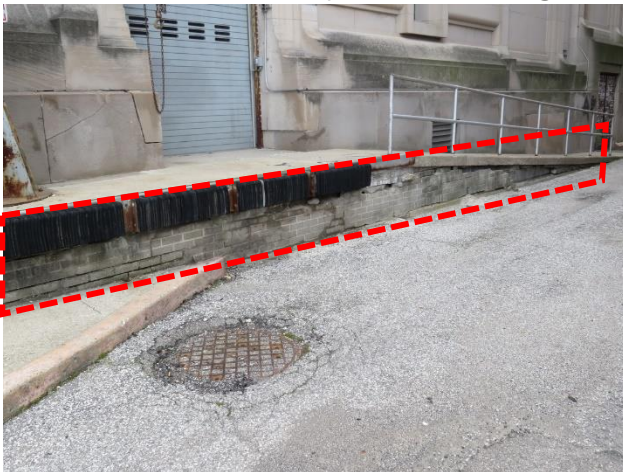
Figure 62. Cracked and missing bricks along loading dock facade.

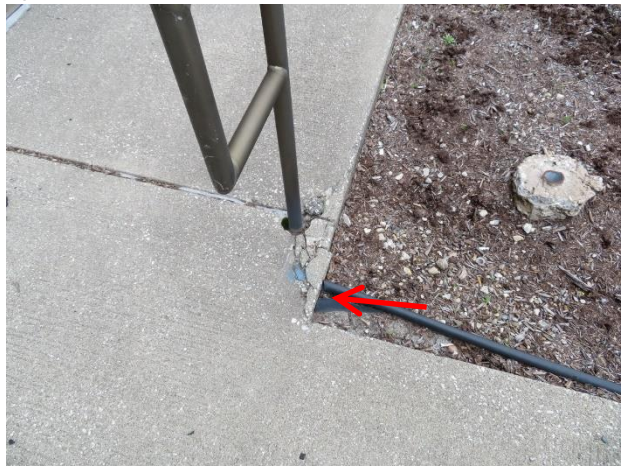
Figure 64. Cracked concrete at base of ramp handrail.

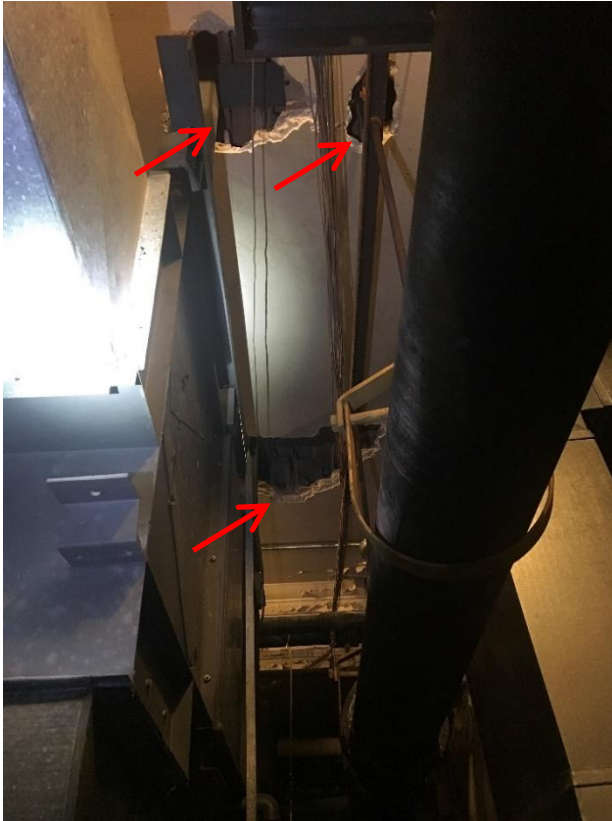
Figure 74. Basement mechanical room showing damage to structural fireproofing at the ceiling level.

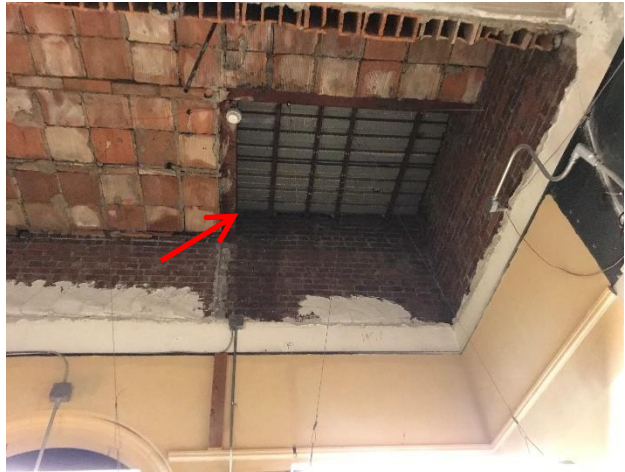
Figure 75. Damaged structural fireproofing near the freight elevator on the first floor.

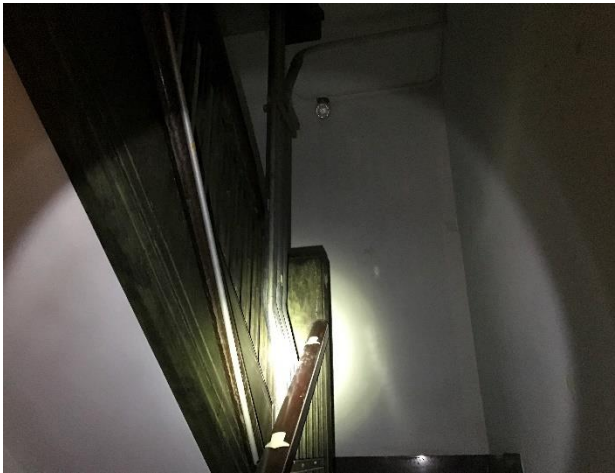
Figure 76. Wall constructed in stairway obstructing egress path of enclosed stairway

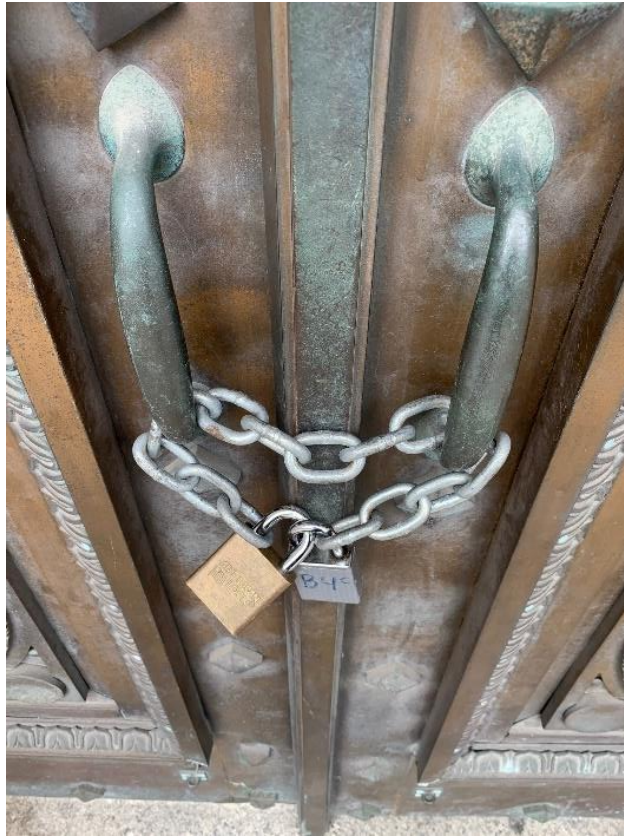
Figure 77. Chain lock on the outside of the main entrance doors creating an obstructed egress condition.

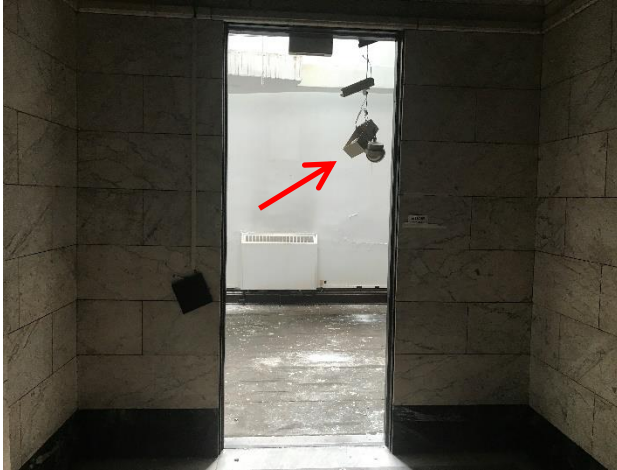
Figure 78. Damage exit sign and emergency light

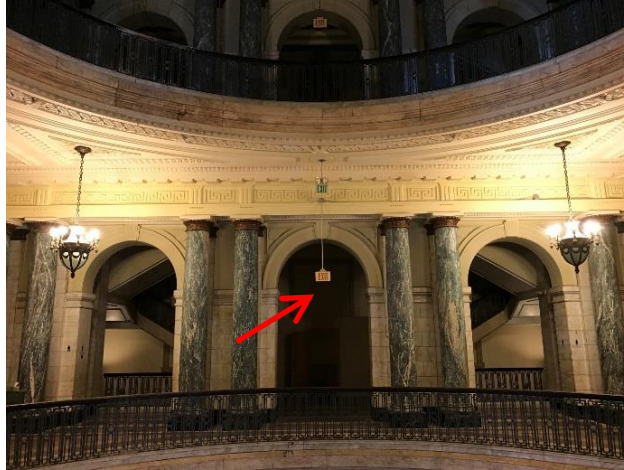
Figure 79. Burnt out exit signage in main atrium space
