***CITY MARKET AND OLD CITY HALL***  
***Indianapolis, Indiana***

***OLD CITY HALL FACILITY ASSESSMENT AND CAPITAL PLANNING REPORT***

***JSH No.: 21060108***

***Date***  
***08/06/2021***

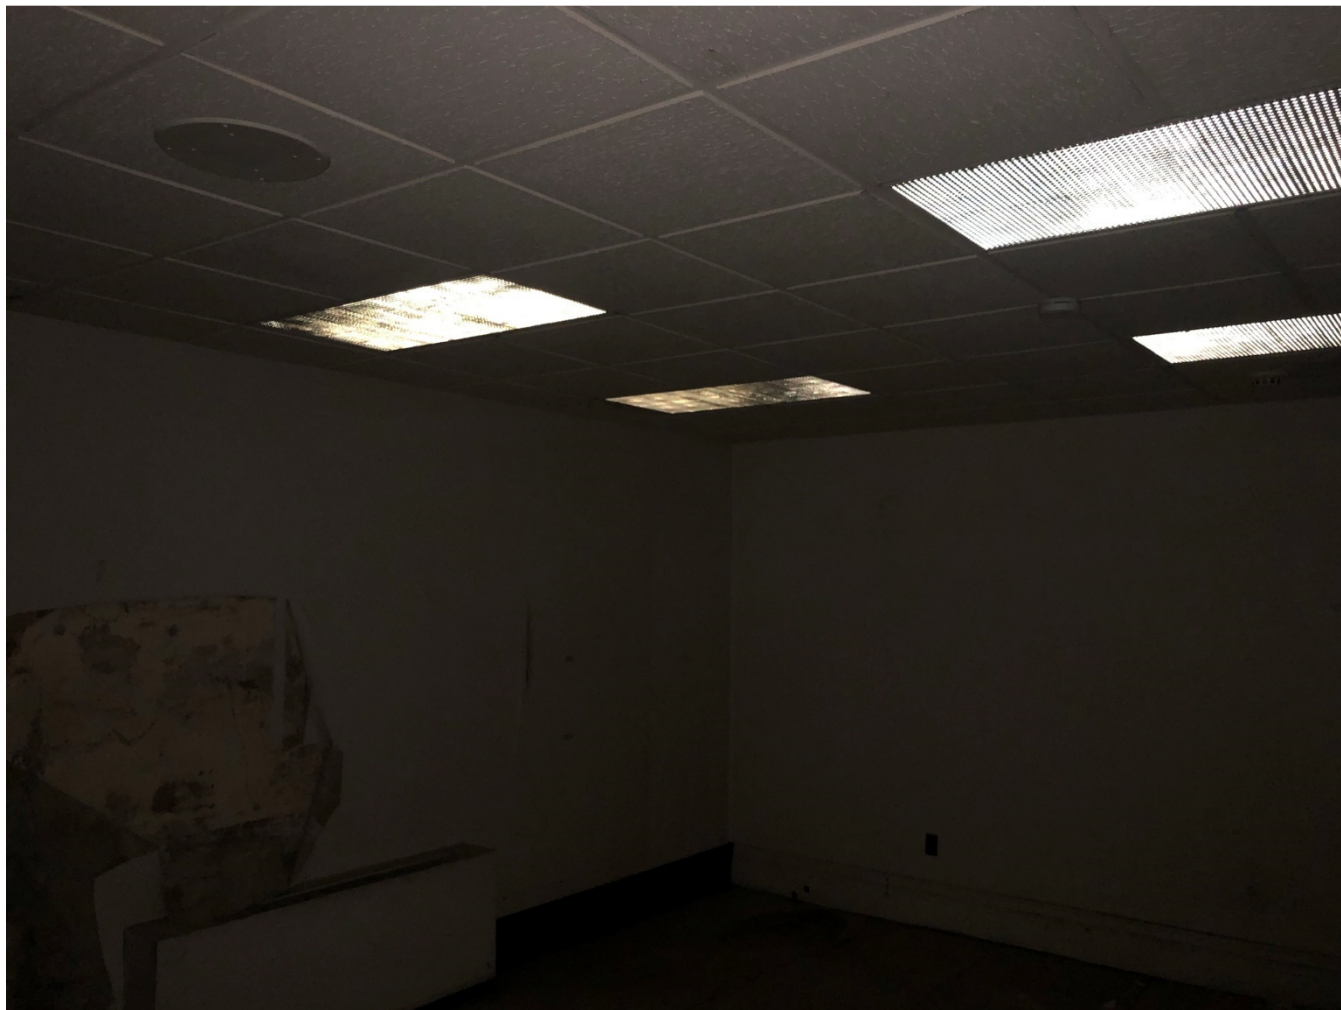
*Photo OCH - 4 - 1: Office south of central stairs. Drop ceiling covering original plaster ceiling.*

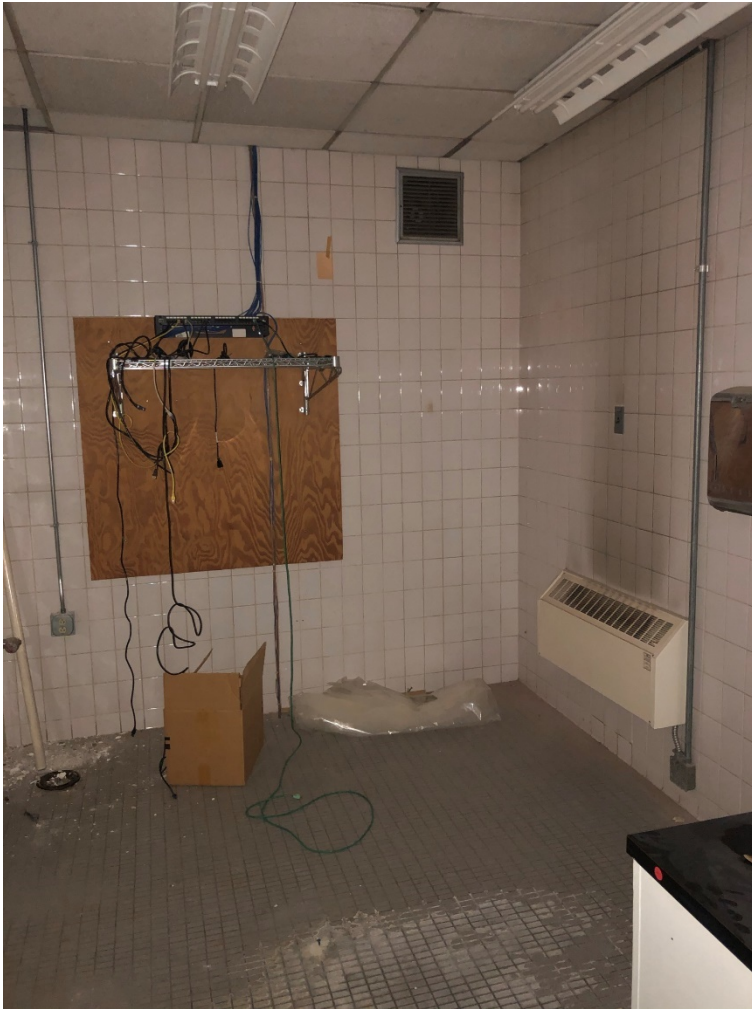
*Photo OCH - 4 - 2: Former bathroom east of council chamber utilized as MDF room.*

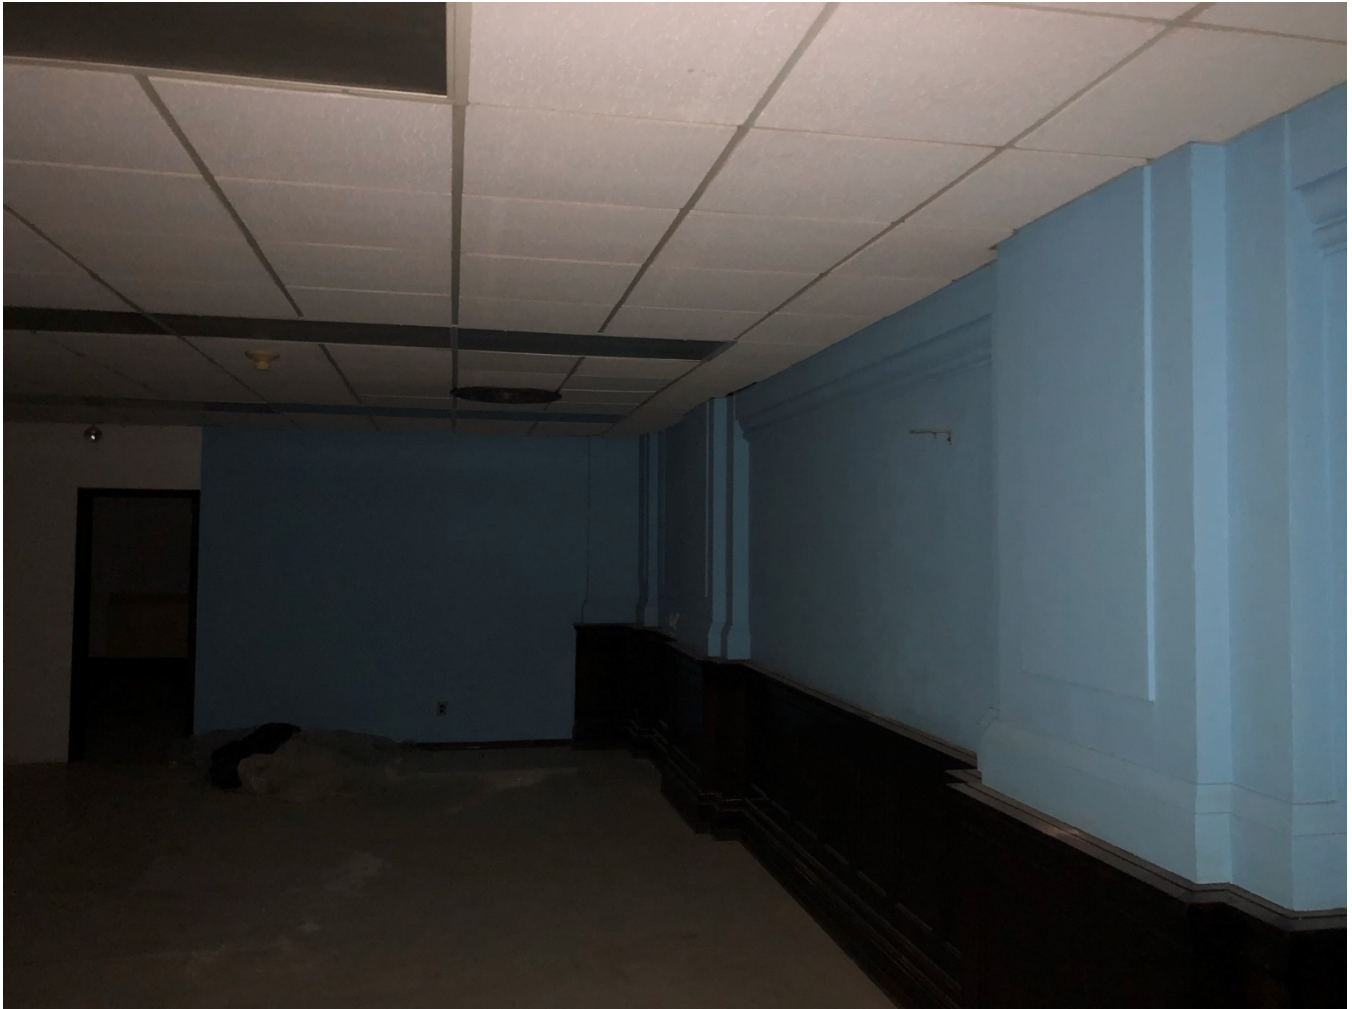
*Photo OCH - 4 - 3: Council chamber. Drop ceiling covering original plaster ceiling. Window openings blocked in.*

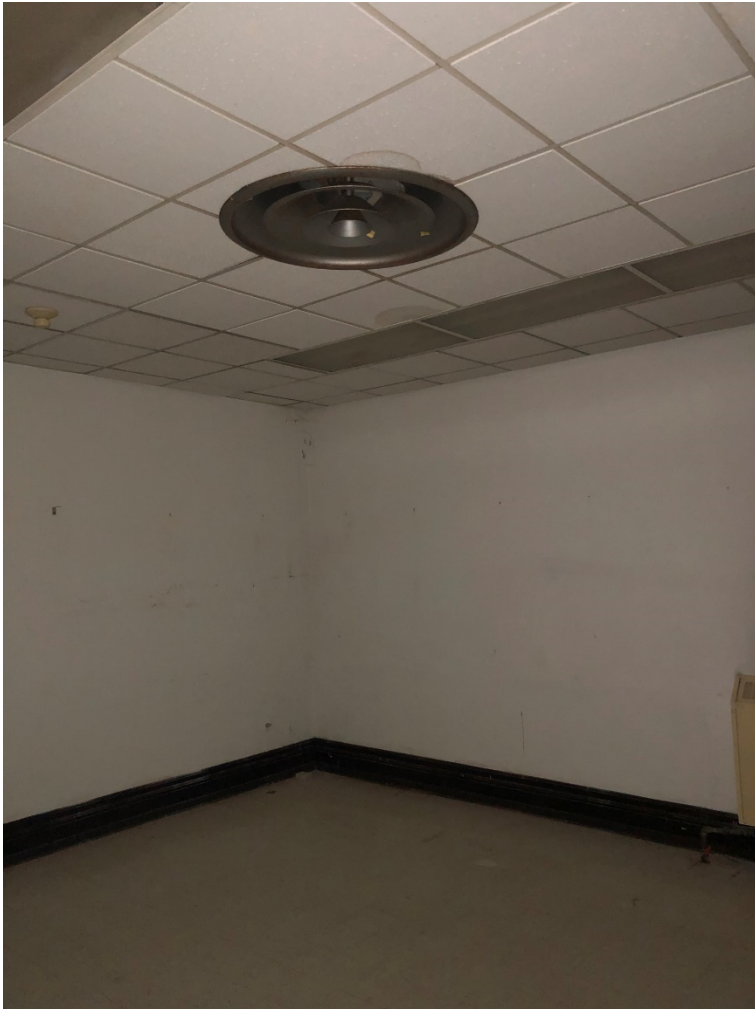
*Photo OCH - 4 - 4: Office west of council chamber. Drop ceiling covering original plaster ceiling. Window openings blocked in and plastered.*

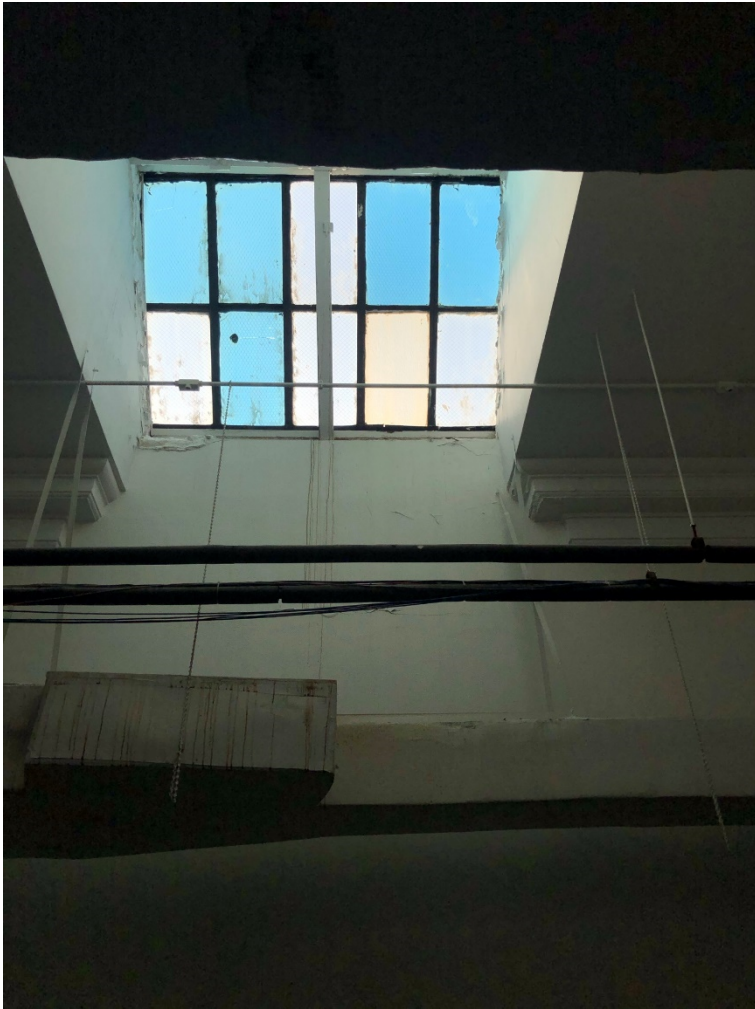
*Photo OCH - 4 - 9: Office east of the rotunda. Original skylight. Same room as Photo OCH-4-8.*

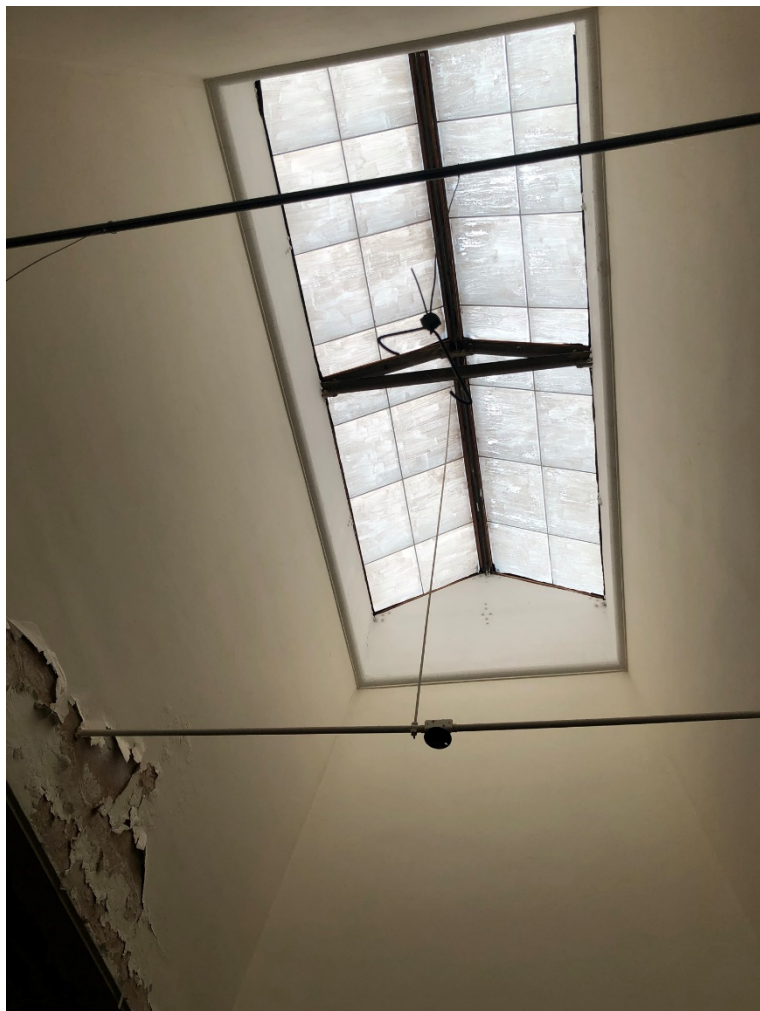
*Photo OCH - 4 - 10: Lobby north of rotunda. Original skylight. Same room as Photo-OCH-4-11.*

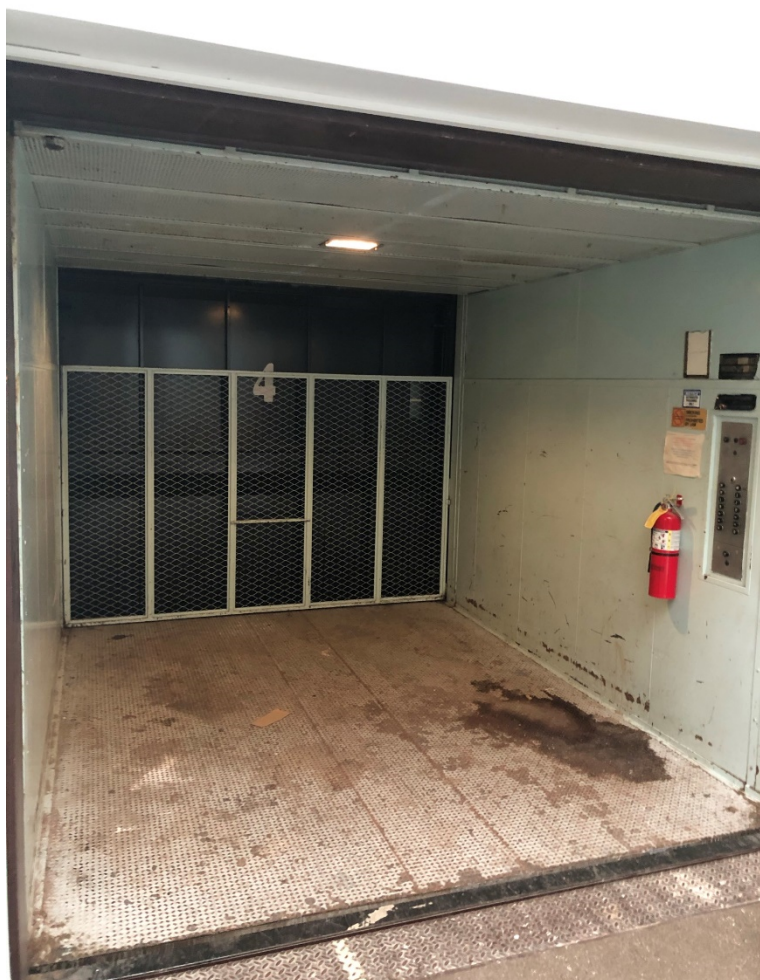
*Photo OCH - 4 - 12: Interior of freight elevator.*

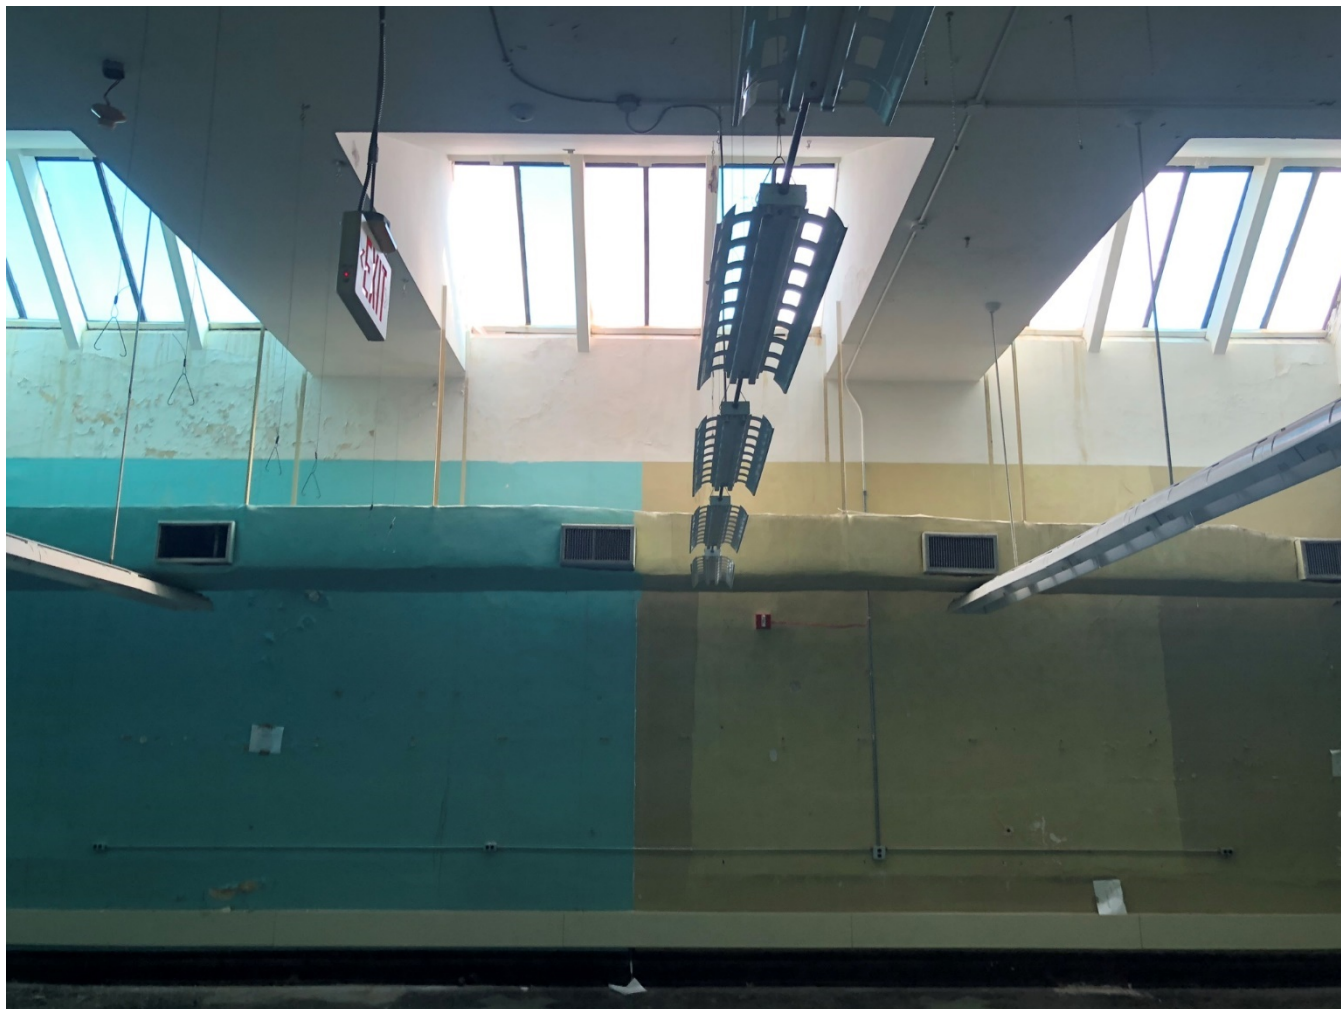
*Photo OCH - 4 - 13: Office north of rotunda. Original plaster ceiling and skylights. Windows openings blocked in and plastered. Same room as OCH-4-14.*

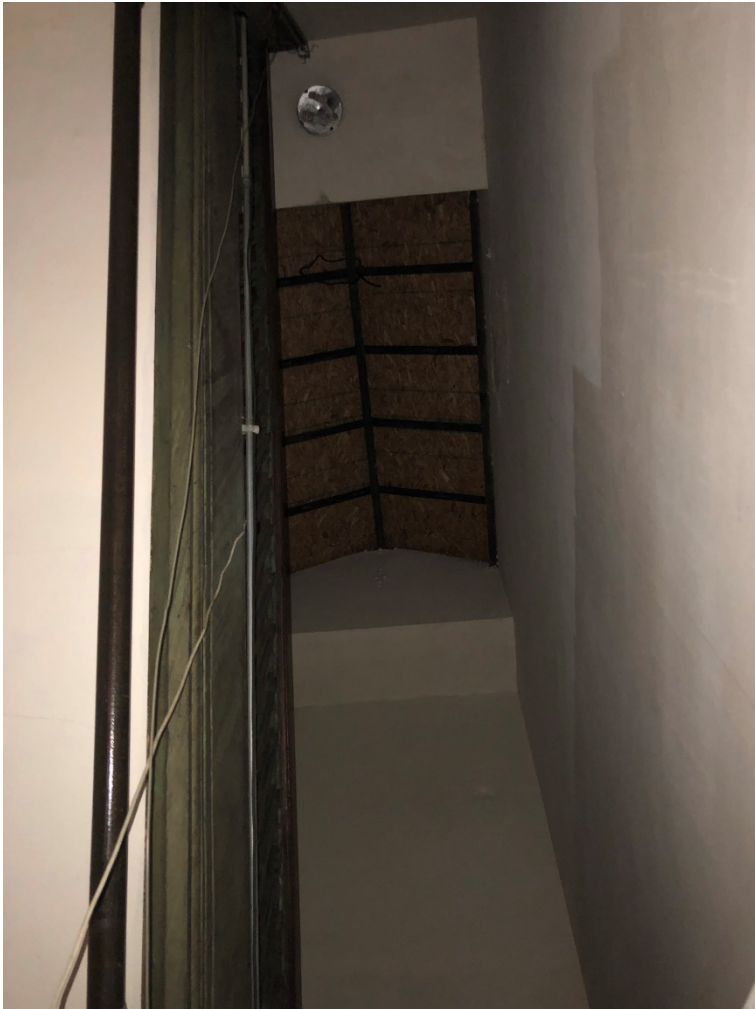
*Photo OCH - 4 - 18: North private stair. Skylight over stairwell. Roofing installed over original skylight.*

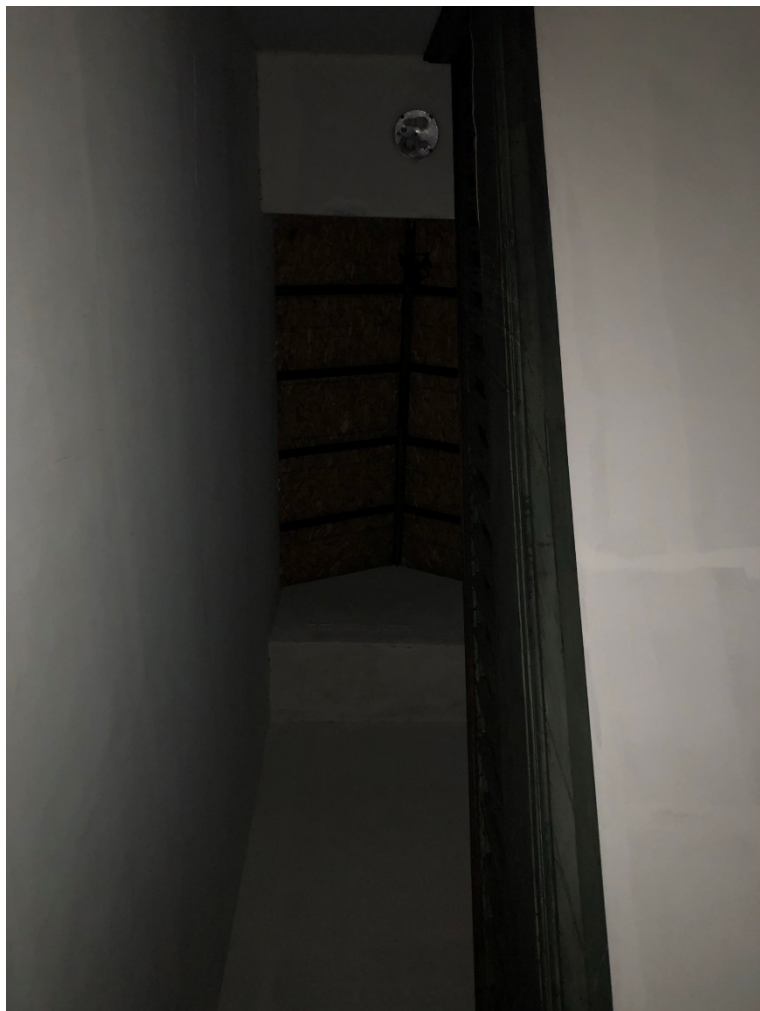
*Photo OCH - 4 - 19: South private stair. Skylight over stairwell. Roofing installed over original skylight.*

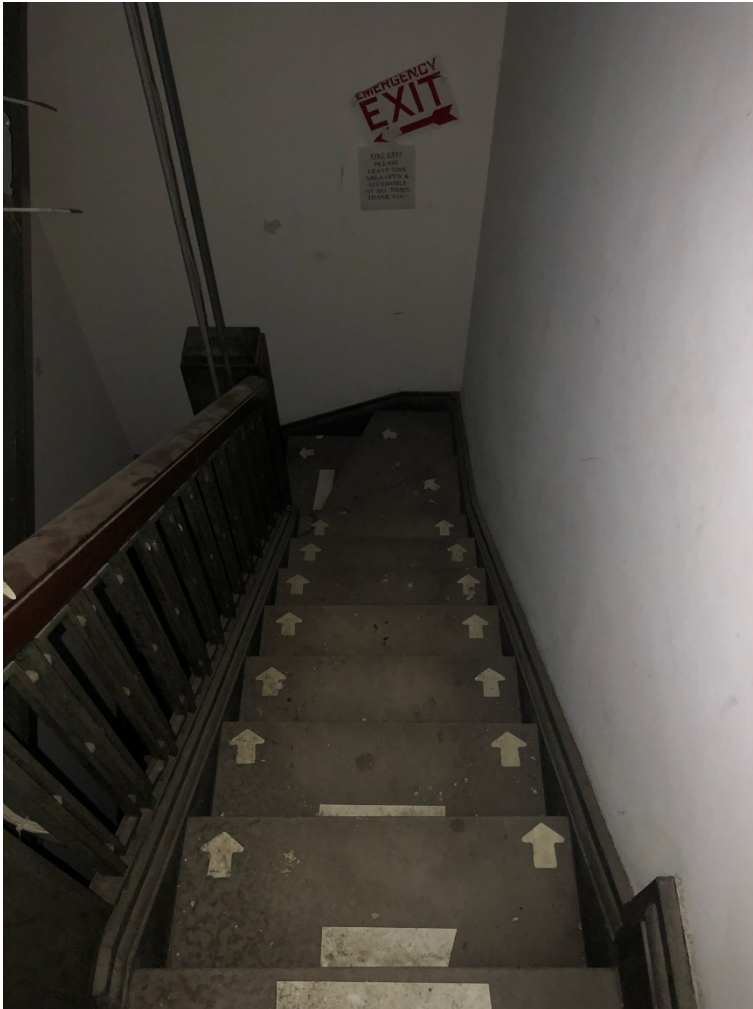
*Photo OCH - 4 - 20: South private stair view from 4<sup>th</sup> floor. Handrail only on one side.*

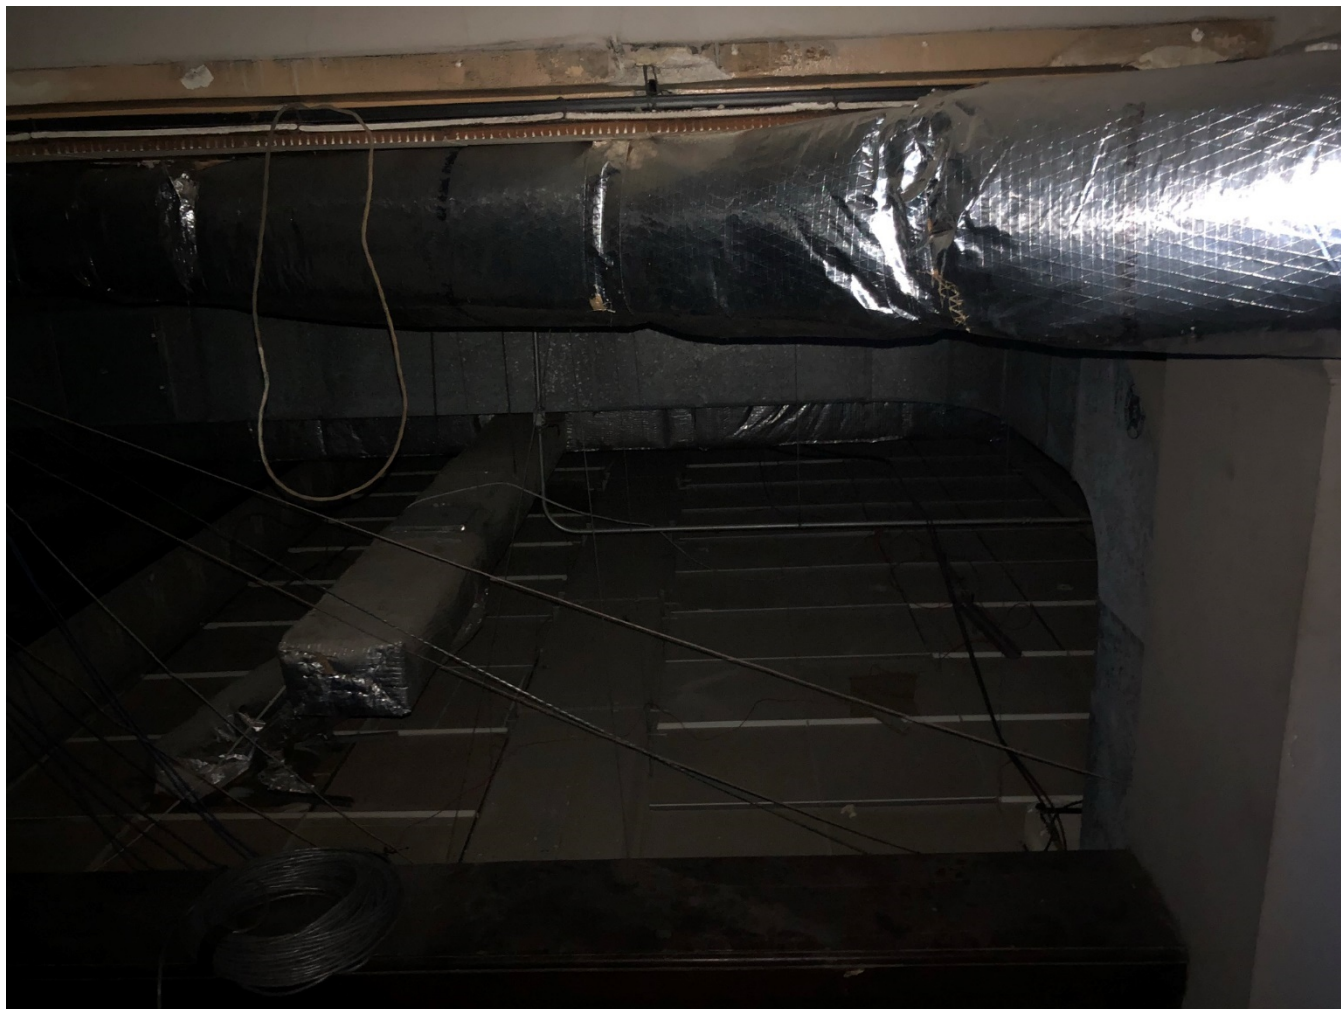
*Photo OCH - 4 - 24: View from mezzanine looking over council chambers. Suspended ceiling blocks view. Ductwork fills space about suspended ceiling.*

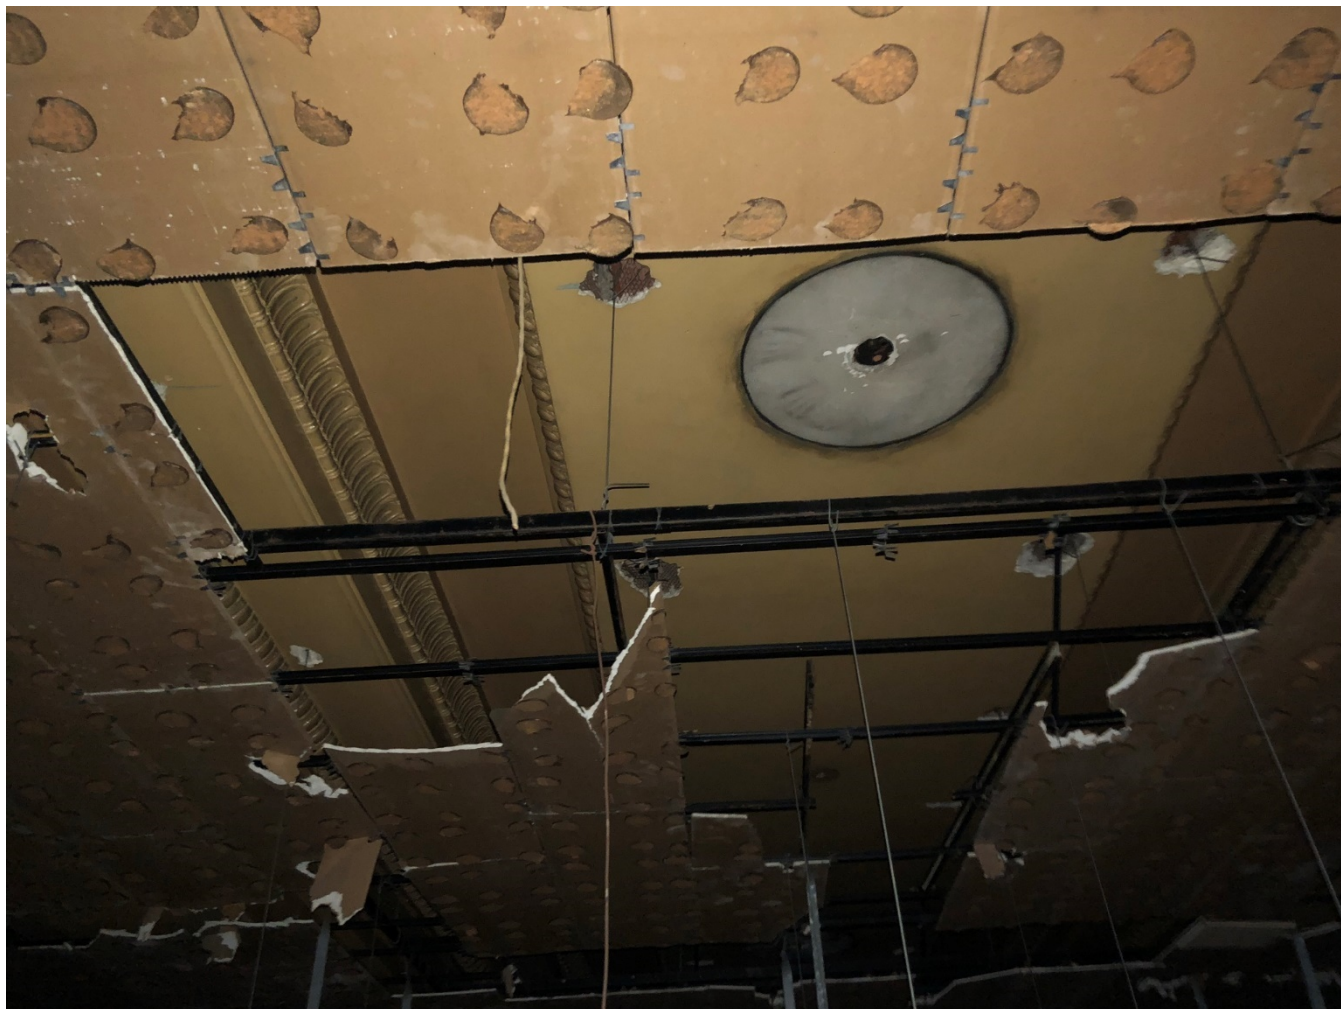
*Photo OCH - 4 - 25: View from mezzanine looking at original plaster ceiling.*

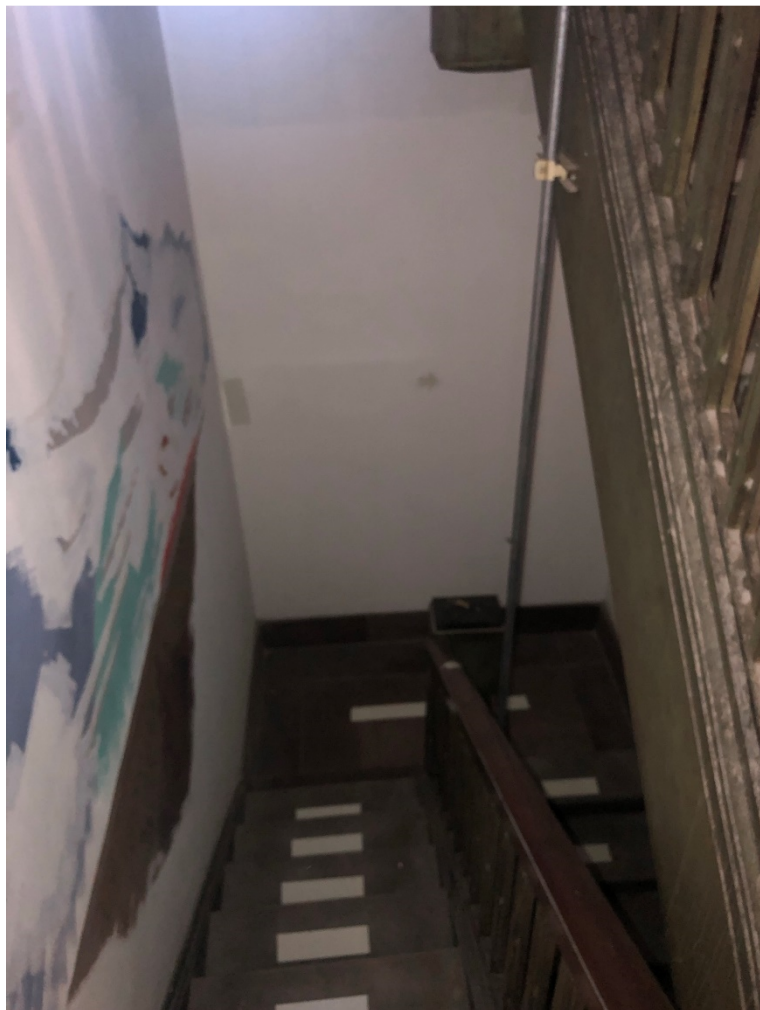
*Photo OCH - 3 - 1: North private stair view from 3<sup>rd</sup> floor. Handrail only on one side.*

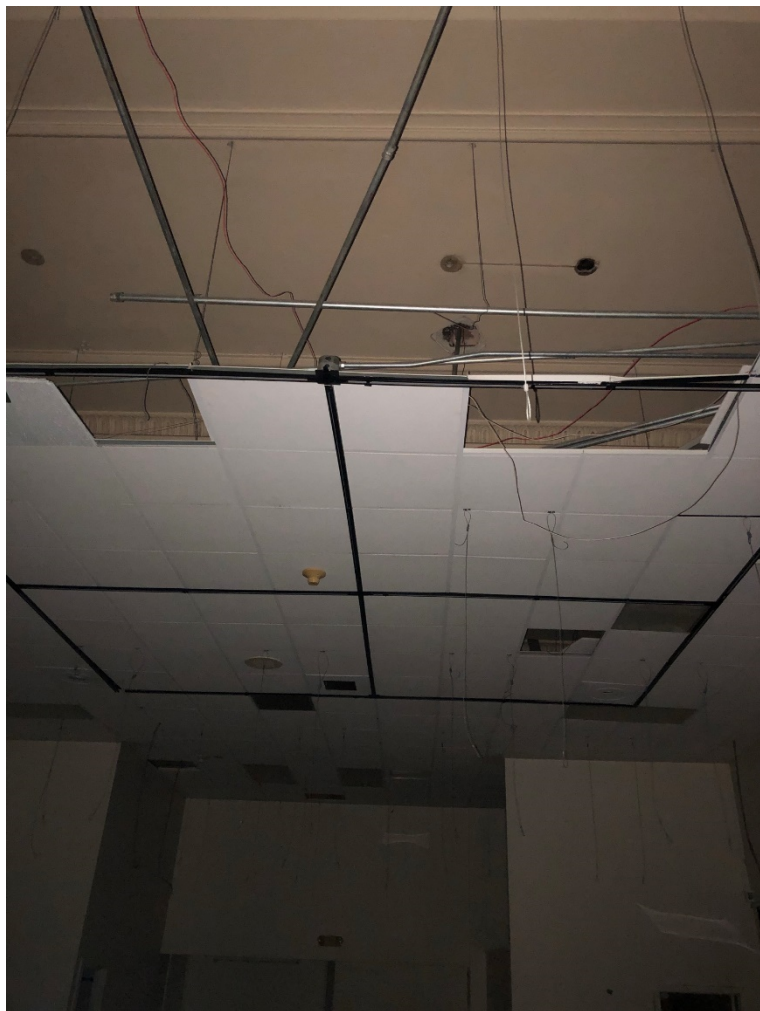
*Photo OCH - 3 - 9: Room south of south lobby. Original plaster ceiling partially exposed. Plaster walls are not original and cover original walls. Same room as OCH-3-8 and OCH-3-10.*

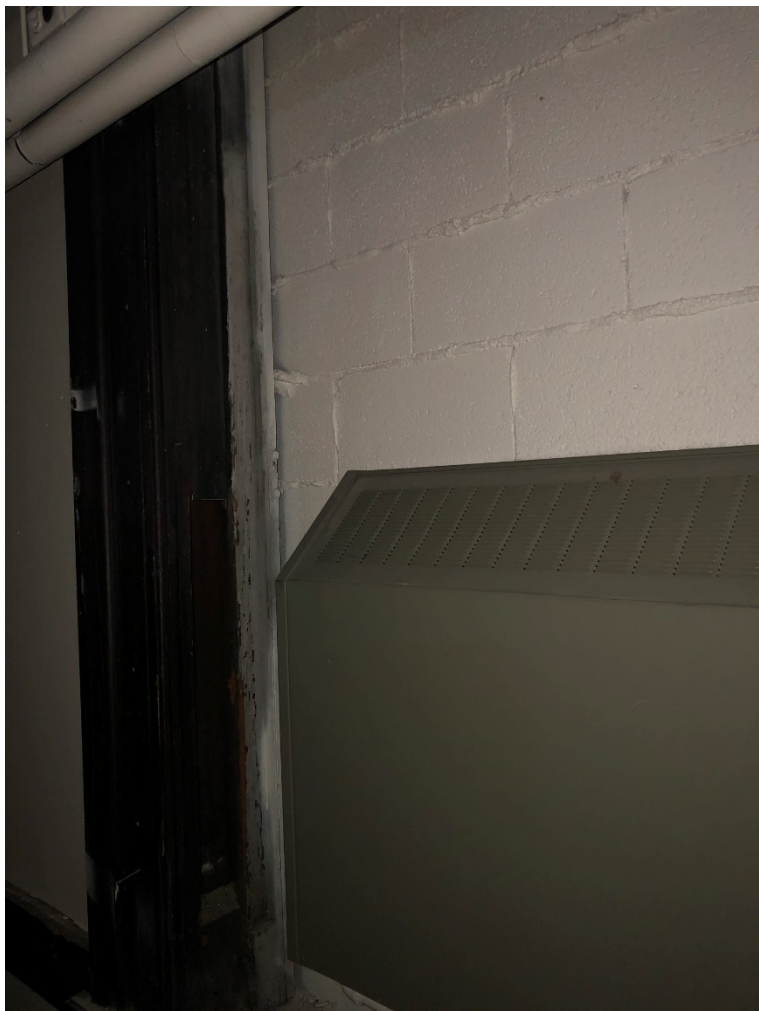
*Photo OCH - 3 - 10: Room south of south lobby. Original windows removed and opening blocked. Same room as OCH-3-8 and OCH-3-9.*

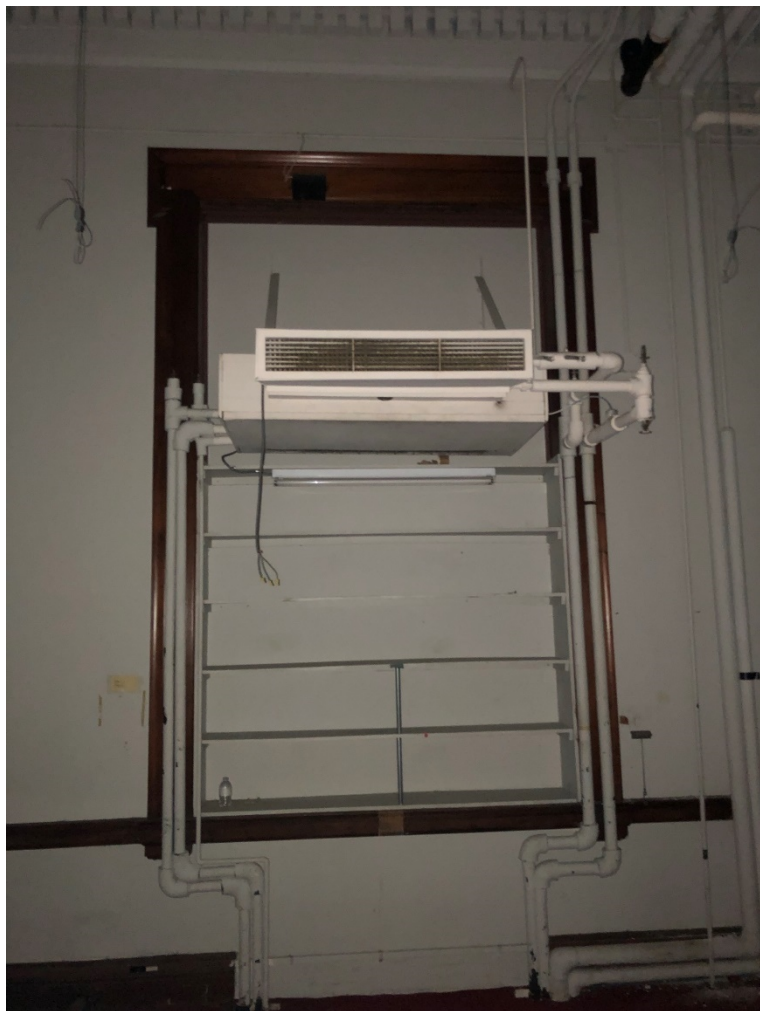
*Photo OCH - 3 - 11: Room west of south lobby. Original window removed and opening blocked.*

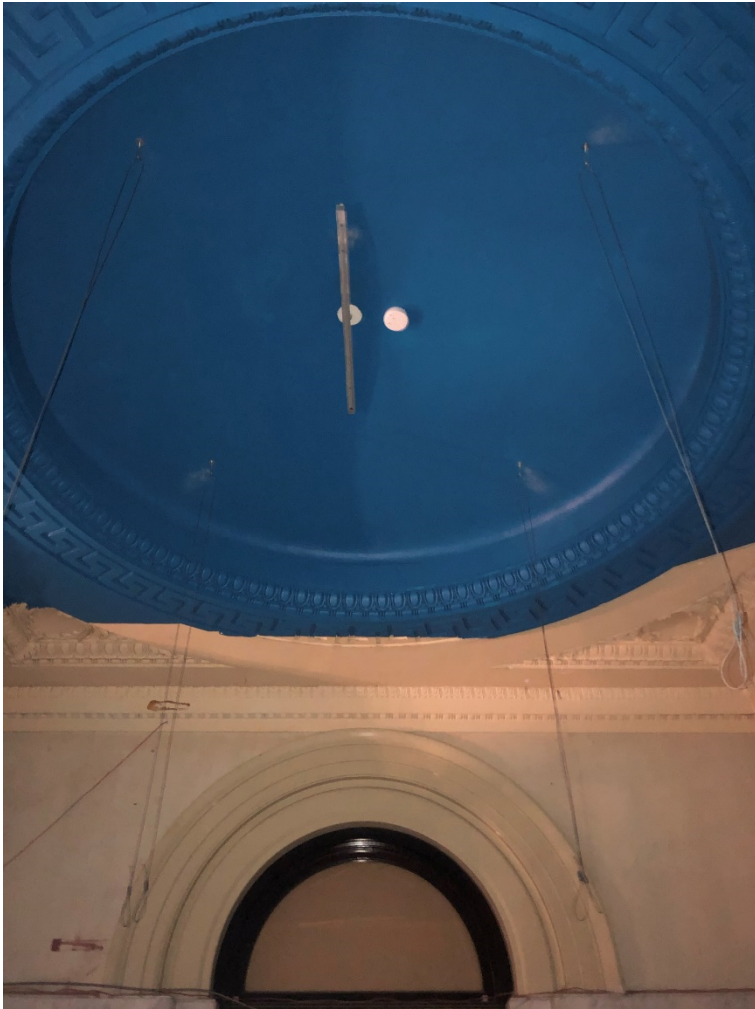
*Photo OCH - 3 - 12: South lobby. Original plaster ceiling largely intact.*

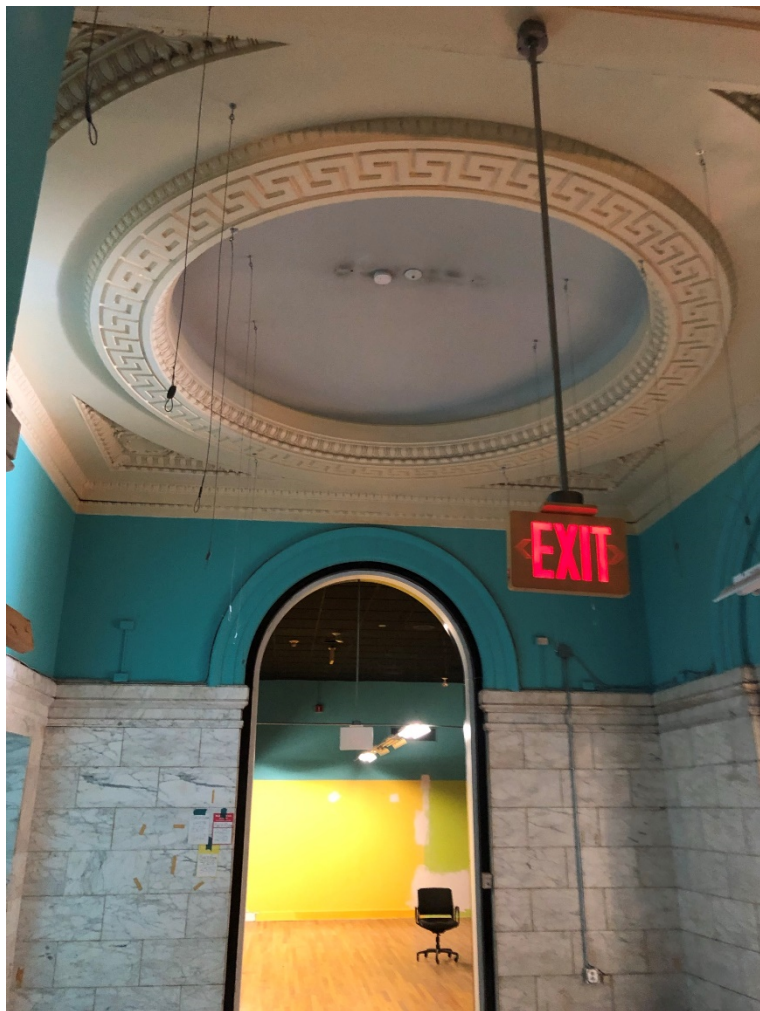
*Photo OCH - 3 - 13: North lobby. Original plaster ceiling and wall and marblework largely intact.*

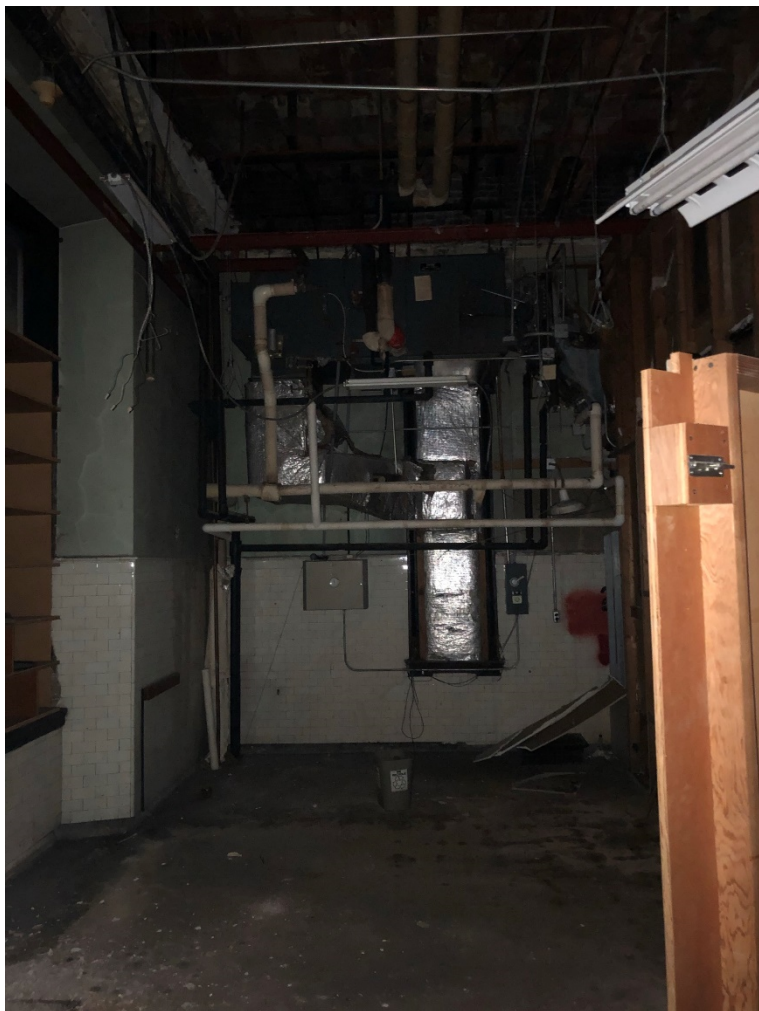
*Photo OCH - 3 - 17: Divided space in room north of the north lobby. Original windows removed and blocked. Mechanical equipment serves the room north of the north lobby.*

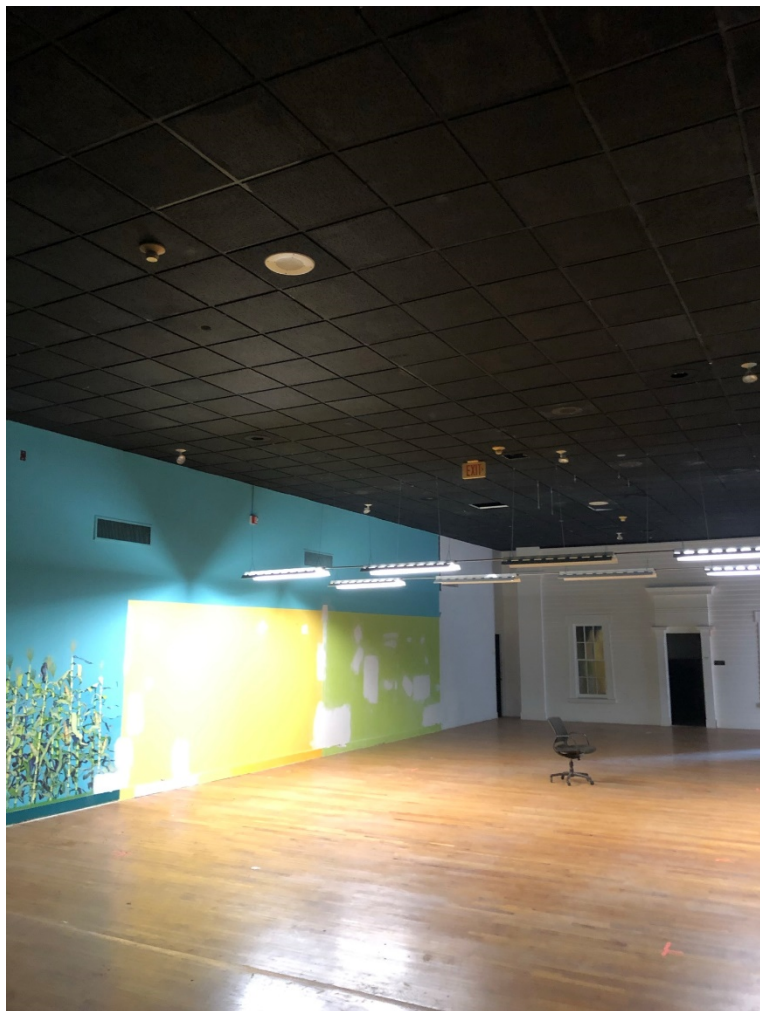
*Photo OCH - 3 - 18: Room north of the north lobby. Dropped ceiling covers original plaster ceiling. Plaster walls are not original and cover original walls.*

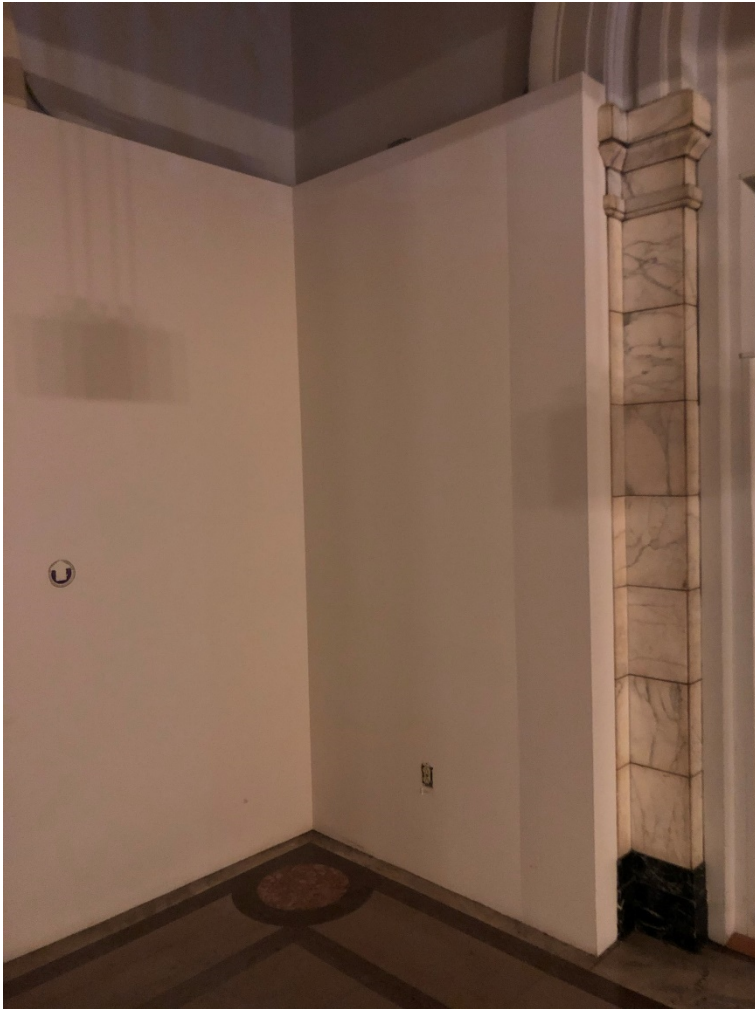
*Photo OCH - 2 - 4: South lobby. Exhibit walls cover original plaster walls.*

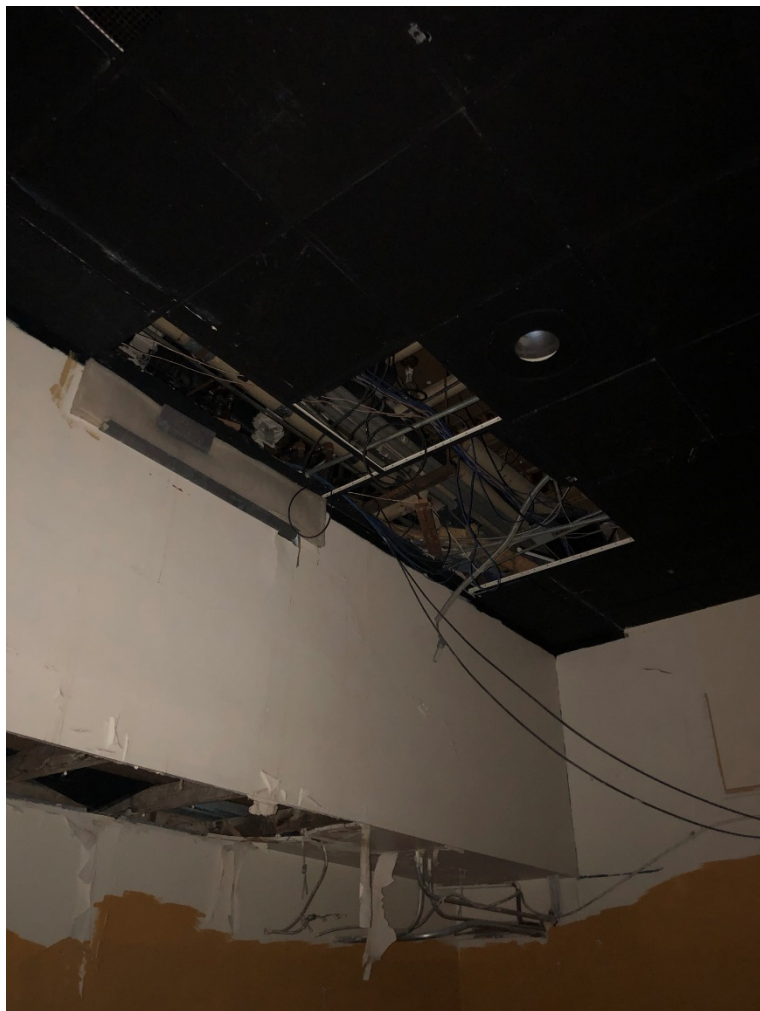
*Photo OCH - 2 - 5: Room east of south lobby. Dropped ceiling covers original plaster ceiling. Original windows removed and openings blocked and covered.*

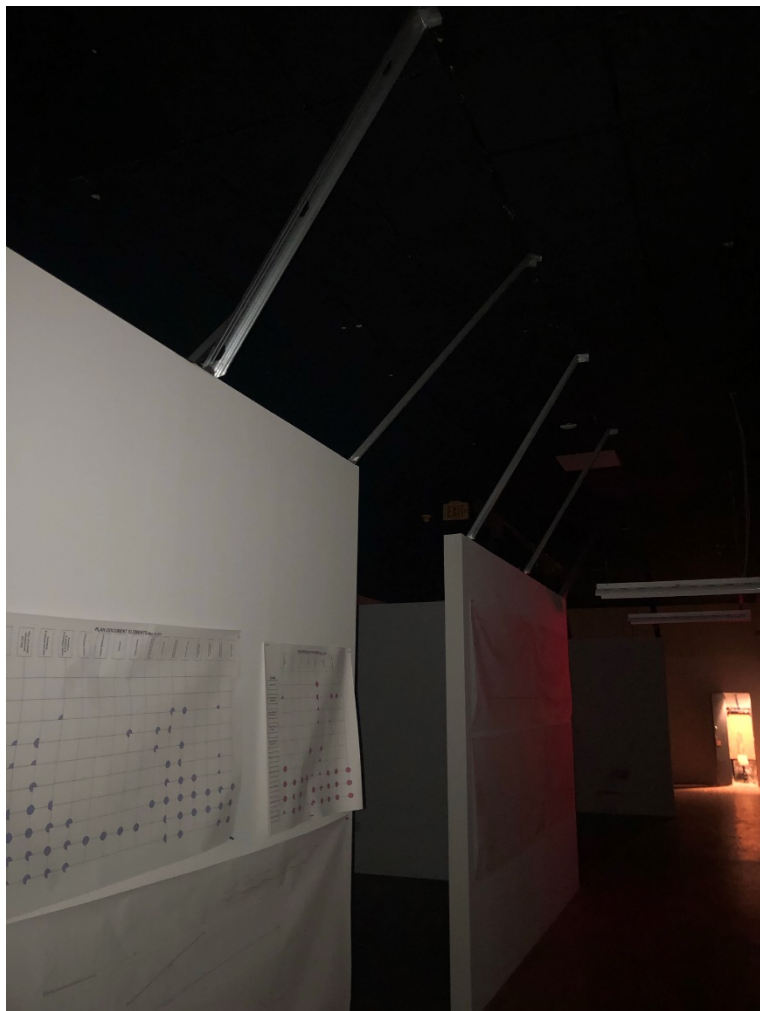
*Photo OCH - 2 - 7: Room south of the south lobby. Walls installed for exhibitions.*

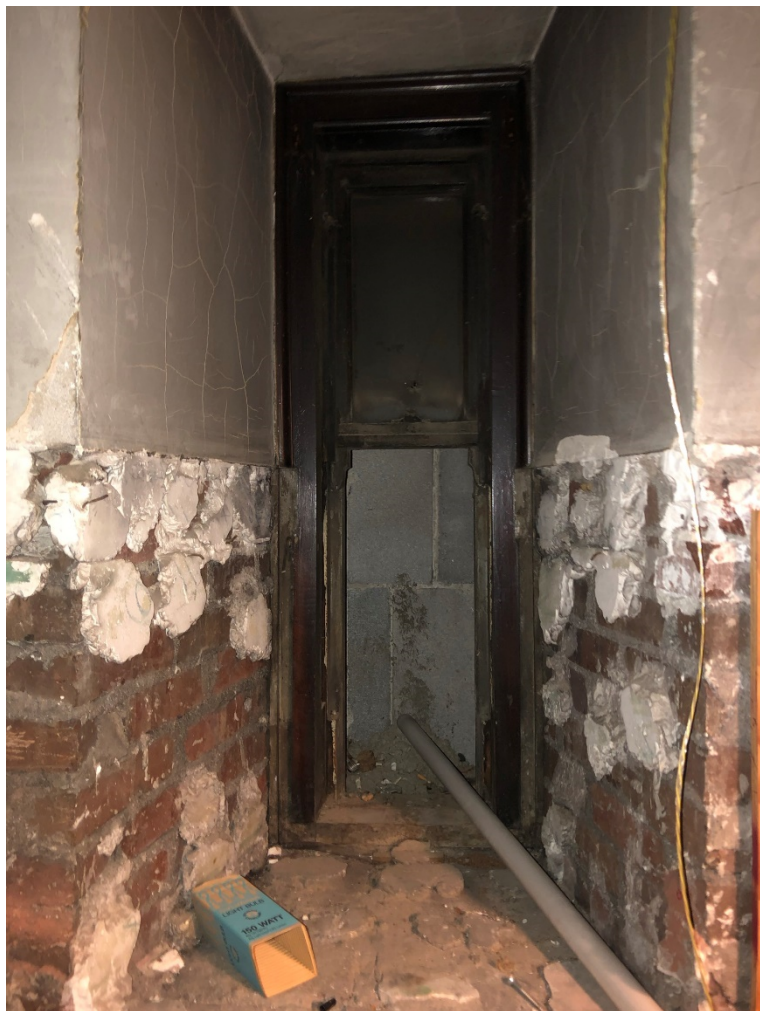
*Photo OCH - 2 - 8: West end of room south of south lobby. Mechanical space located behind plaster exhibit walls. Original window removed and blocked in. Same space as photos OCH-2-9 and OCH-2-10.*
