***CITY MARKET AND OLD CITY HALL***  
***Indianapolis, Indiana***

***OLD CITY HALL FACILITY ASSESSMENT AND CAPITAL PLANNING REPORT***

***JSH No.: 21060108***

***Date***  
***08/06/2021***

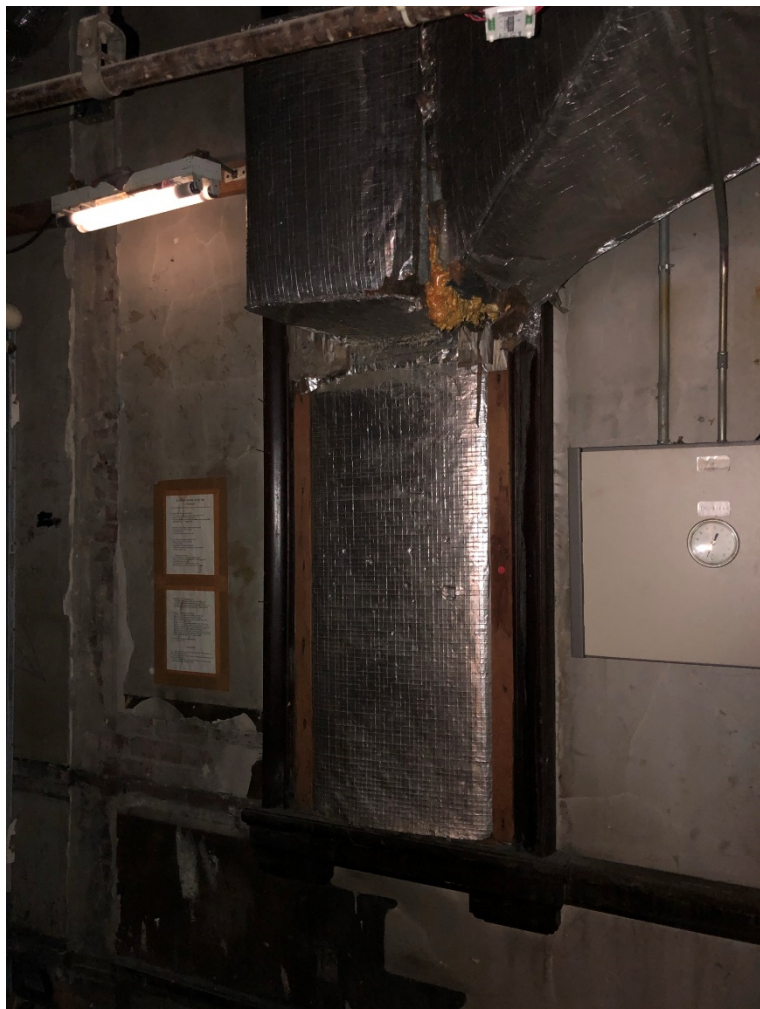
*Photo OCH - 2 - 9: West end of room south of south lobby. Mechanical space located behind plaster exhibit walls. Original room removed and used for mechanical system. Same space as photos OCH-2-8 and OCH-2-10.*

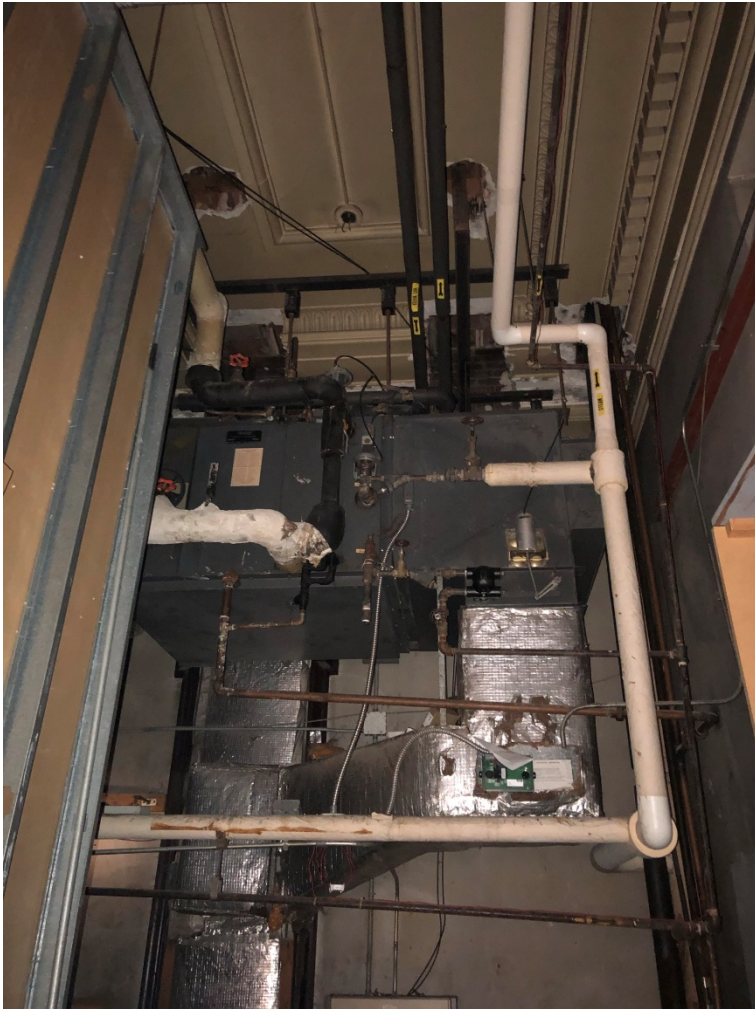
*Photo OCH - 2 - 10: West end of room south of south lobby. Mechanical space located behind plaster exhibit walls. Equipment in southwest corner. Same space as photos OCH-2-8 and OCH-2-9.*

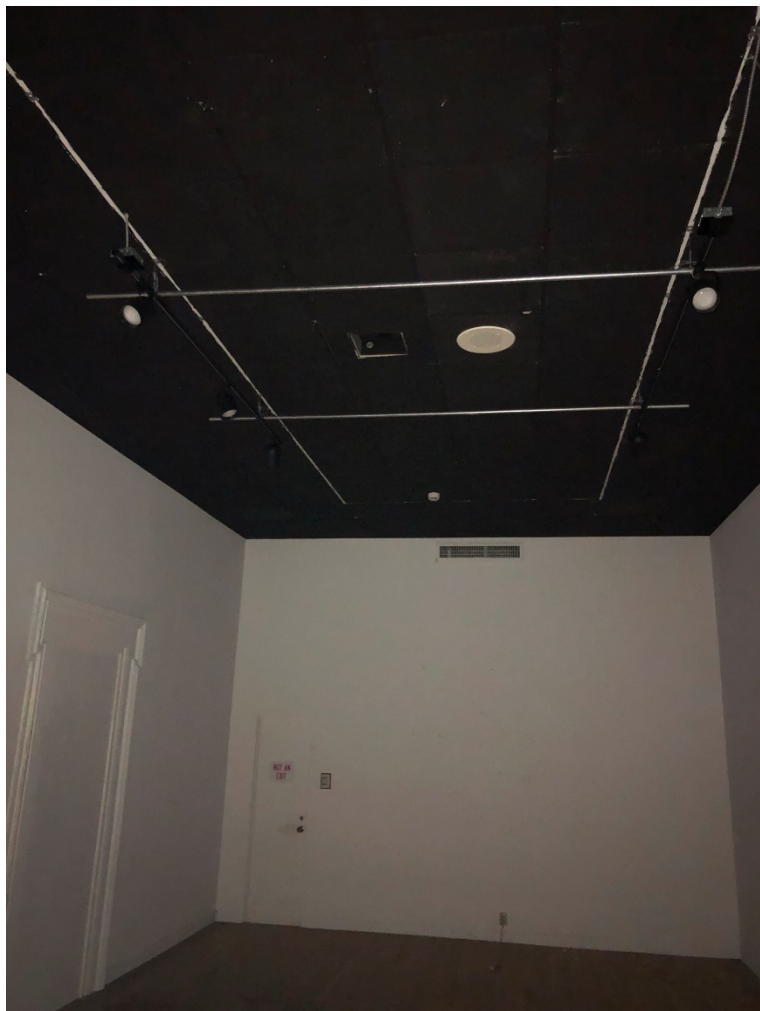
*Photo OCH - 2 - 11: Room west of south lobby. Dropped ceiling covers original plaster ceiling. Plaster wall covers original plaster wall and blocked-in window opening.*

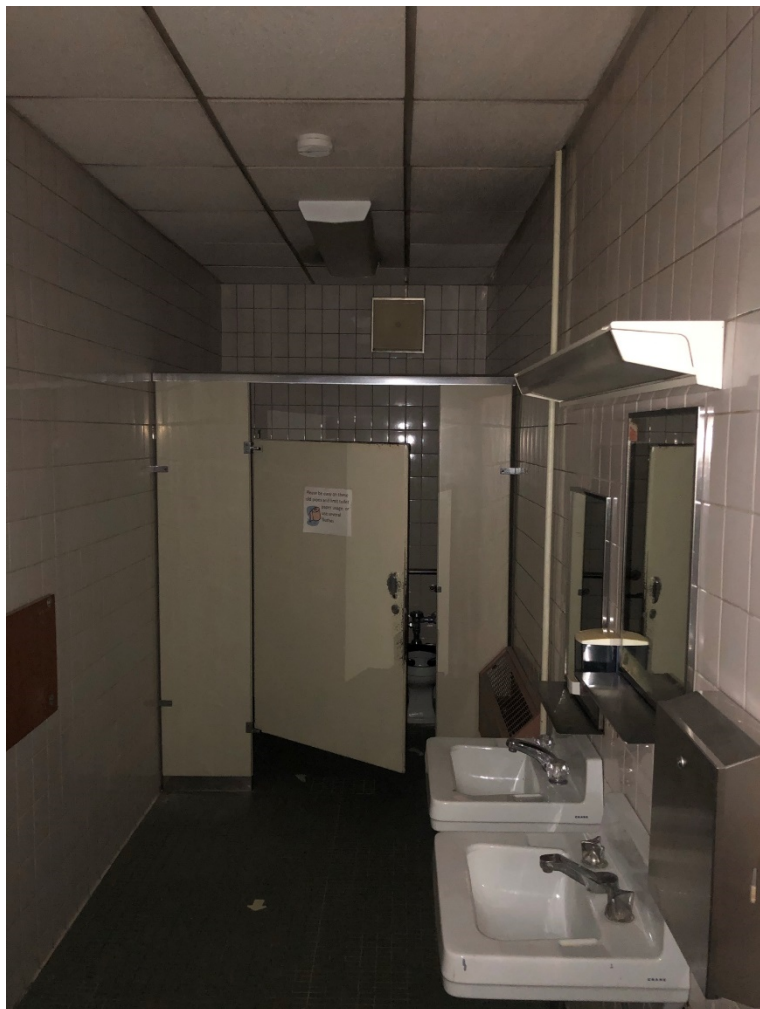
*Photo OCH - 2 - 12: Bathroom south of central stairs. Because of narrow pathway, restroom will not meet accessibility requirements.*

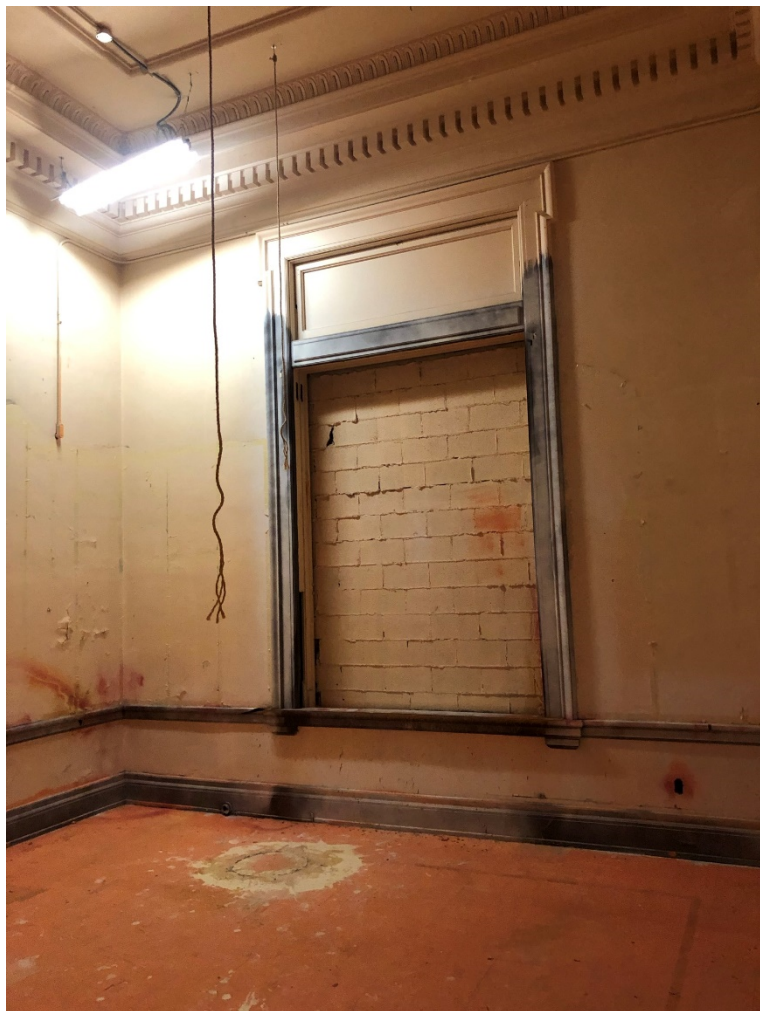
*Photo OCH - 2 - 13: Room west of north lobby. Original window removed and opening blocked.*

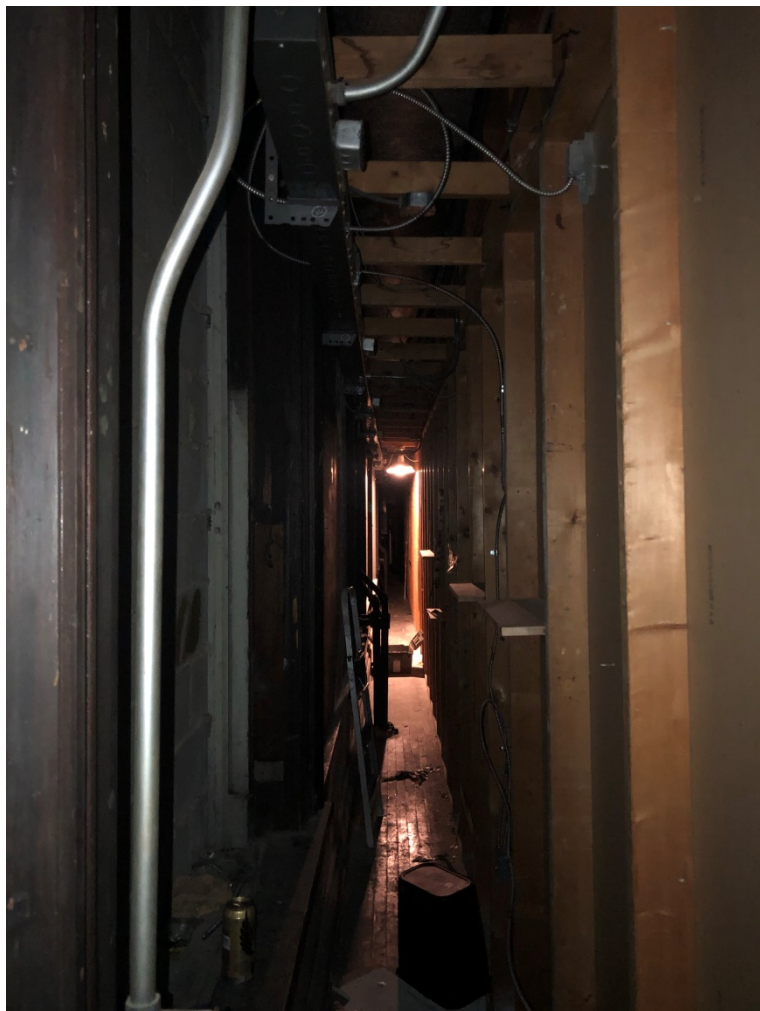
*Photo OCH - 2 - 14: Room north of north lobby. Behind the exhibit walls.*

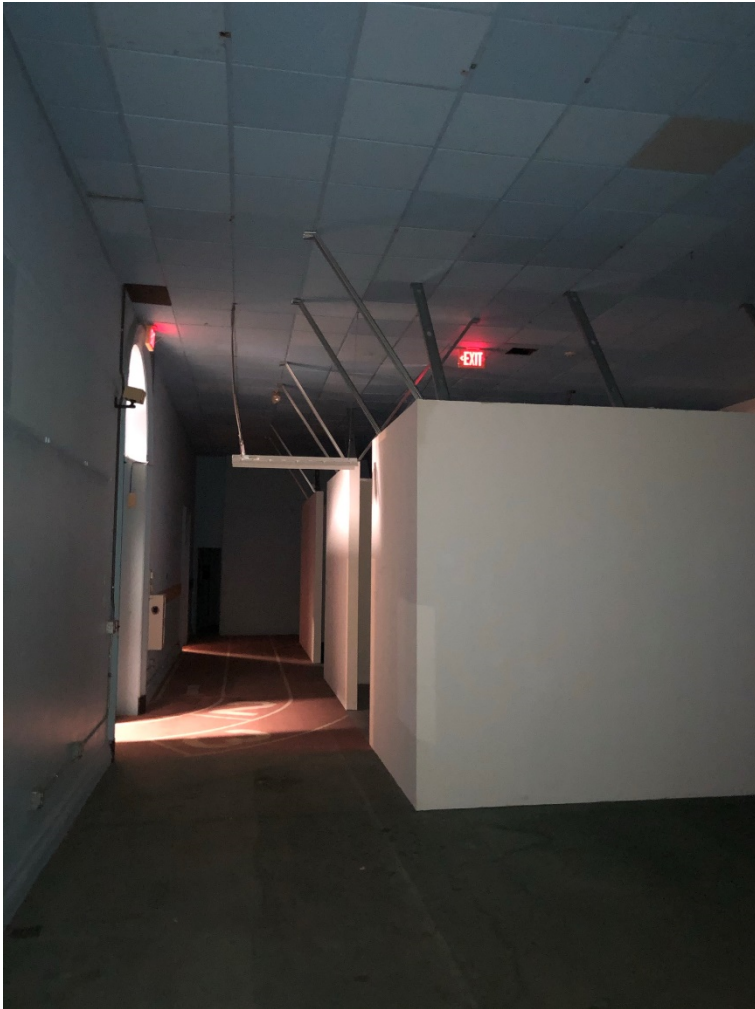
*Photo OCH - 2 - 15: Room north of north lobby. Dropped ceiling coverings original plaster ceiling. Walls installed for exhibits.*

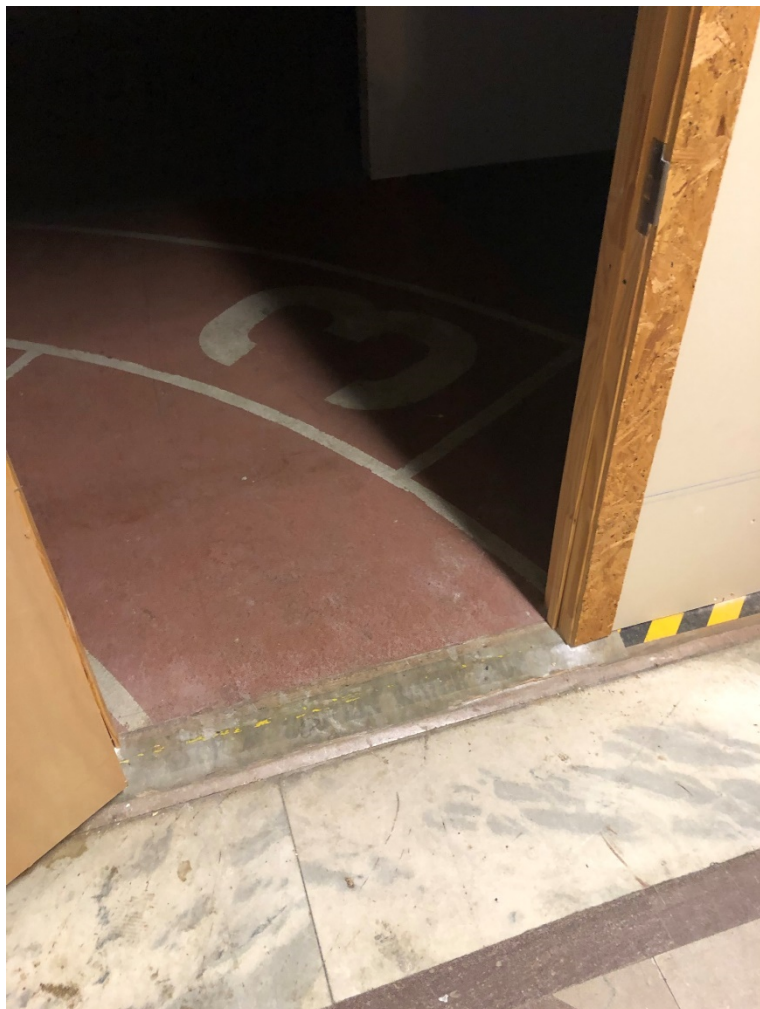
*Photo OCH - 2 - 16: Non-original floor in room north of north lobby.*

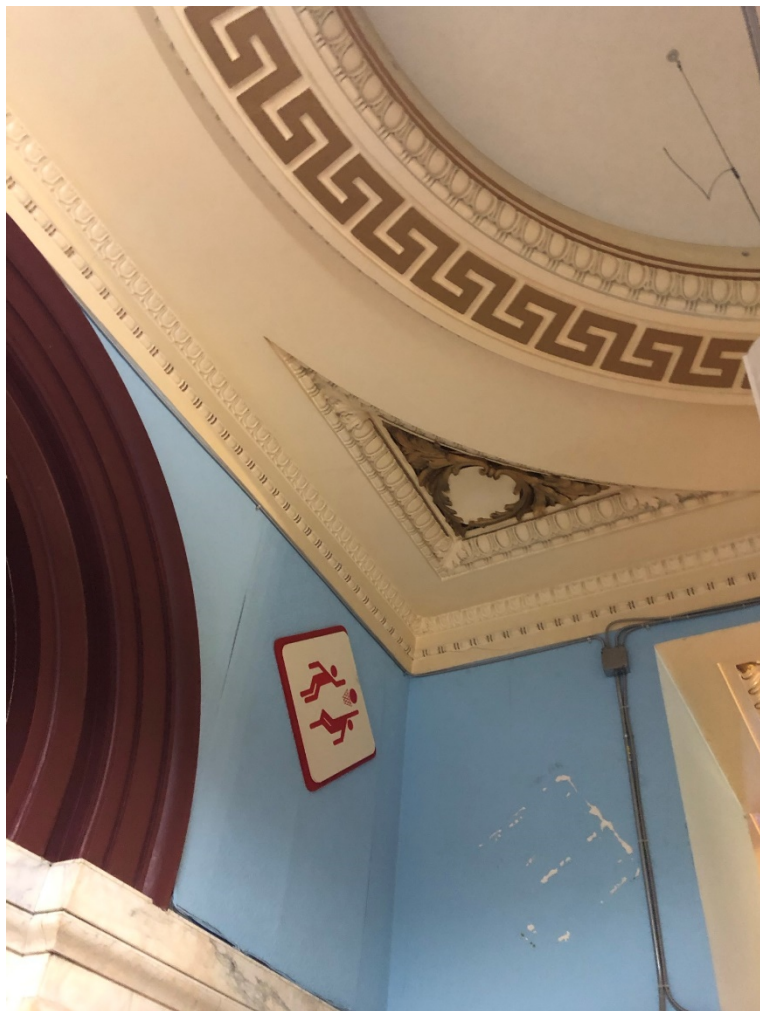
*Photo OCH - 2 - 17: North lobby. Original plaster ceiling and walls. Exhibit graphics applied to original plaster.*

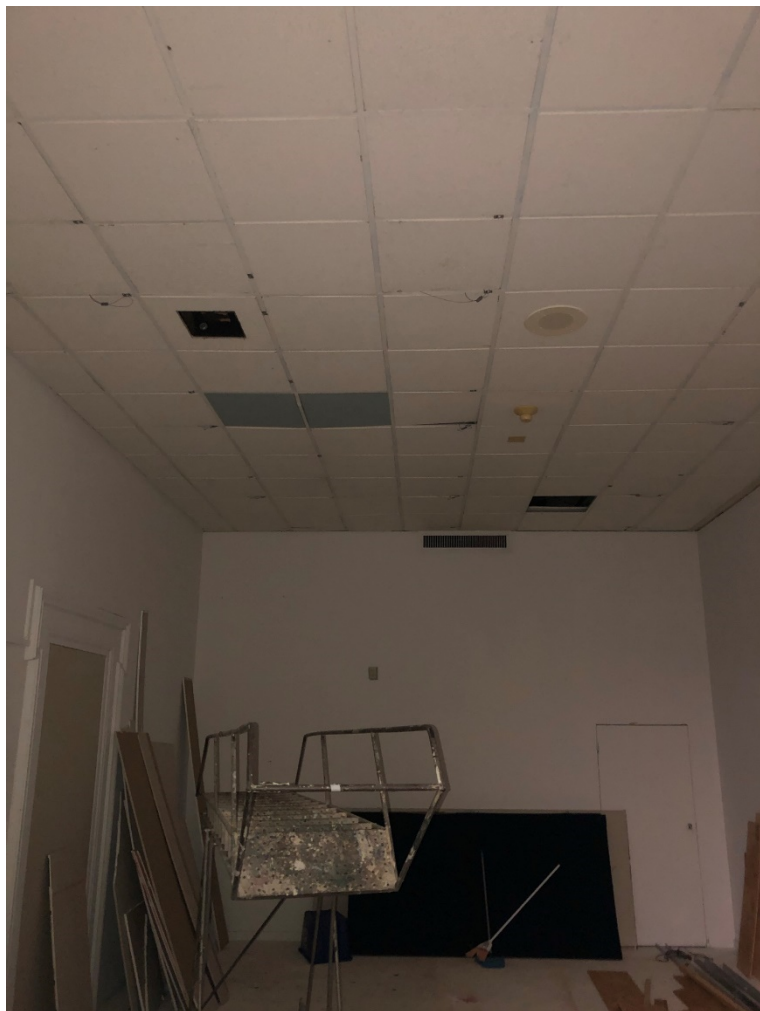
*Photo OCH - 2 - 18: Room east of north lobby. Dropped ceiling covers original plaster ceiling. Plaster wall covers original plaster wall and blocked-in window opening.*

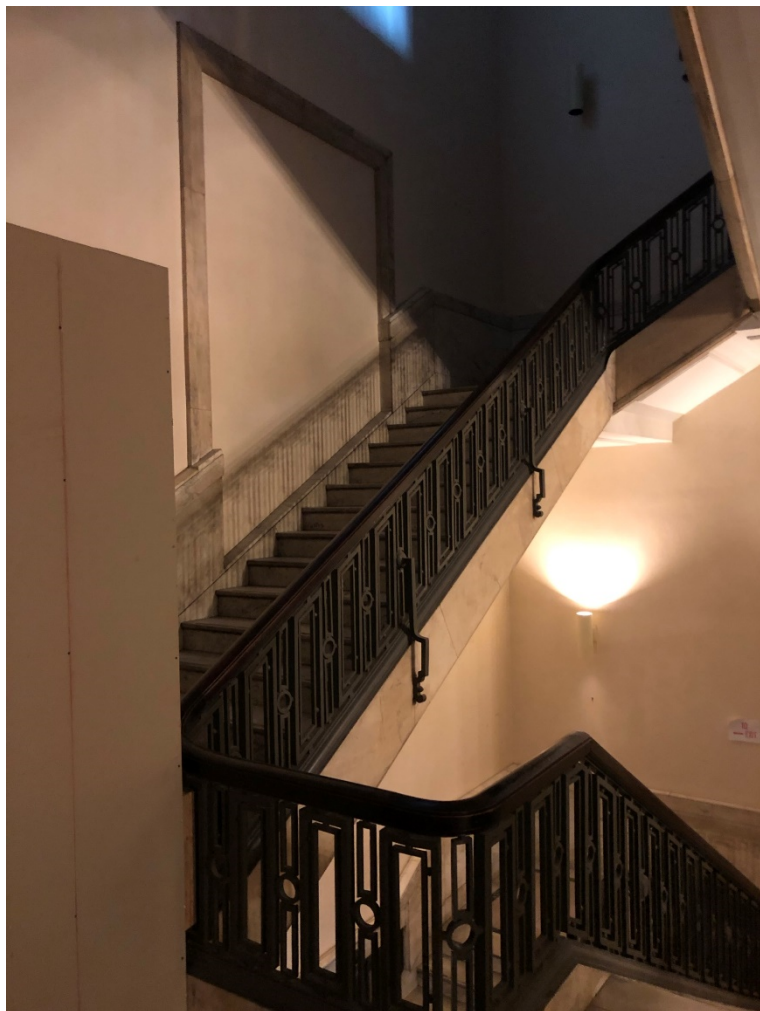
*Photo OCH - 2 - 19: North side of central stairs. Wall and door installed to control access above second floor. Original windows removed and openings blocked. Handrail only on one side of stairs.*

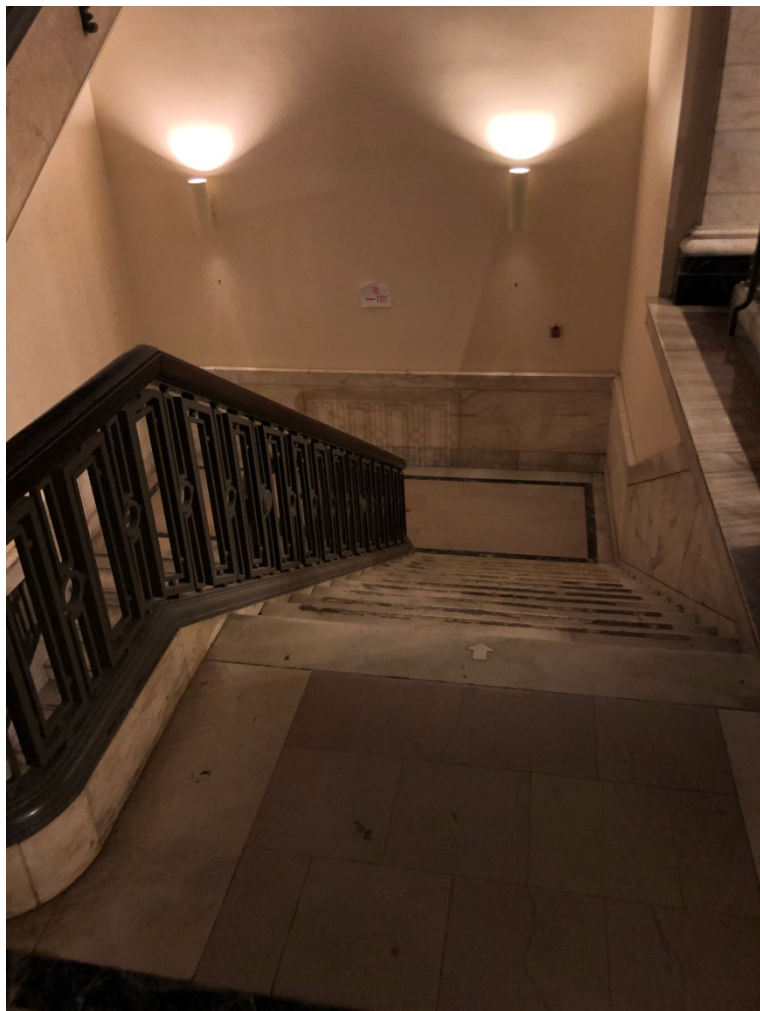
*Photo OCH - 2 - 20: North side of central stairs. Handrail only on one side of stairs.*

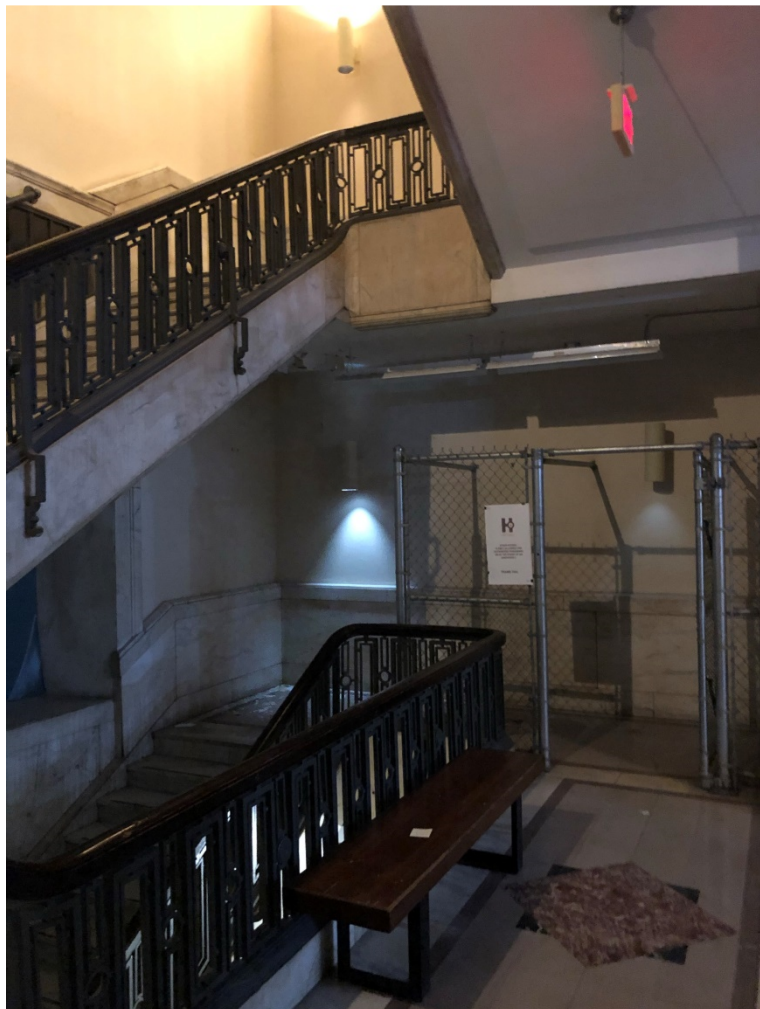
*Photo OCH - 1 - 1: North side of central stairs. Chain link used to control access to basement. Handrail only on one side.*

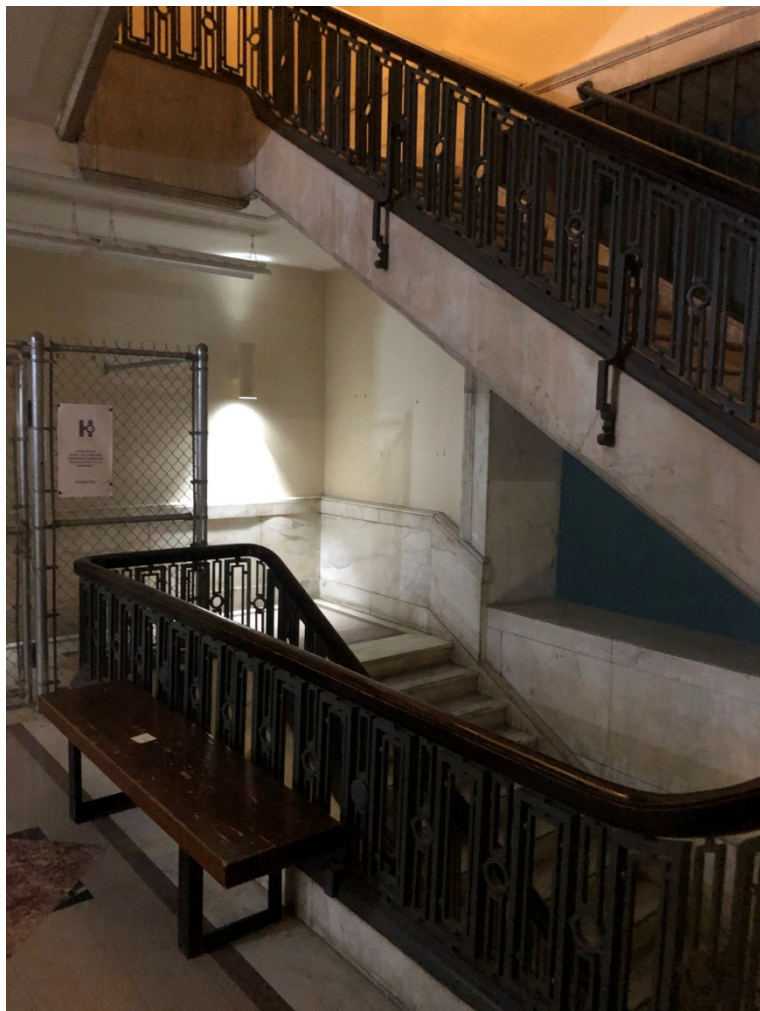
*Photo OCH - 1 - 2: South side of central stairs. Chain link used to control access to basement. Handrail only on one side.*

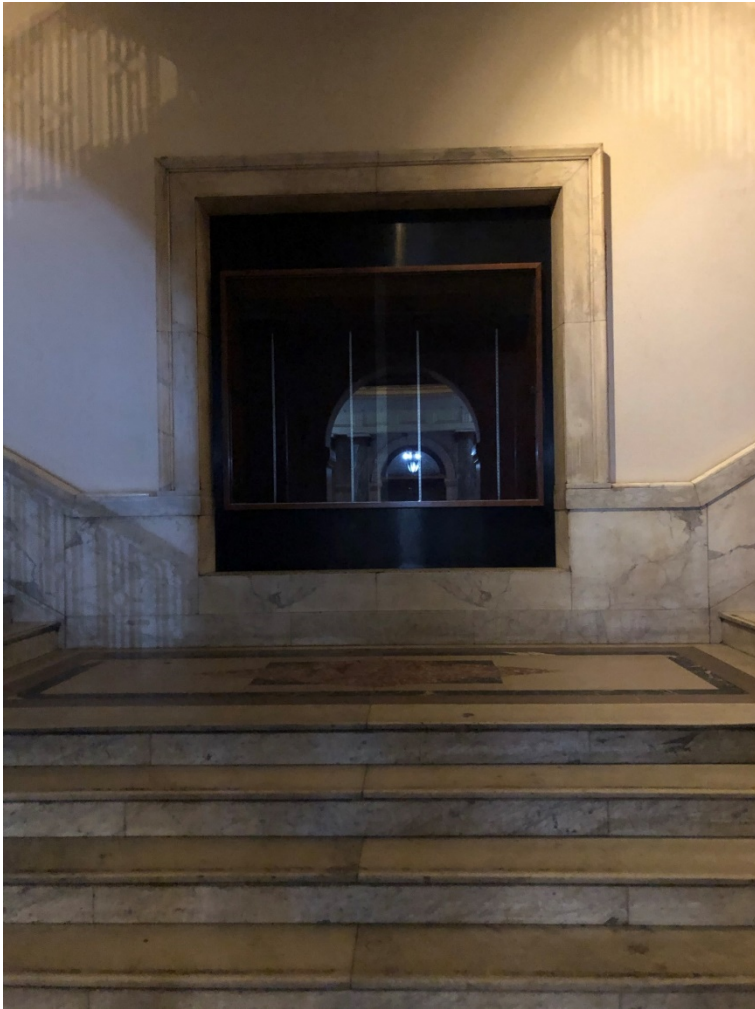
*Photo OCH - 1 - 3: Landing at central stairs. Original window removed and blocked in. Used as display case.*

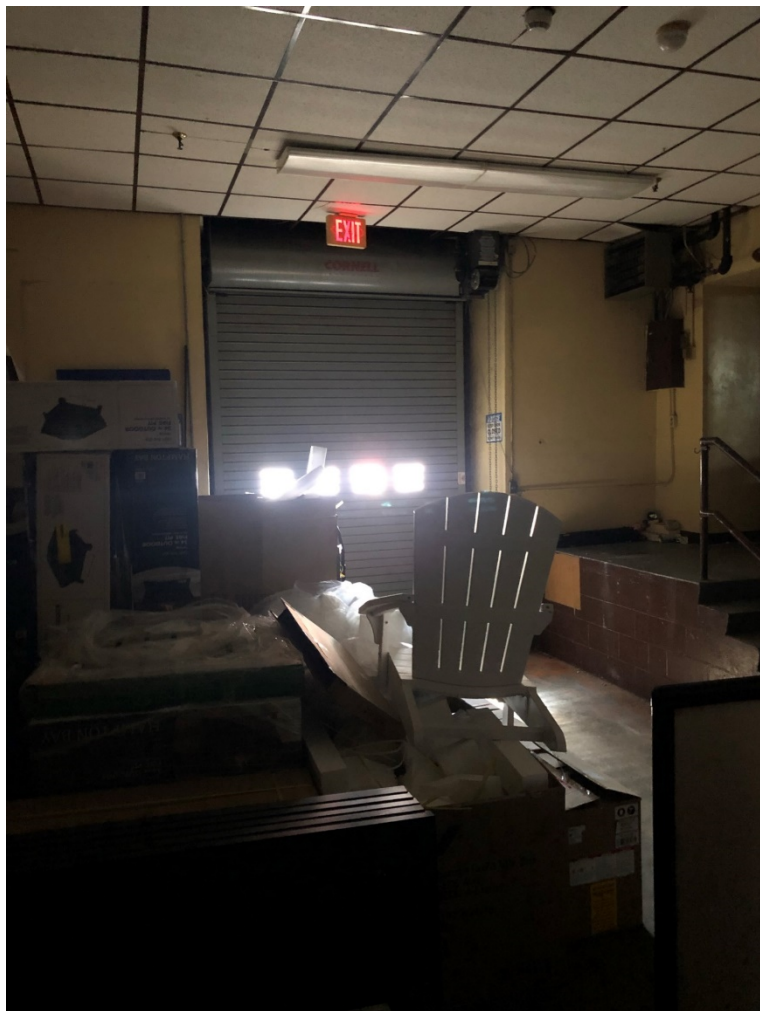
*Photo OCH - 1 - 6: Room west of north lobby. Overhead door opens to alley. Dropped ceiling covers original plaster wall.*

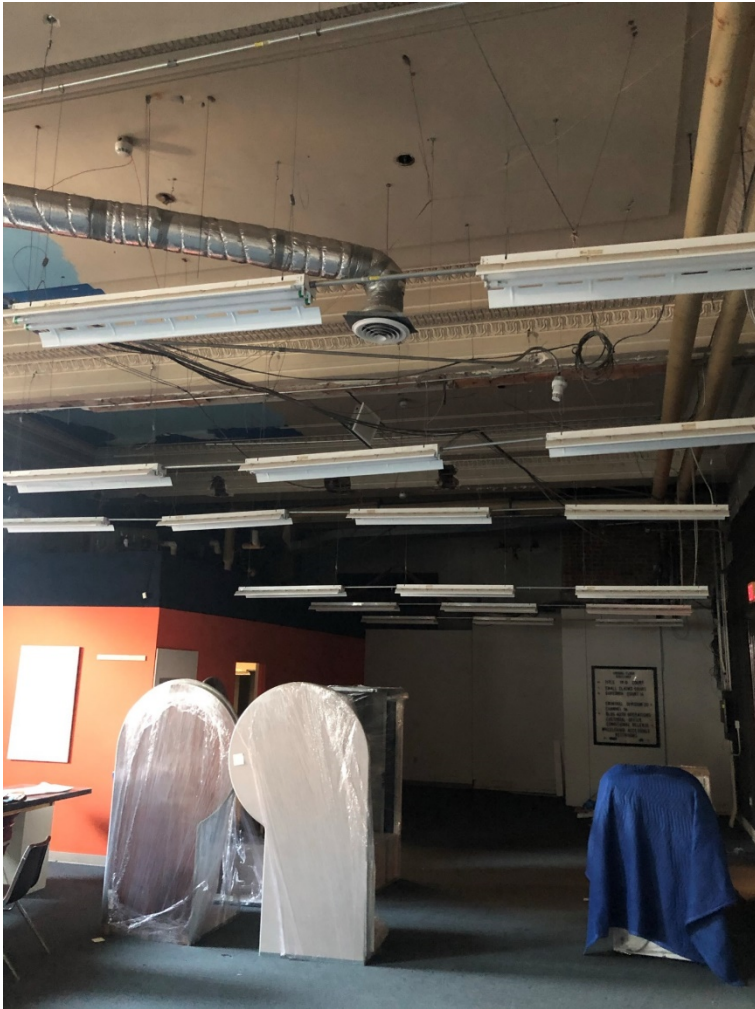
*Photo OCH - 1 - 7: Room north of north lobby. Dropped ceiling removed. Exhibit walls in place. Same room as photos OCH-1-8 and OCH-1-9.*

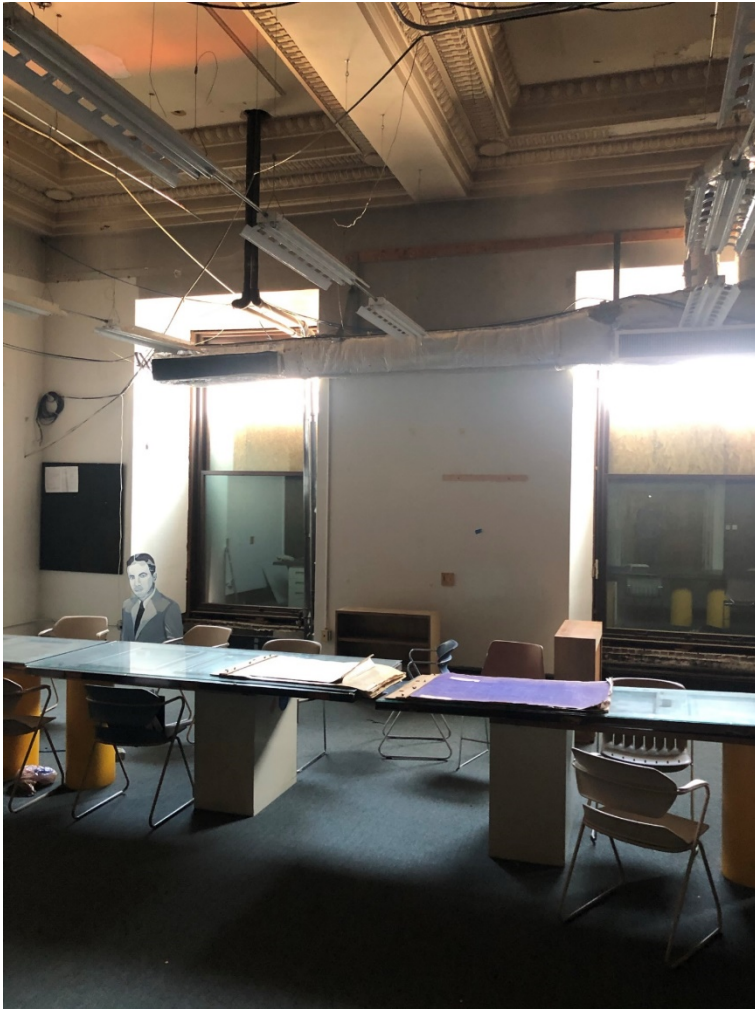
*Photo OCH - 1 - 8: Room north of north lobby. Dropped ceiling removed. Three window openings restored. Same room as photos OCH-1-7 and OCH-1-9.*

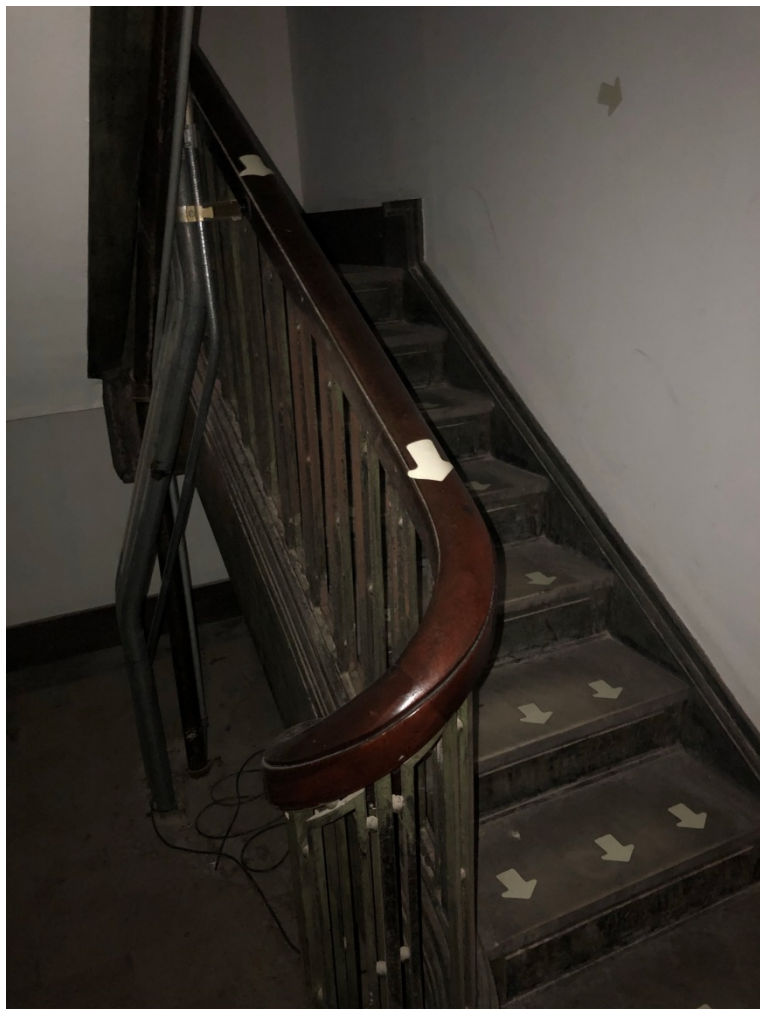
*Photo OCH - 1 - 11: Bottom of north private stairs. Handrails only on one side. Stairs do not exit to the exterior or to an egress path.*

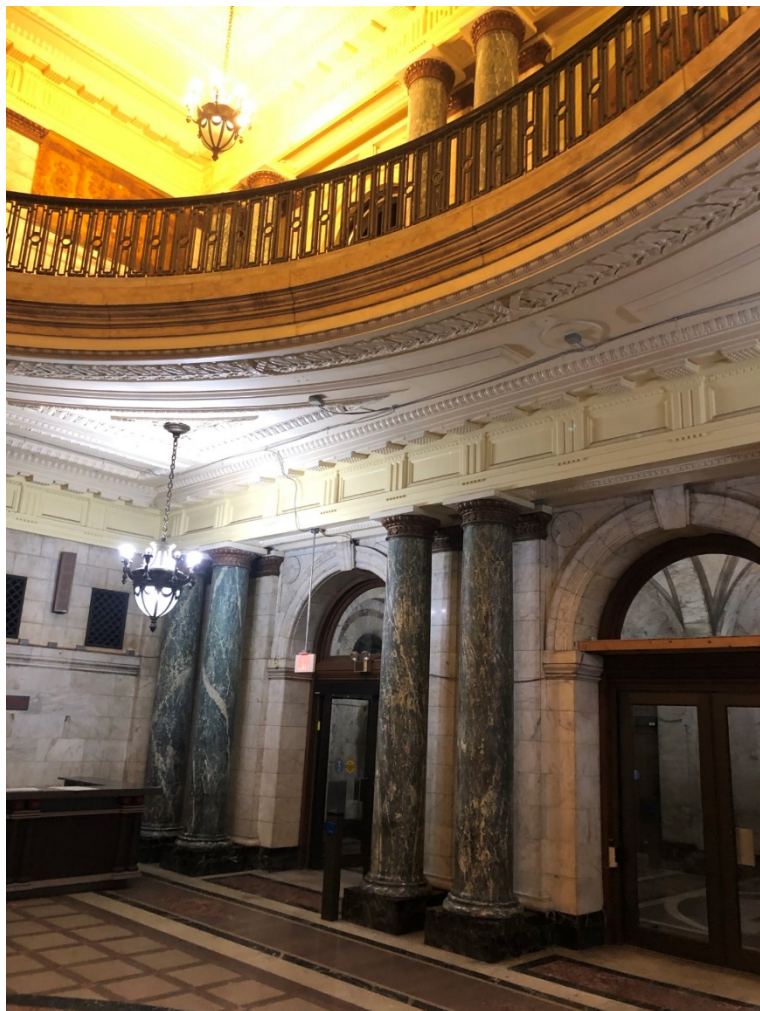
*Photo OCH - 1 - 13: Rotunda viewed from south end. Electrical conduits and metal wrapped wiring surface mounted on original plaster and marble.*

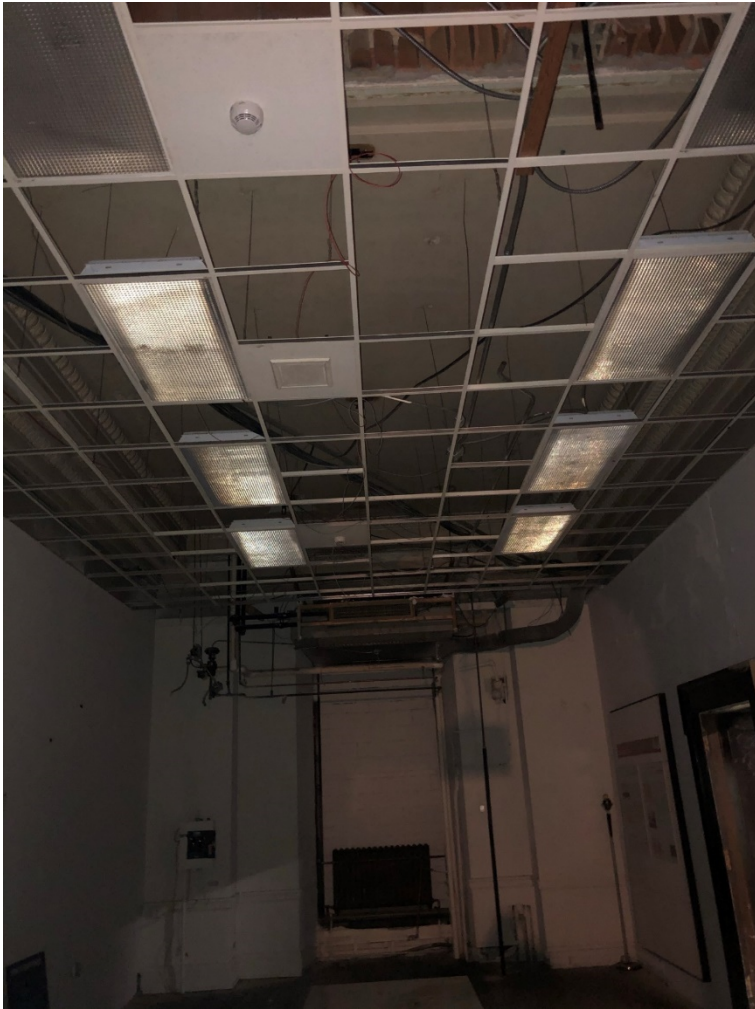
*Photo OCH - 1 - 14: Room east of south lobby. Dropped ceiling covering original plaster ceiling. Original window removed and opening blocked.*

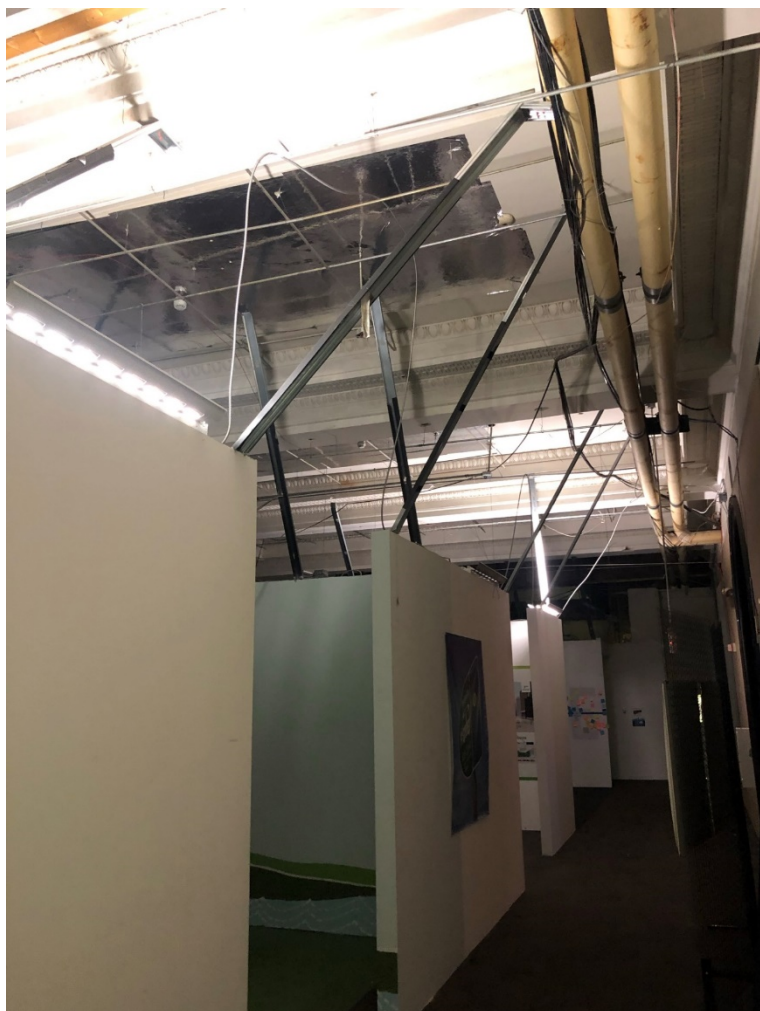
*Photo OCH - 1 - 15: Room south of south lobby. Dropped ceiling removed. Exhibit walls in place. Same room as photo OCH-1-16.*

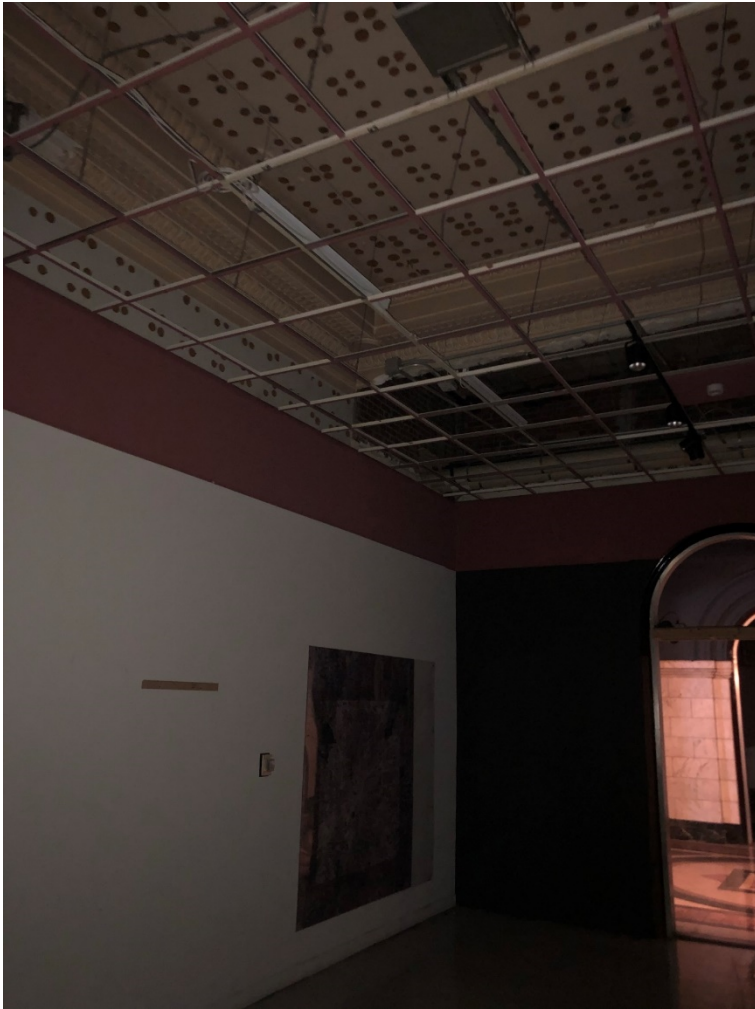
*Photo OCH - 1 - 17: Room west of south lobby. Dropped ceiling grid in place. South lobby viewed beyond.*

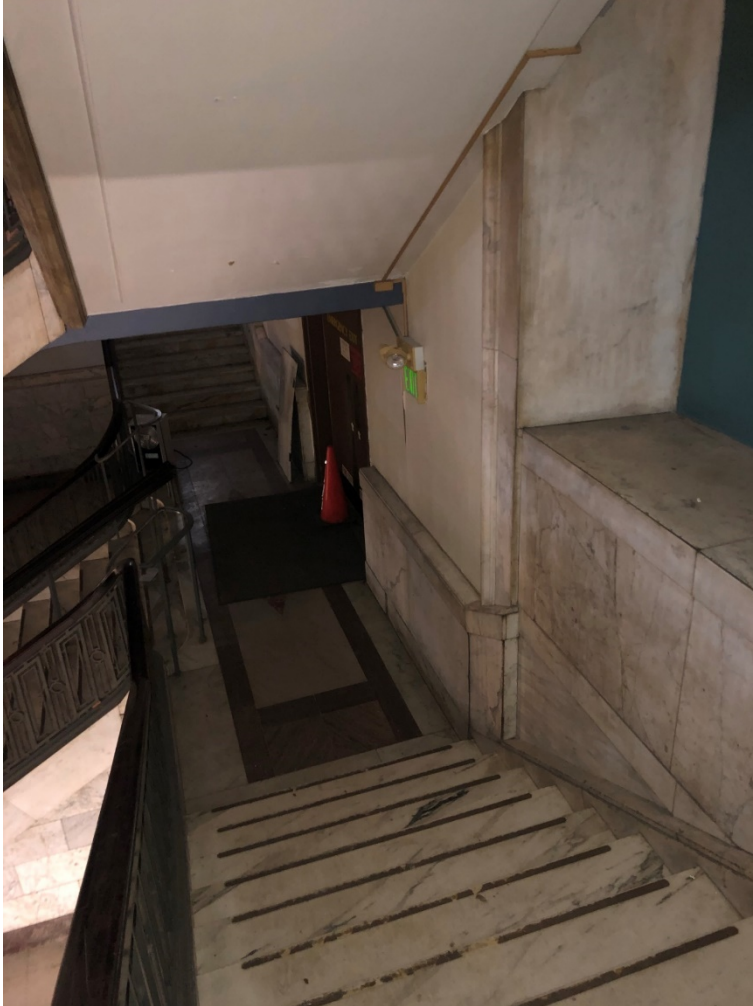
*Photo OCH - B - 1: North side of central stairs leading to basement landing. Egress stairs on right. Handrail only on one side.*

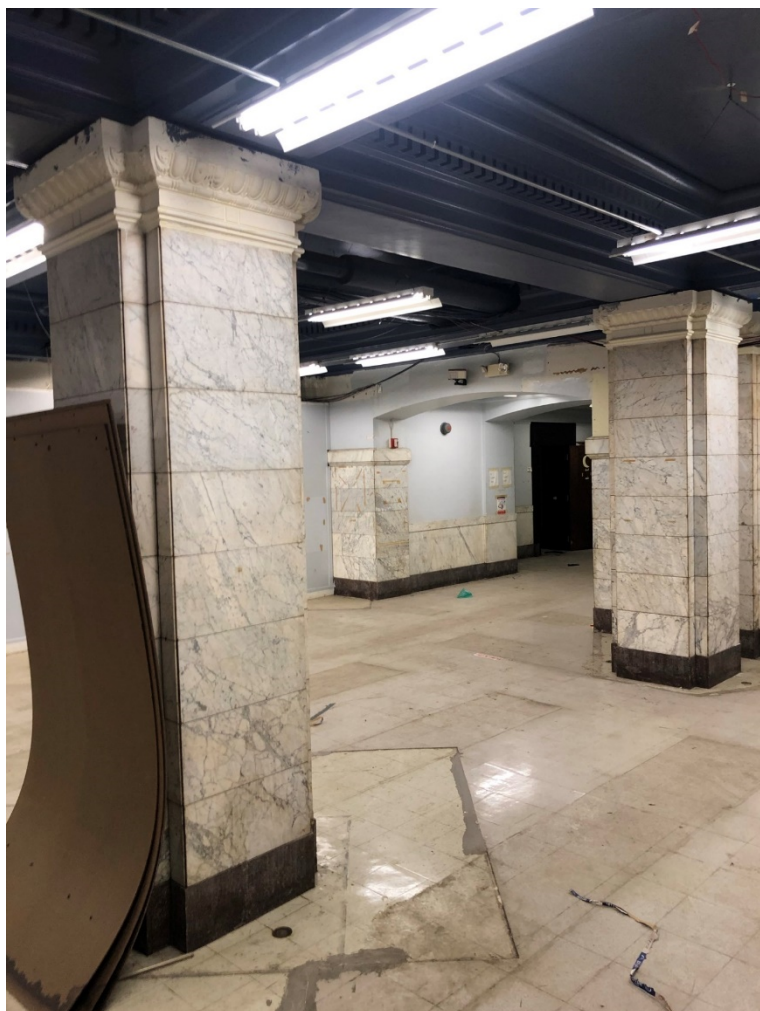
*Photo OCH - B - 2: Central lobby under rotunda.*

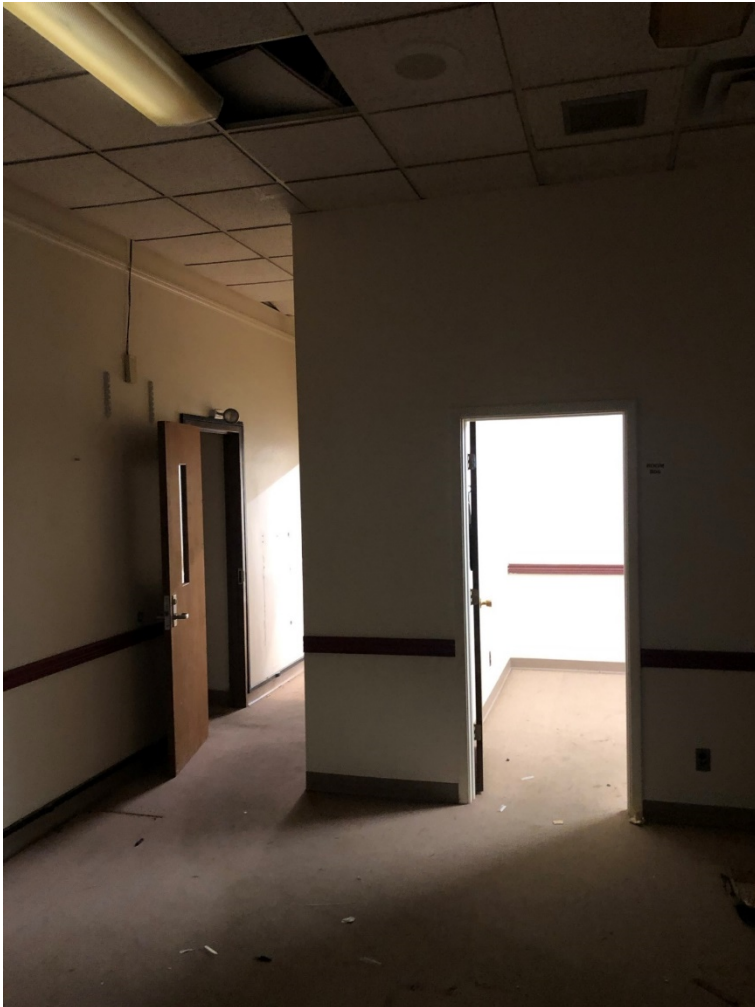
*Photo OCH - B - 3: Room west of south lobby. Drop ceiling covers original ceiling. Office partitions are not original.*

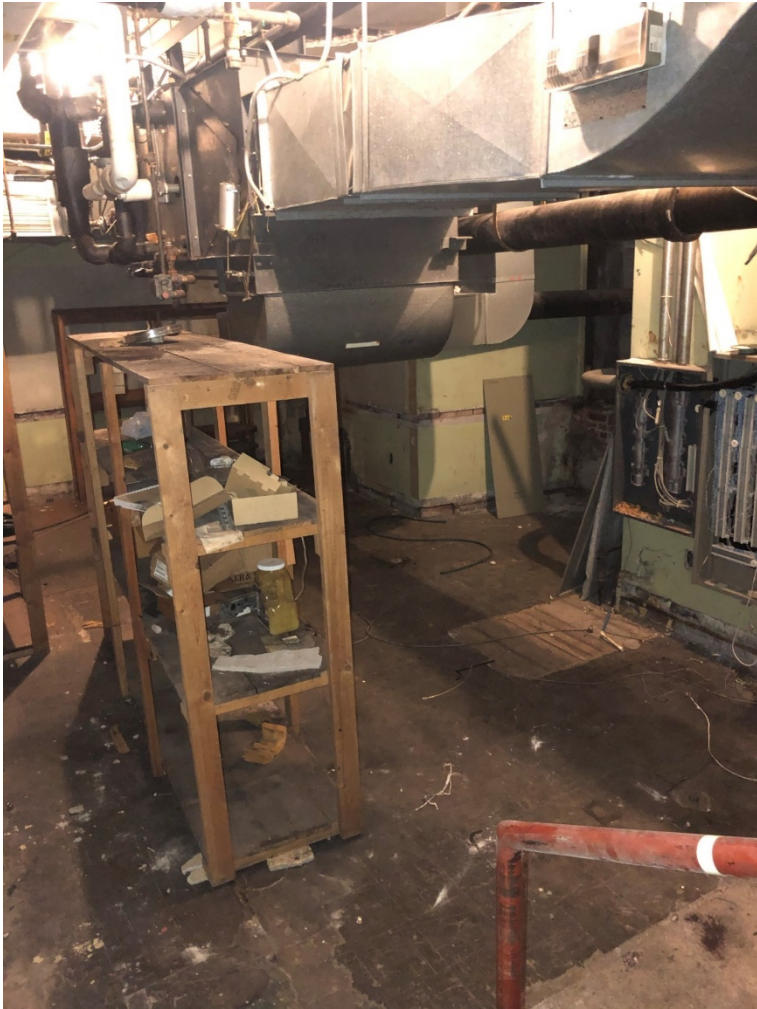
*Photo OCH - B - 4: Mechanical room at west end of room south of south lobby.*

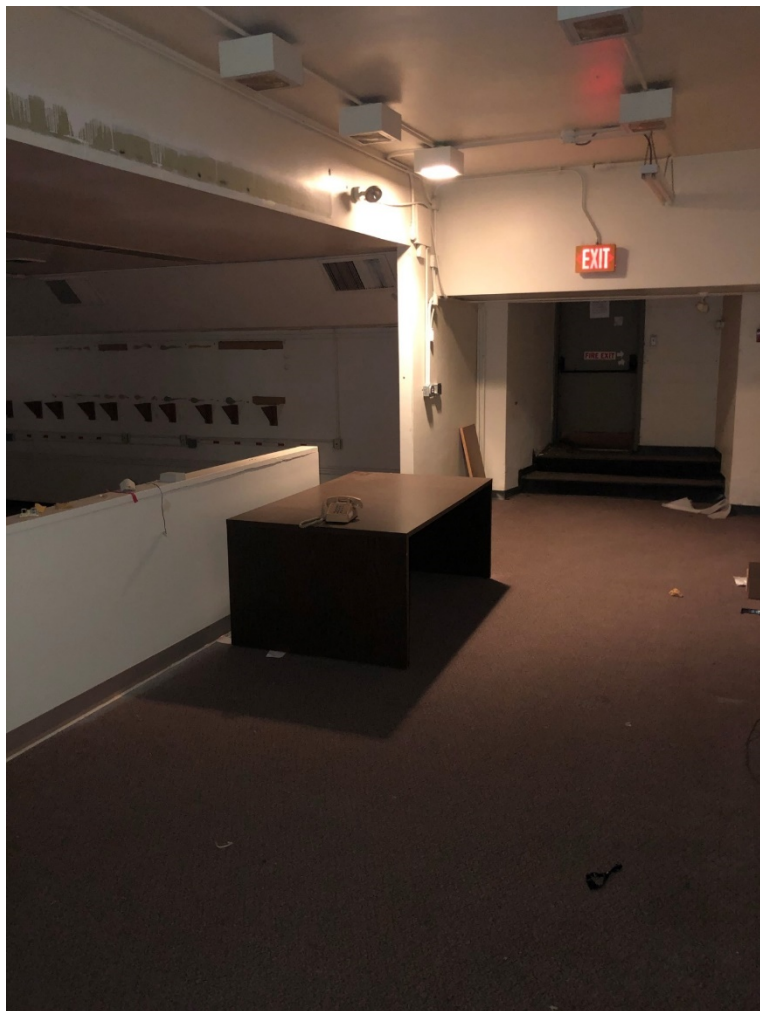
*Photo OCH - B - 5: Room south of south lobby. Access to egress door in south wall.*

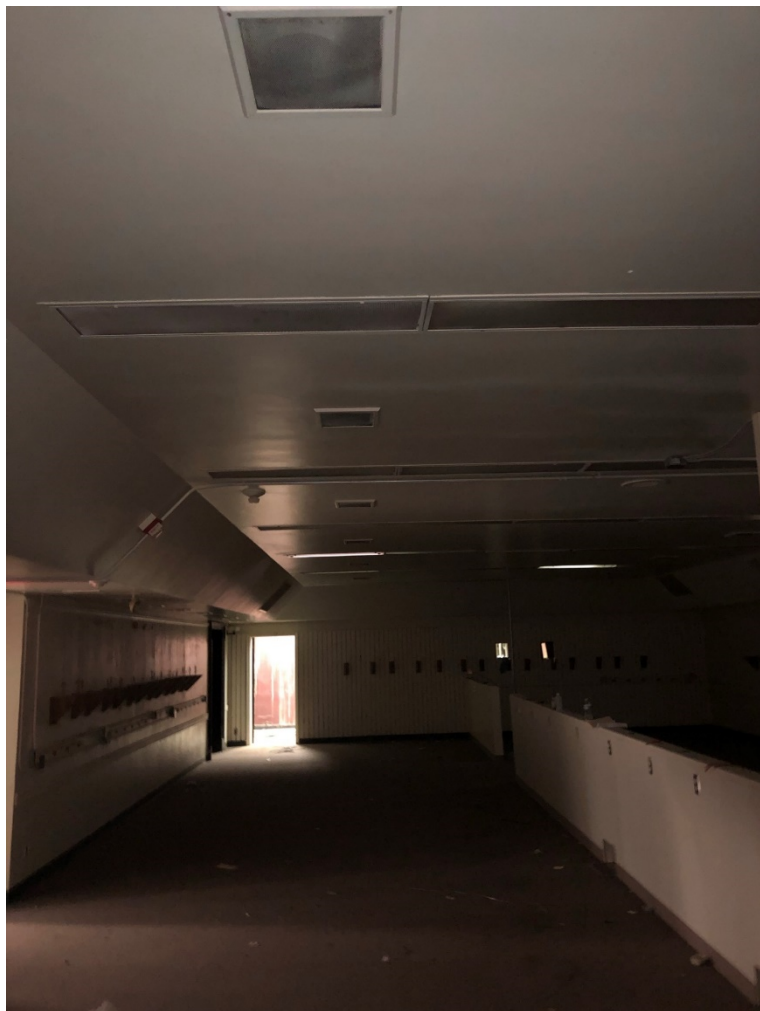
*Photo OCH - B - 6: Room south of south lobby.*
