***CITY MARKET AND OLD CITY HALL***  
***Indianapolis, Indiana***

***OLD CITY HALL FACILITY ASSESSMENT AND CAPITAL PLANNING REPORT***

***JSH No.: 21060108***

***Date***  
***08/06/2021***

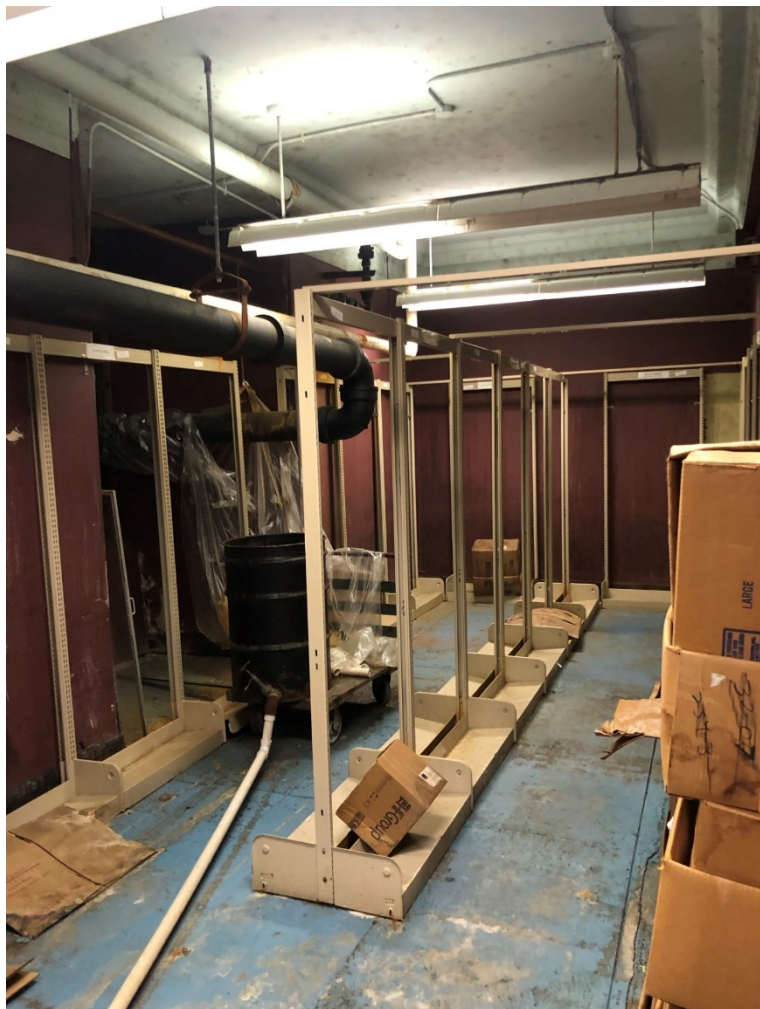
*Photo OCH - B - 7: Storage room in southeast corner of basement.*

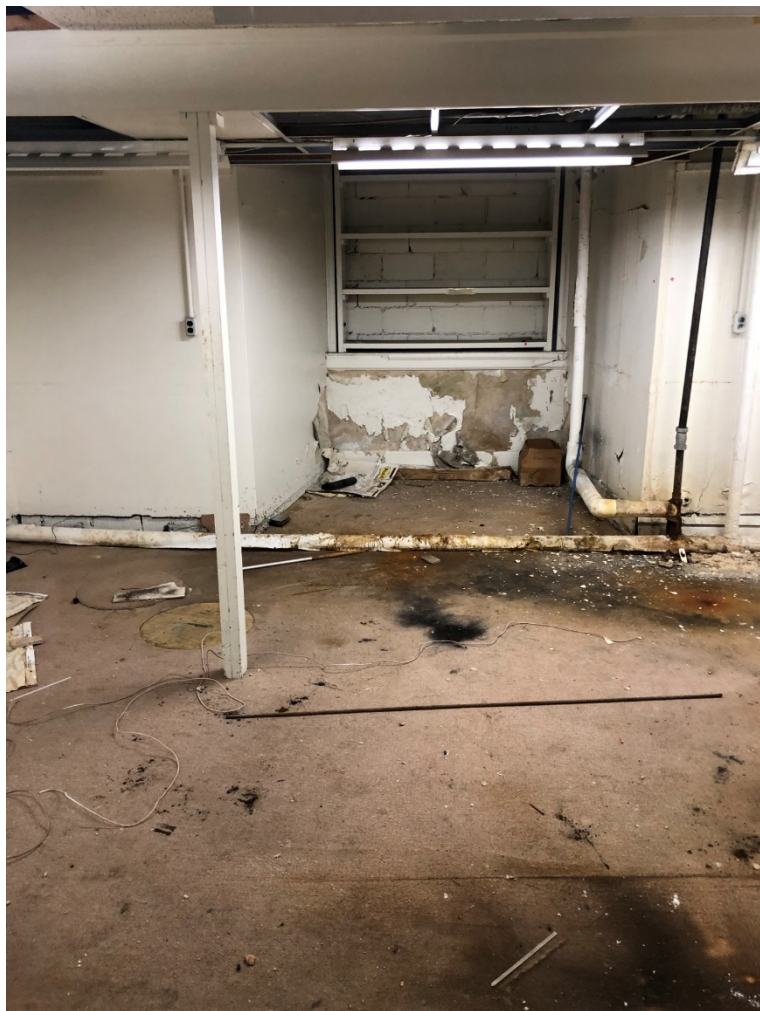
*Photo OCH - B - 8: Room east of south lobby. Same room as photo OCH-B-9.*

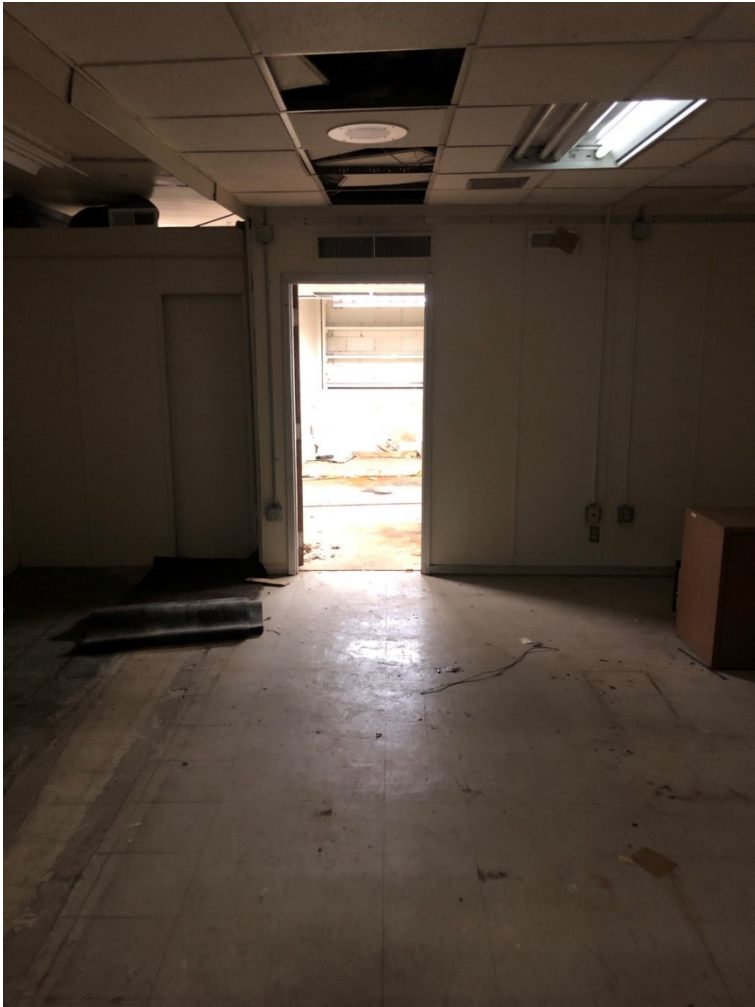
*Photo OCH - B - 9: Room east of south lobby. Drop ceiling covers original ceiling. Same room as photo OCH-B-8.*

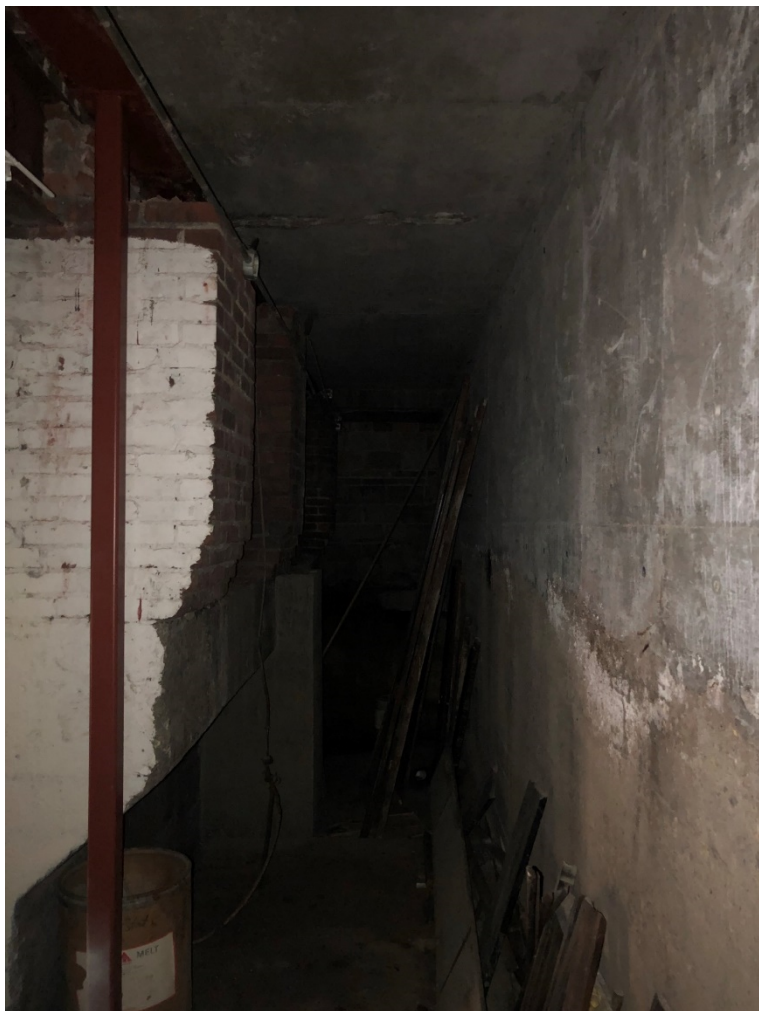
*Photo OCH - B - 10: Chase under front steps.*

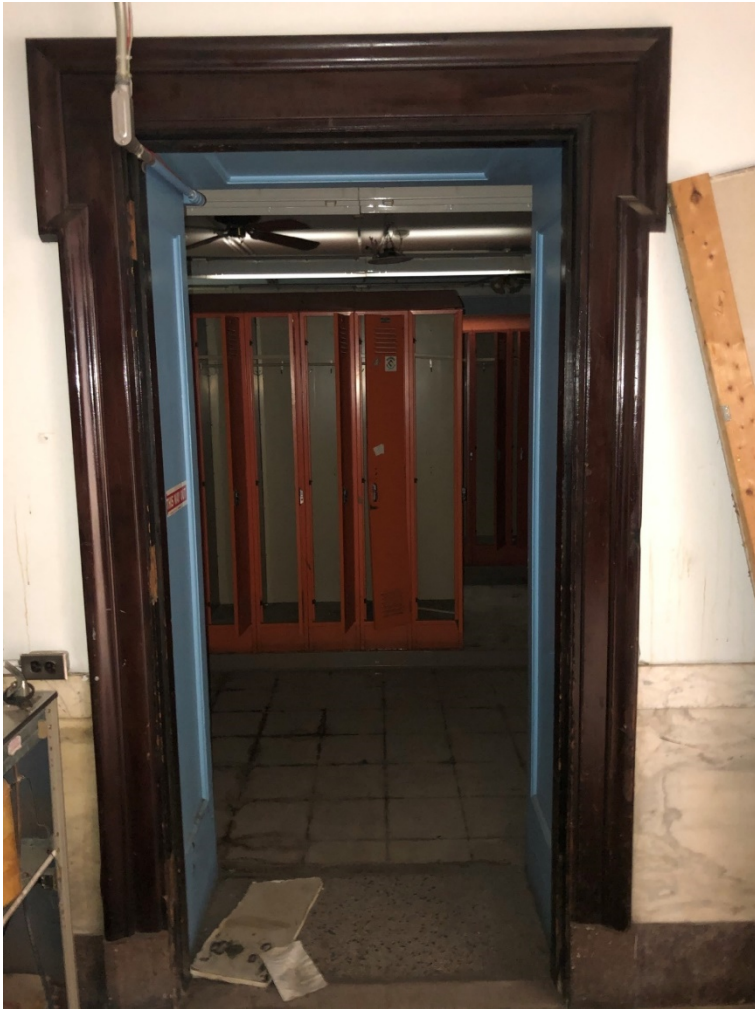
*Photo OCH - B - 11: Room east of north lobby. Previously used as locker room.*

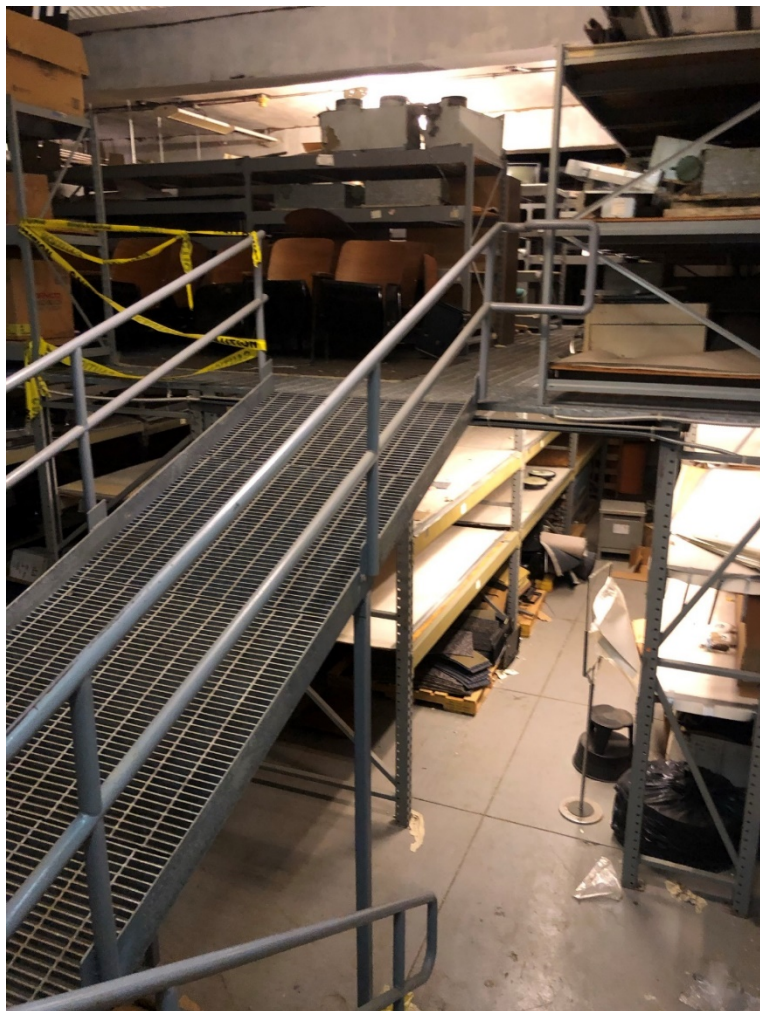
*Photo OCH - B - 12: Storage room in northeast corner of basement.*

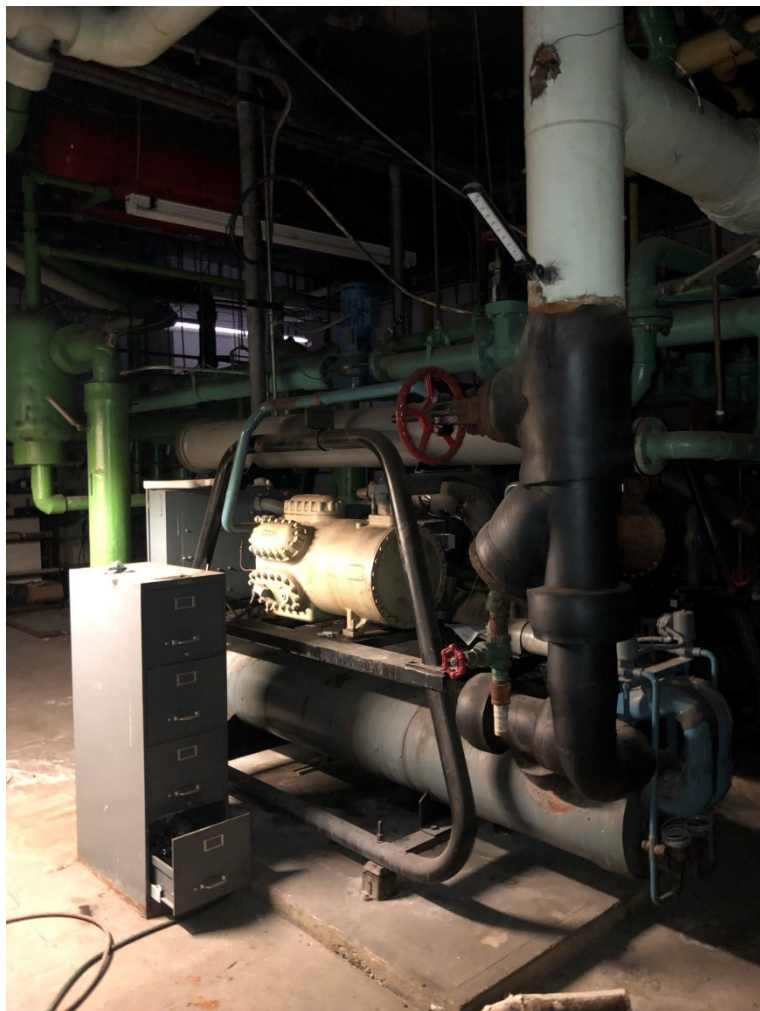
*Photo OCH - B - 13: Mechanical room in northwest corner of basement.*

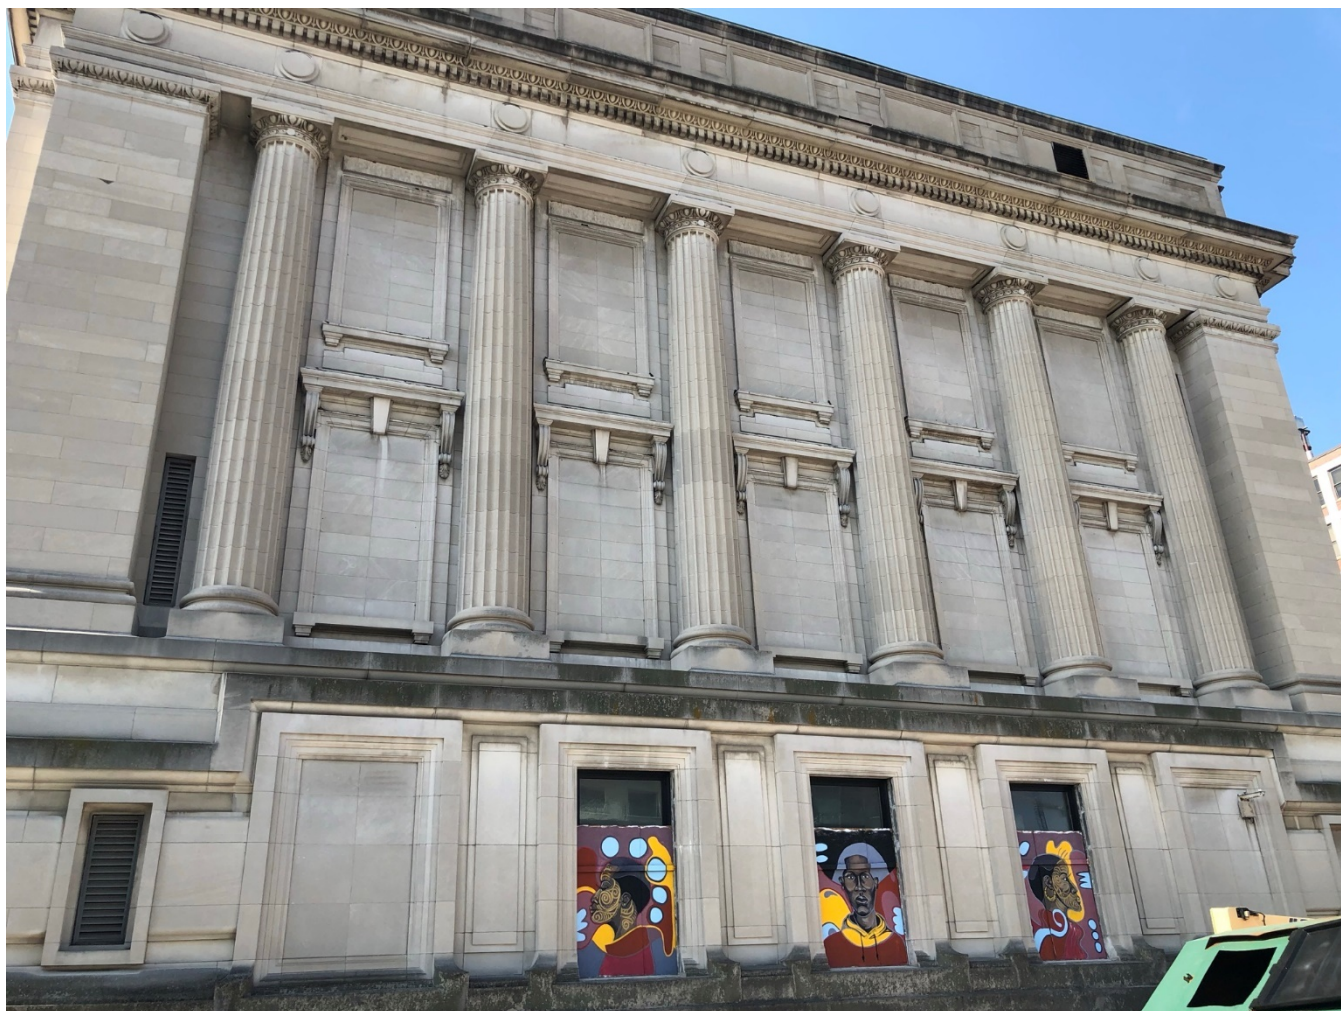
*Photo OCH - EXT - 4: North elevation. Multiple original windows removed and openings blocked. Three restored windows temporarily boarded.*

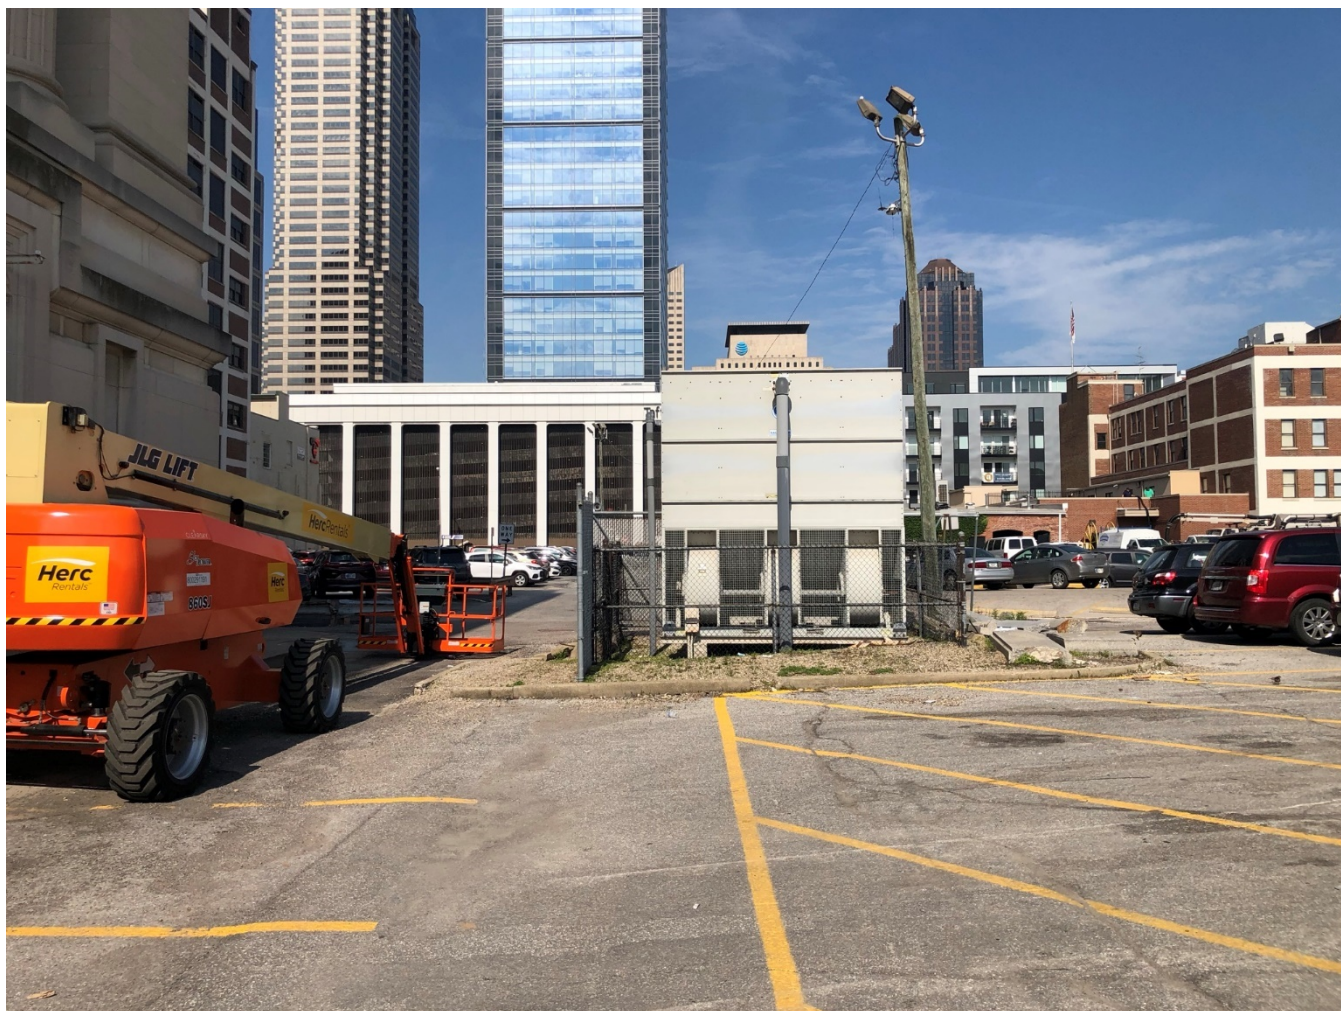
*Photo OCH - EXT - 5: Cooling tower for building located in parking lot north of building.*

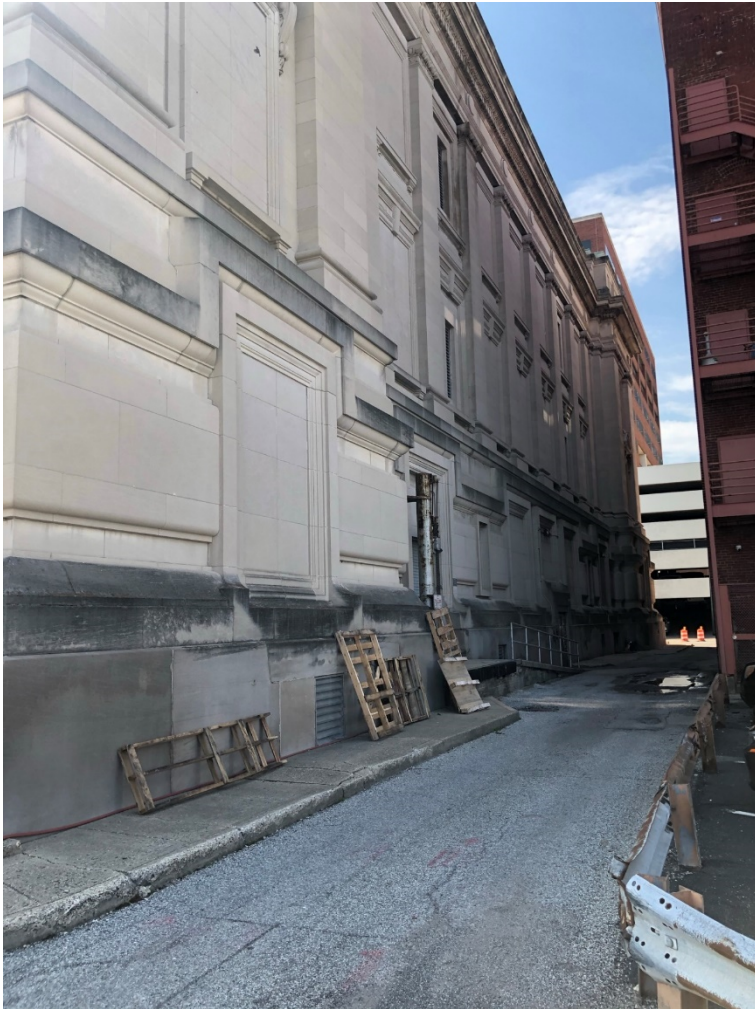
*Photo OCH - EXT - 6: West elevation. Multiple original windows removed and openings blocked. Adjacent to alley.*

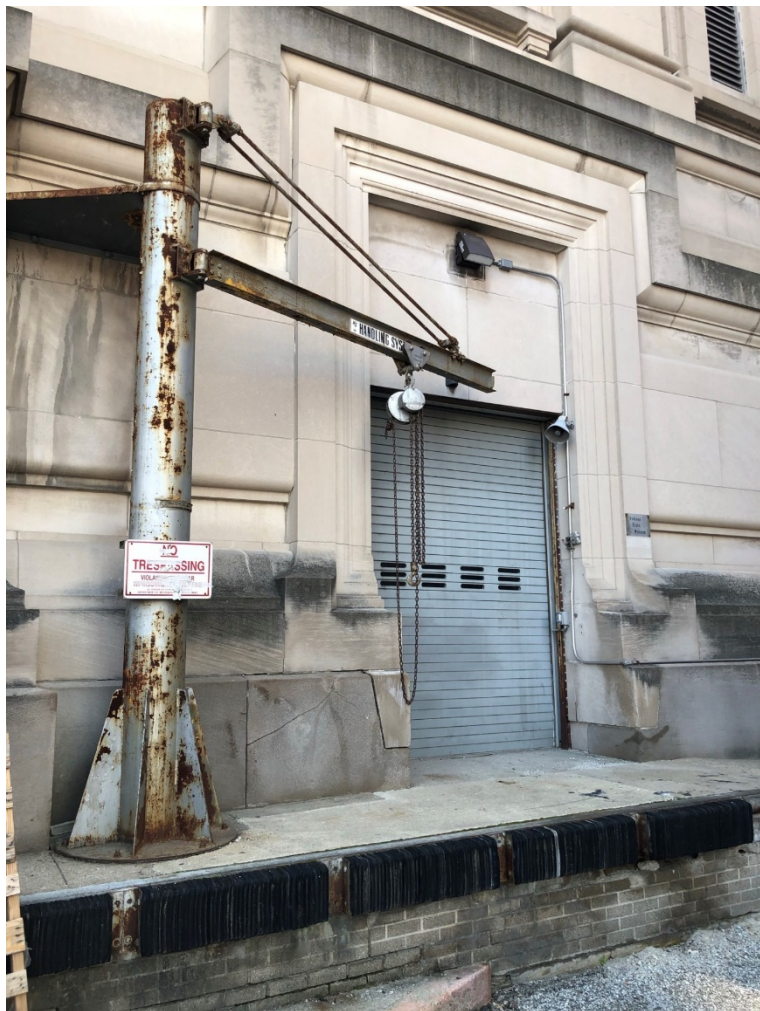
*Photo OCH - EXT - 7: Loading dock and overhead door on west side adjacent to alley.*

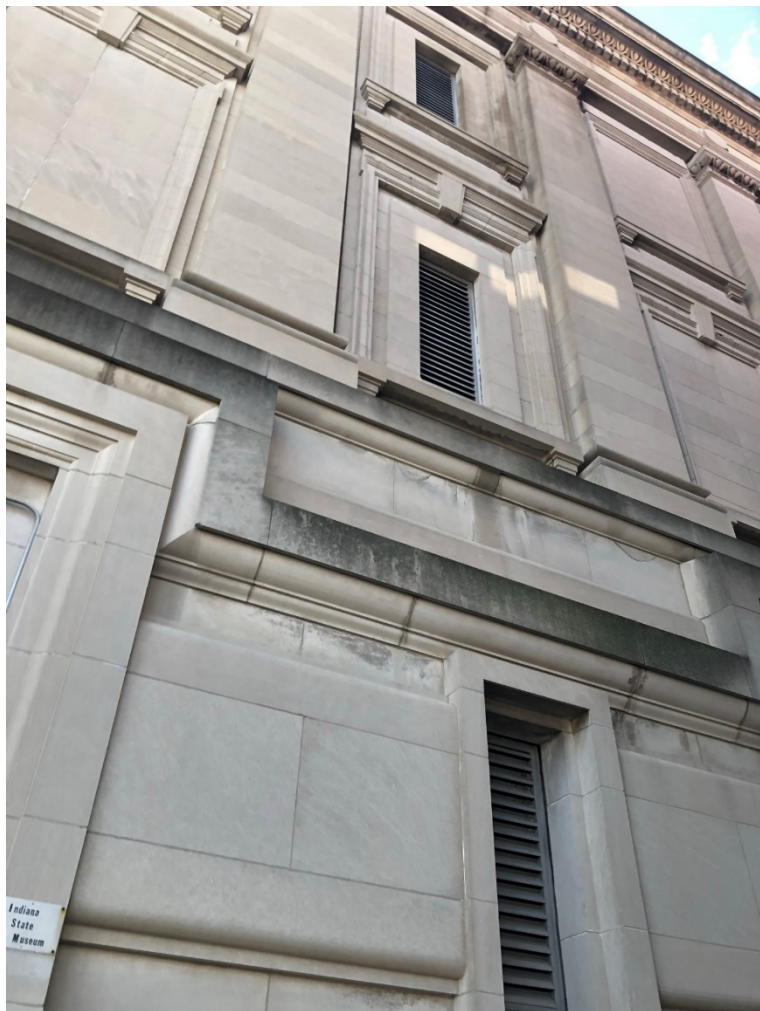
*Photo OCH - EXT - 8: West elevation. Previous window openings at original bathroom locations.*

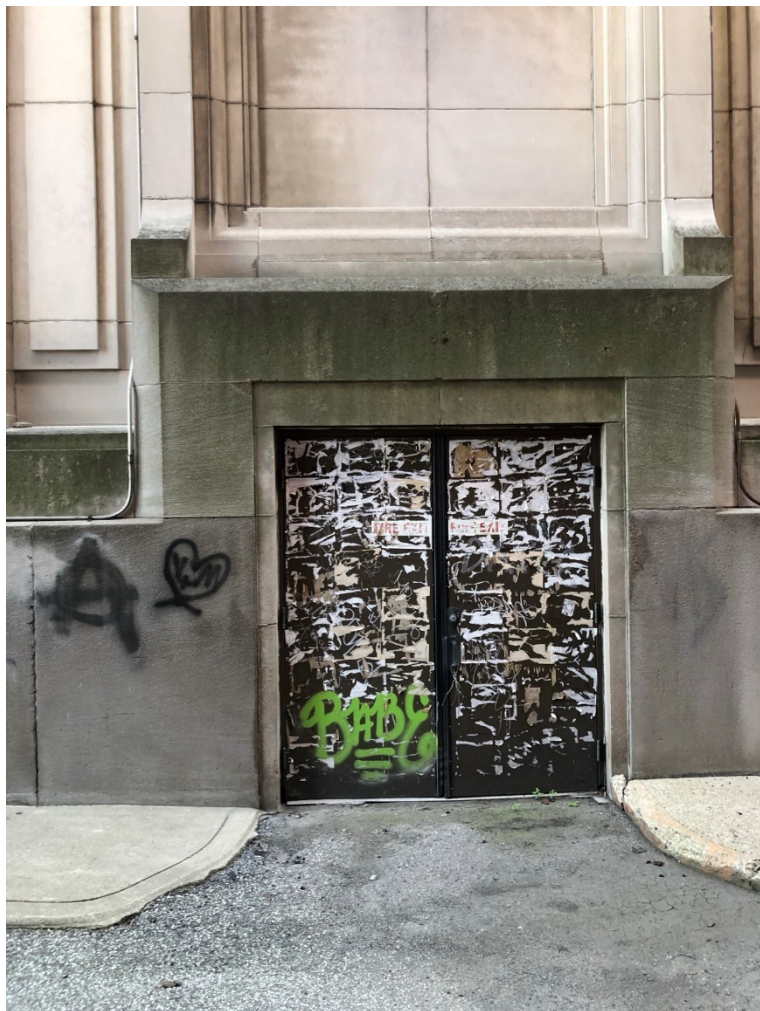
*Photo OCH - EXT - 9: Egress doors at central stairs on west elevation adjacent to alley.*

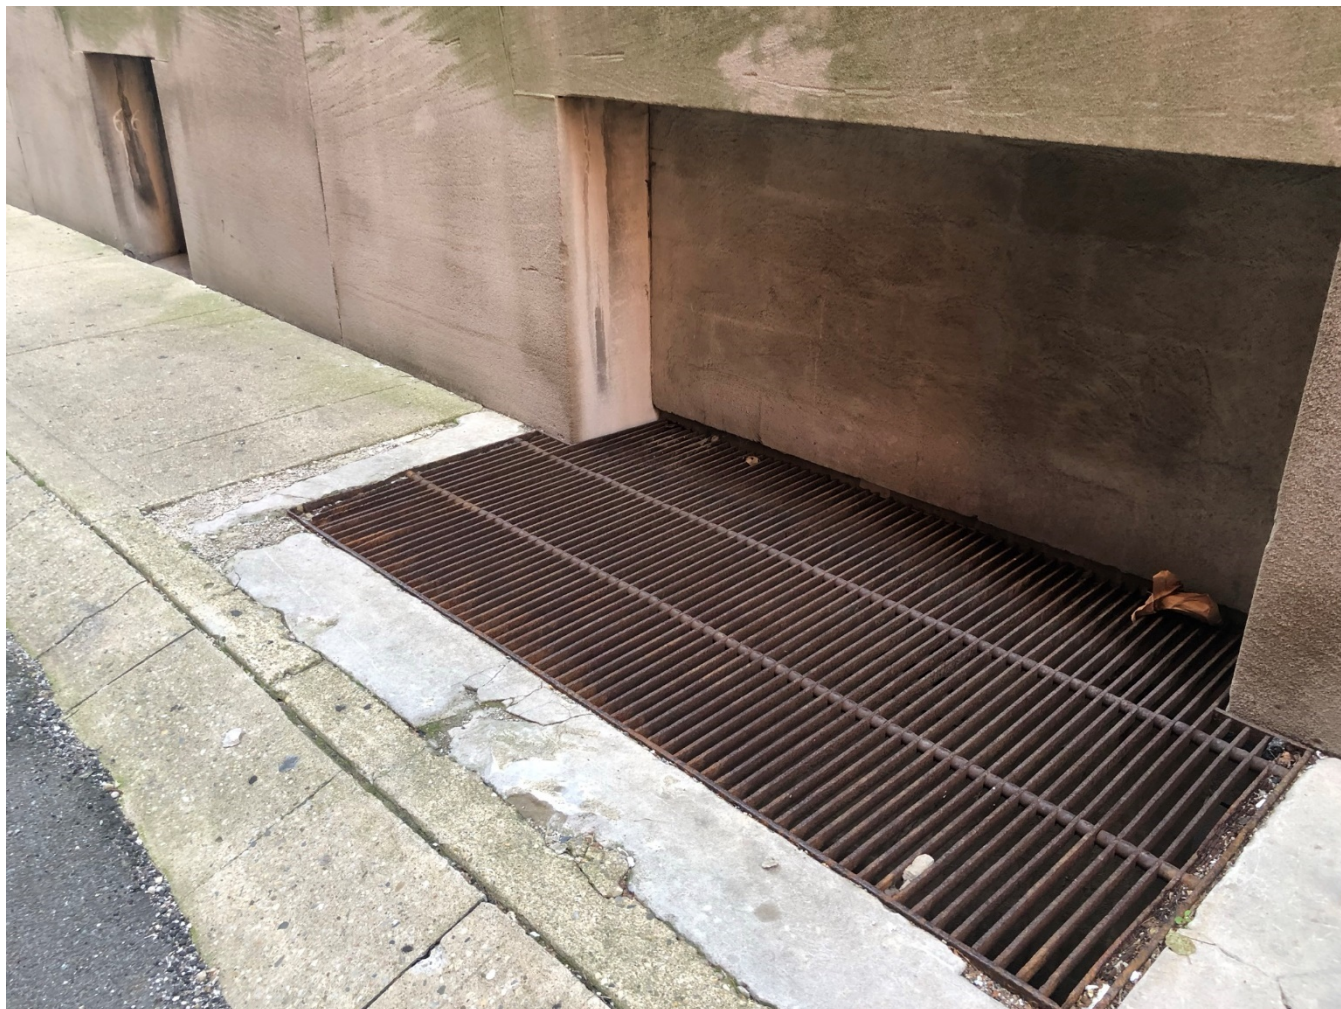
*Photo OCH - EXT - 10: West elevation. Window wells at basement window openings. Window openings blocked.*

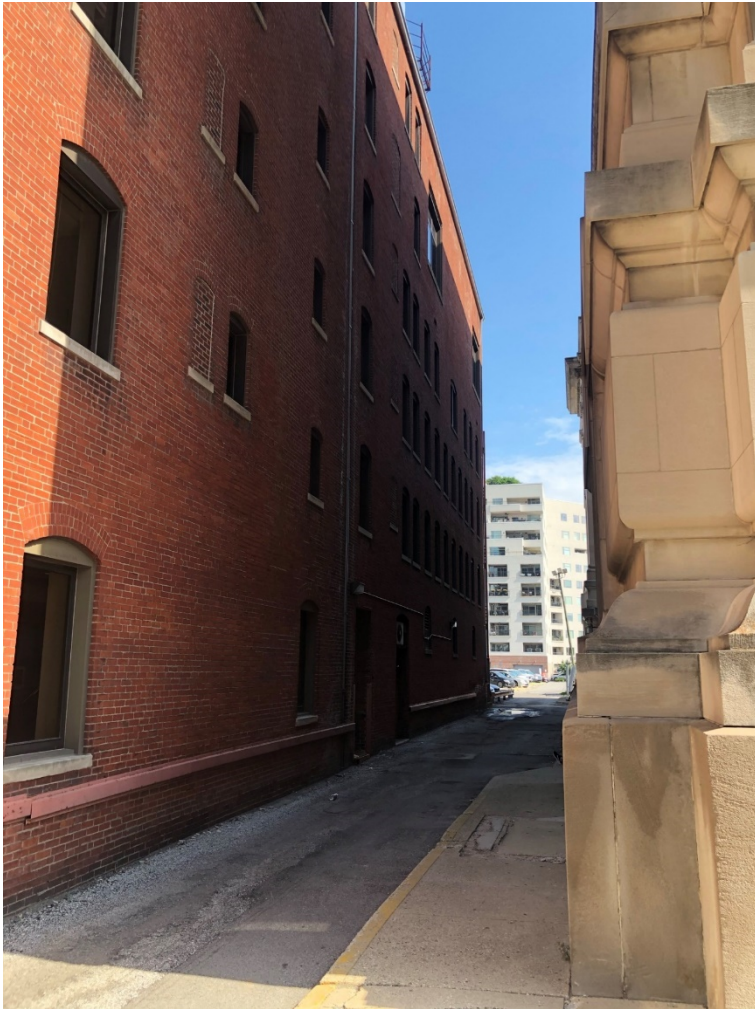
*Photo OCH - EXT - 11: Alley west of building.*

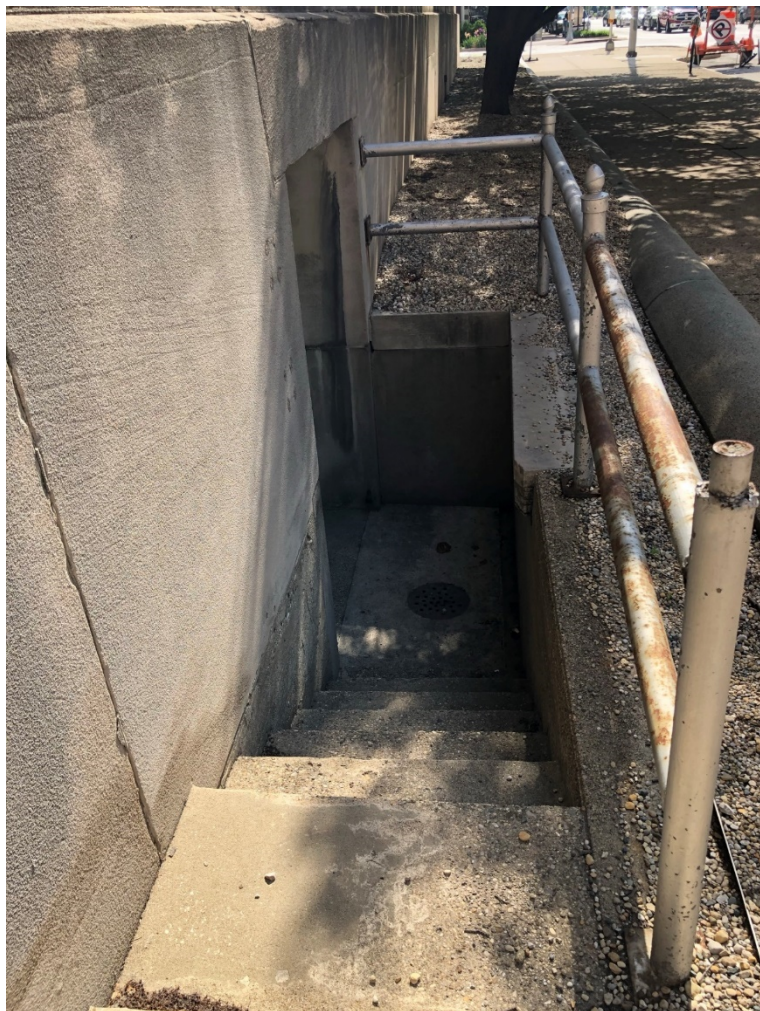
*Photo OCH - EXT - 12: Stairs to basement egress on south elevation adjacent to Ohio Street. No handrails. Guardrail is not code compliant.*

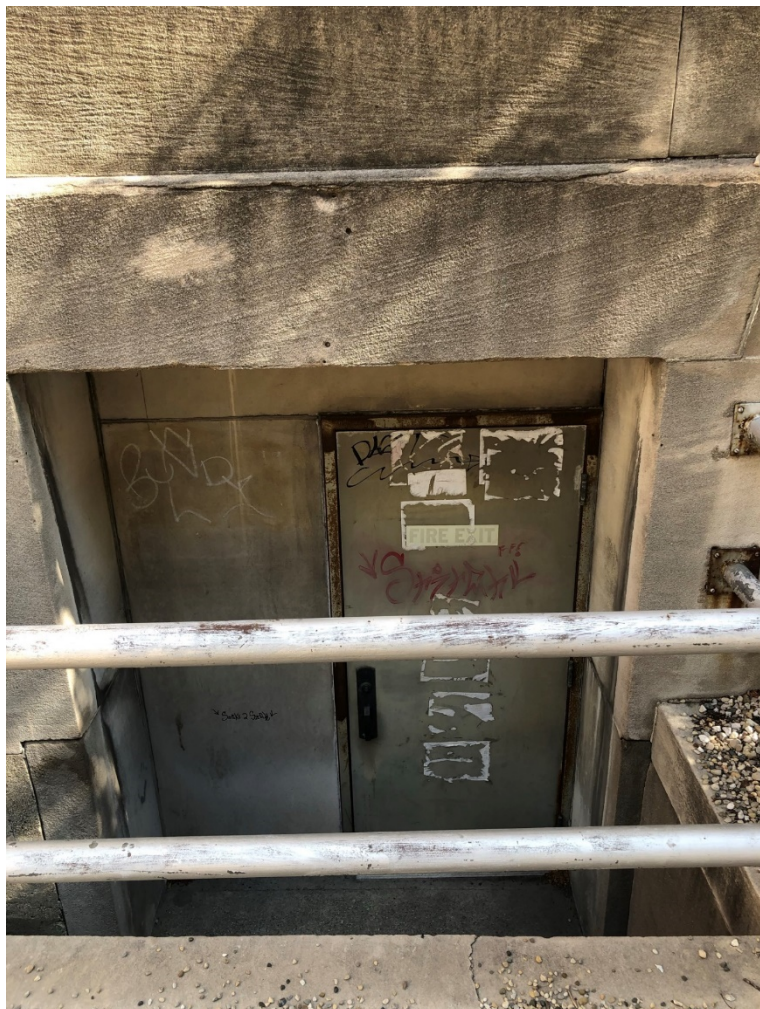
*Photo OCH - EXT - 13: Basement egress door on south elevation adjacent to Ohio Street.*

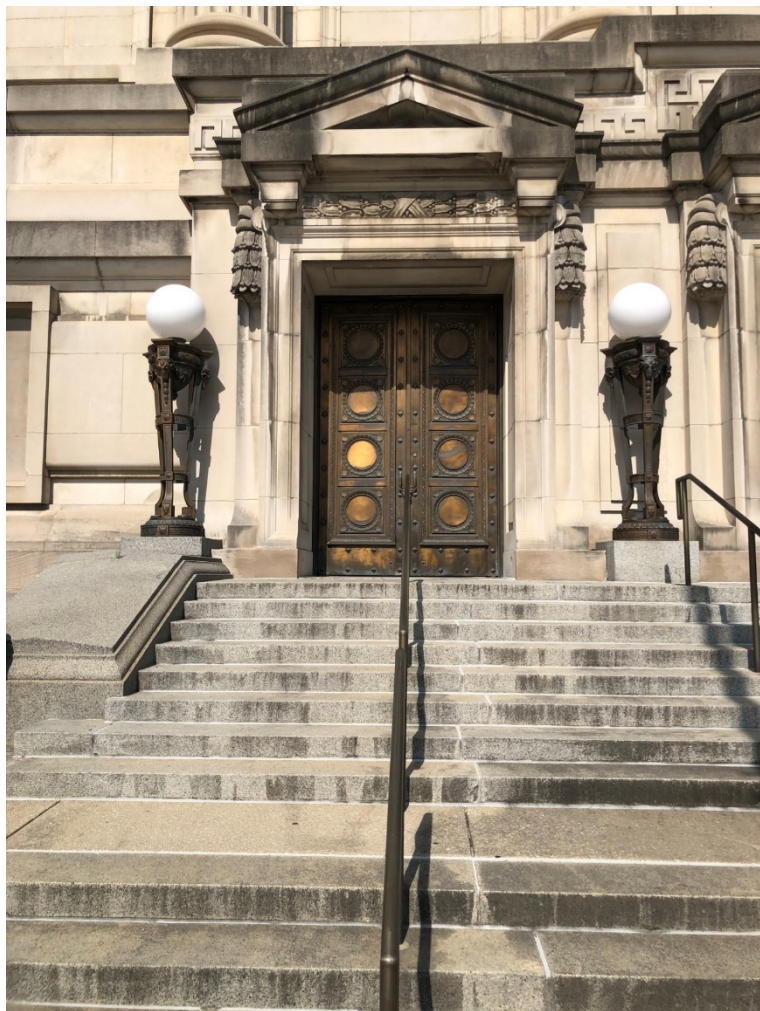
*Photo OCH - EXT - 14: East elevation adjacent to Alabama Street. Stairs leading to bronze doors at vestibule.*

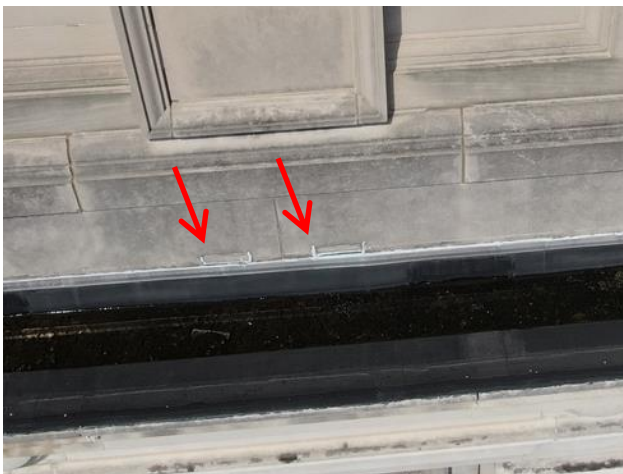
- Observation:** Approximately 6 half-moon shaped spalls and 12 incipient half-moon shaped spalls were observed (Figure 14) at other locations throughout the building facade. The locations of the half-moon shaped spalls often occur at the piers of the facade. Metal anchors exposed by these spalls are typically corroded (Figure 15). Additional limestone spalls and previous repairs are present at isolated locations throughout the facade. A high concentration of previous limestone repairs are present above Roof Area 4 (Figure 16).

Figure 16. Two previous repairs above Roof Area 4.

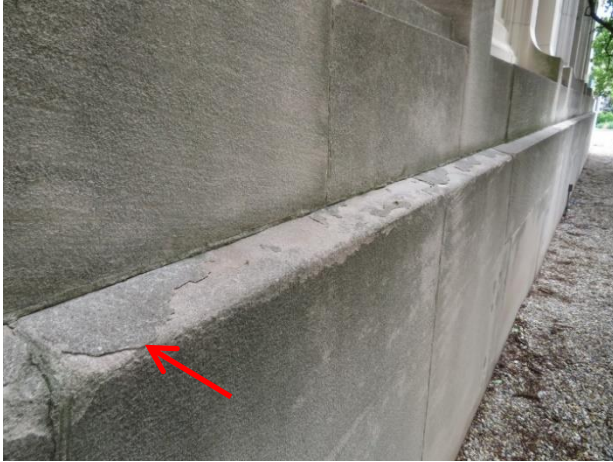
- Observation: Areas of localized exfoliation exist on vertical facing surfaces of limestone at the base of the wall units on the east and south facades (Figure 18). Localized deterioration is present on several limestone units approximately 6 inches above hard-scape surfaces along the east face of the entrance ramp (Figure 19).

Discussion: Exfoliation and deteriorated limestone surfaces are likely the result of cyclic freezing and thawing of water which is held on the surface of the stone. This deterioration may be accelerated by the application of deicing salts on the adjacent hardscape surfaces during winter months. Surface deterioration is primarily an aesthetic concern at this time; however, the condition should be monitored to ensure the deterioration does not continue and compromise the integrity of the stone unit or undermine the support of limestone units above.

Figure 18. Deterioration of horizontal limestone surface on south facade.

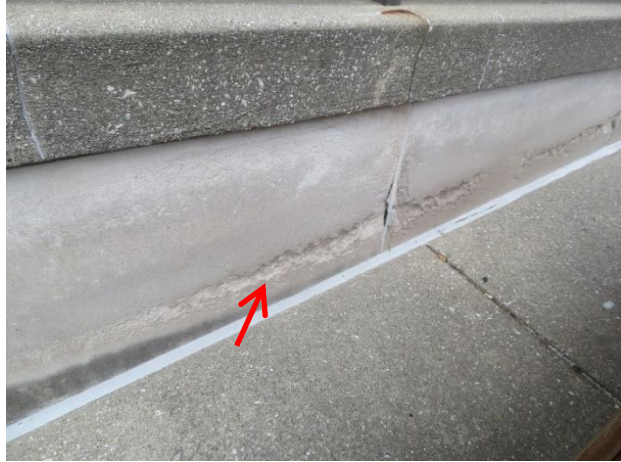
Figure 19. Deterioration of limestone units at the entrance ramp.

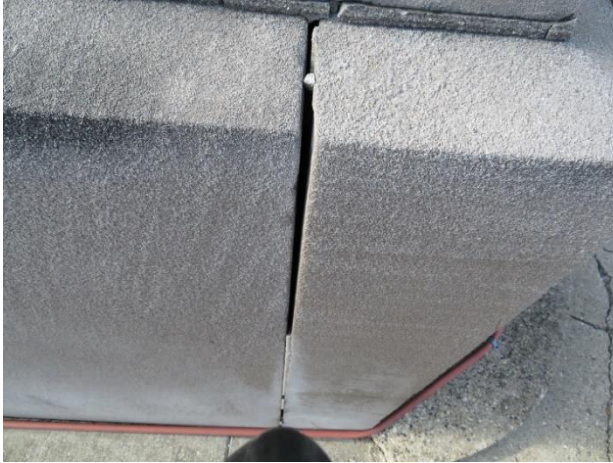
- **Observation:** Eroded and missing mortar at joints between limestone is widespread throughout the facade (Figure 21 and Figure 22). Many upward-facing joints are filled with sealant. Sealant in these joints is well adhered at some locations (Figure 23). At other locations, it has failed adhesively and cohesively.

**Discussion:** Maintaining the mortar and sealant joints on the exterior facade is critical to the management of water through the exterior walls. The exterior walls were designed as mass masonry walls which manage water through shedding bulk water at the surface, and absorption and

evaporation of a limited quantity of moisture. Deteriorated or missing mortar and sealant at exterior limestone joints provide open avenues for water to enter the wall system. Excessive amounts of water entering the mass masonry wall system through mortar joints may exceed the wall's capacity to manage water and result in interior water leakage and damage to underlying elements and interior finishes.

Figure 21. Open head joint at the base of north facade near northwest corner.

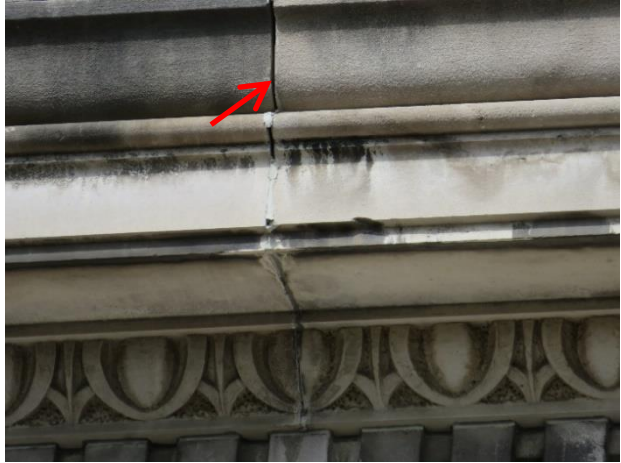
Figure 22. Open head joint below cornice along east facade.

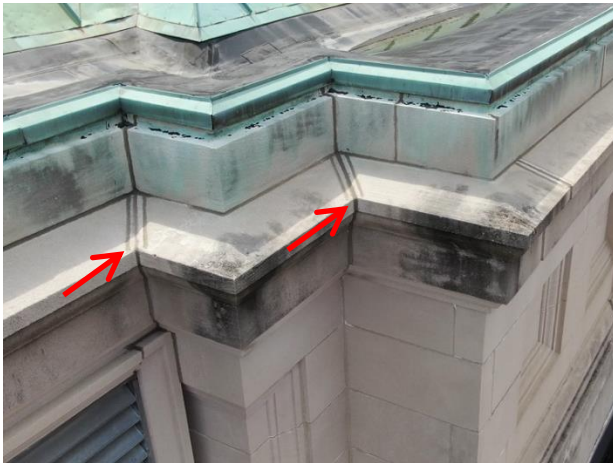
Figure 23. Upward facing sealant joints near the north re-entrant corner on the west facade.

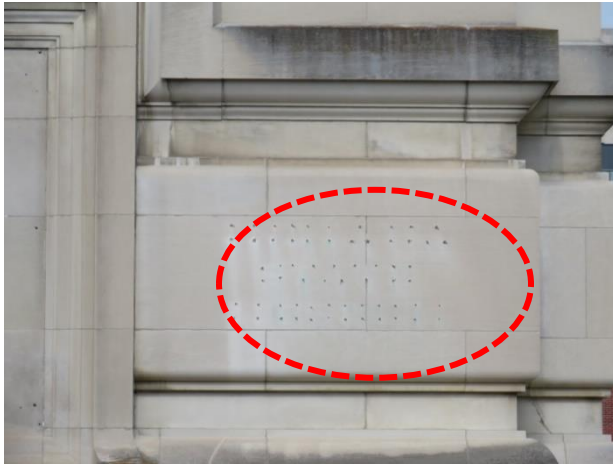
- Observation:** Abandoned anchors and fasteners were observed at ten limestone units throughout the facade. At approximately eight locations, spalls in the limestone unit or mortar patches are adjacent to the abandoned anchors and fasteners. At two locations on the southeast and northeast corners of the building, high concentrations of abandoned anchors related to former signage are present and contributing to staining of adjacent limestone (Figure 28 and Figure 29).

Figure 28. High concentration of abandoned anchors at northeast corner, likely from former signage for Indiana State Museum.

**Discussion:** Abandoned anchors in the limestone units present a possible risk of future distress to the limestone caused by corrosion of the anchors over time as discussed above. The abandoned anchors should either be removed, or the limestone units replaced to mitigate this risk.

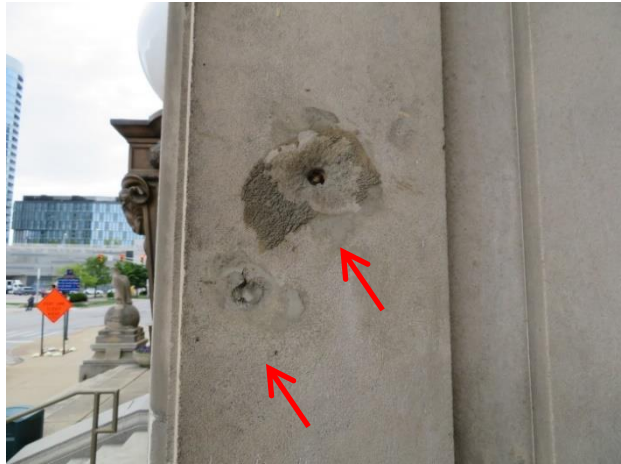
Figure 29. Spall and incipient spall at two abandoned anchors near east entrance doors.

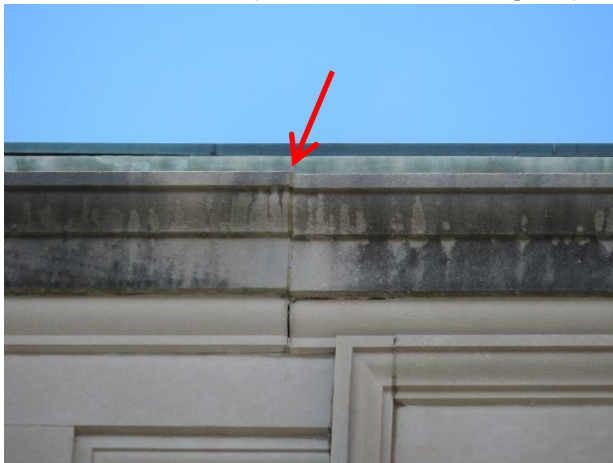
- Observation:** Several displaced limestone units exist throughout the facade (Figure 30 and Figure 31).

Figure 30. Displaced limestone unit at north facade.

**Discussion:** A close-up inspection of the displaced units should be performed to determine if the units are secure or if replacement or anchorage repairs are required.

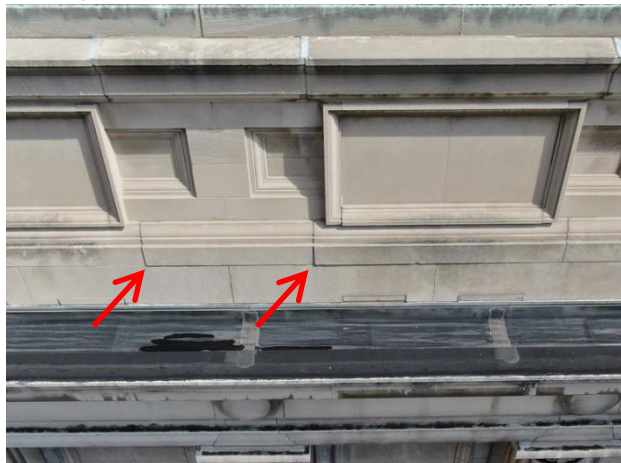
Figure 31. Displaced limestone units along south facade

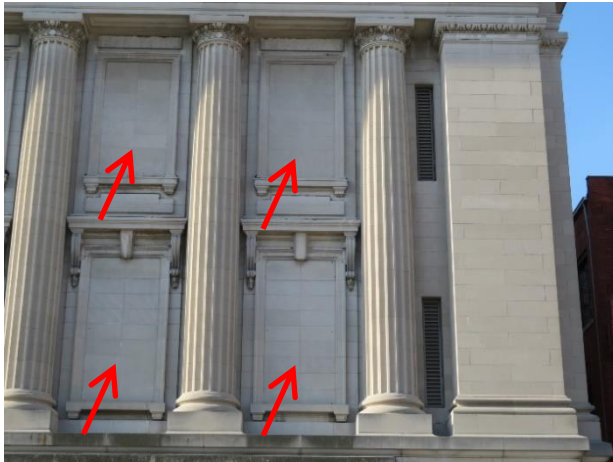
- **Observation:** Most windows throughout the building are infilled with limestone and CMU (Figure 32). Original wood window frames exist behind these infill panels at many window locations. Most, but not all, sash and counterweights are not present in the window frame (Figure 33). CMU infill is positioned approximately 1 inch outboard from the front of the jambs of the window frame.

**Discussion:** The original window openings were infilled with limestone circa 1965 as part of renovations to the building to house the Indiana State Museum. Based on detail 28 on sheet A7 of the 1964 renovation drawings prepared by James Associates, the infill limestone panels were anchored to the jambs and at heads and sills. The exact configuration of this anchorage is not documented. The wood window frame is intact behind many infilled openings. Based on the position of the CMU infill, it is likely that the original wood brickmold was removed from the outside face of the frame to accommodate the masonry infill work. Also, as part of the window infill project, cast iron grills originally present at fourth floor windows were removed.

Figure 32. Infilled window openings on north facade.

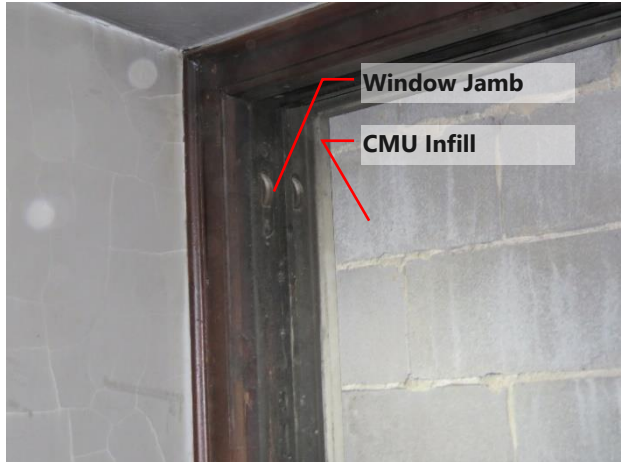
Figure 33. original wood window frame behind infilled window opening

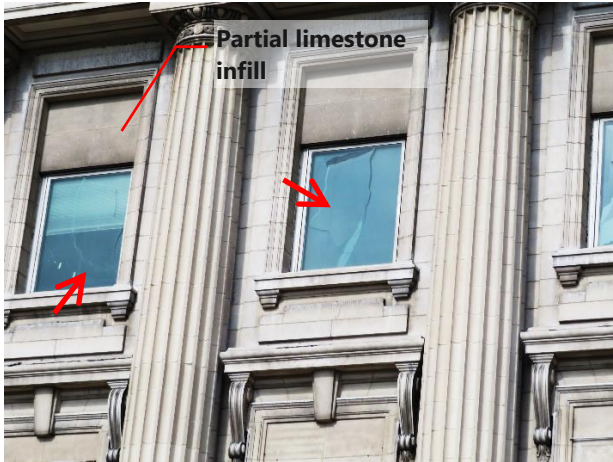
- **Observation:** Where windows are present at the third floor along the east elevation. Many contain broken glass panes (Figure 34). Rigid insulating panels were present at the interior face of most third-floor windows with broken glass and were therefore inaccessible. At one window which was accessible from the interior, broken glass was confined to the interior pane of the insulated glazing unit (IGU) only.

**Discussion:** Based on our exterior and interior assessment, it was typically unclear if the cracked window glass occurs on the exterior or interior pane of the IGU. Similar broken glass panes have been present since 2009 based on findings from the 2009 Condition Survey. Broken glass in the exterior pane presents a possible overhead material falling hazard to pedestrians.

Figure 34. Broken glass at two windows along east facade.

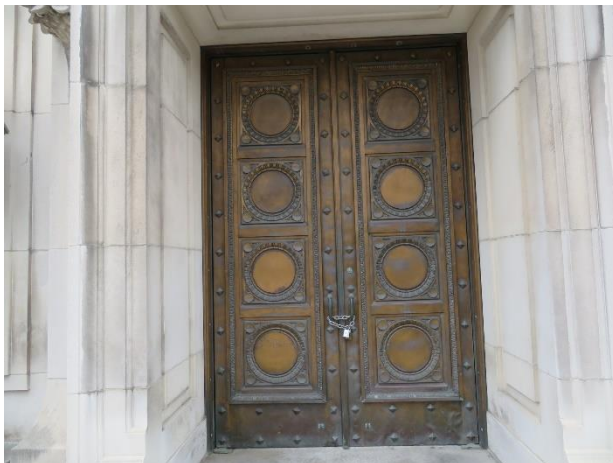
- Observation:** The three entrance doors on the east facade exhibit multiple different types of deterioration (Figure 35). This deterioration includes missing bronze sheet metal elements; corrosion of bronze sheet metal (Figure 36); separation and splitting of the bronze sheet metal (Figure 37); splitting and denting near the door hinges (Figure 38). At the one location of exposed core, the wood contained visible deterioration.

**Discussion:** Bronze sheet-metal cladding is relatively thin and susceptible to breakage and splitting over time and due to localized impact. Breaches in the bronze cladding may result in water infiltration into the door and deterioration of the wood core. Corrosion of the bronze indicates that original wax or lacquer protective coatings have degraded. Corrosion can be exacerbated by the use of deicing salts. Corrosion of bronze sheet metal can result in pitting, pinholes, or loss of the metal over time.

Figure 35. Overall view of one bronze clad door.

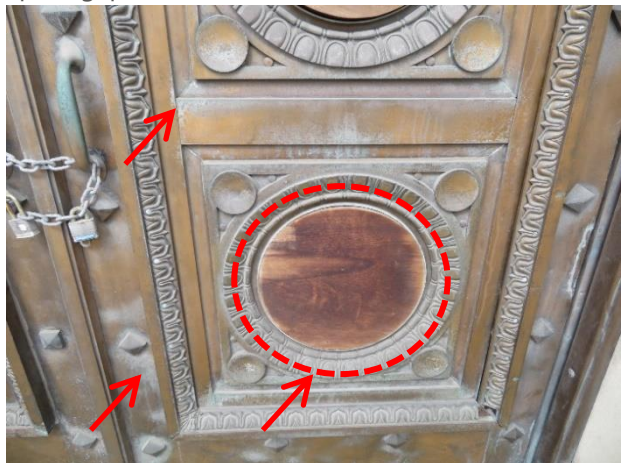
Figure 36. Missing bronze sheet metal at decorative coin (dashed ellipse) and surface corrosion on bronze sheet metal (red arrows)

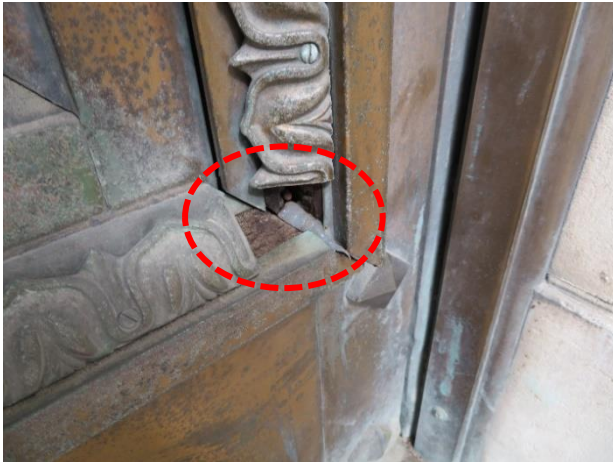
Figure 37. Open joint in bronze sheet metal with exposed and deteriorated wood core visible behind.
