***CITY MARKET AND OLD CITY HALL***  
***Indianapolis, Indiana***

***OLD CITY HALL FACILITY ASSESSMENT AND CAPITAL PLANNING REPORT***

***JSH No.: 21060108***

***Date***  
***08/06/2021***

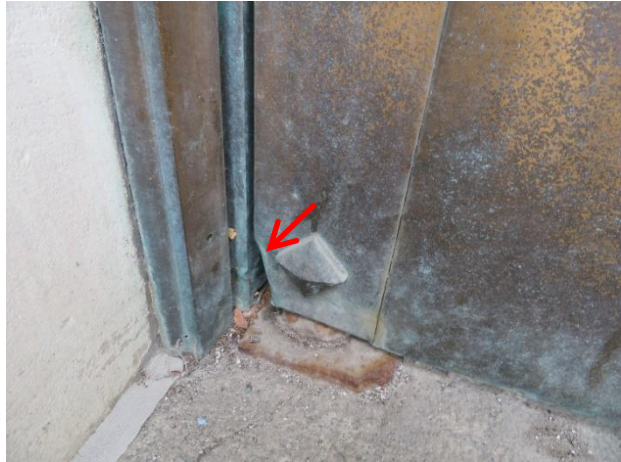
- Observation:** The three entrance doors on the east facade exhibit multiple different types of deterioration (Figure 35). This deterioration includes missing bronze sheet metal elements; corrosion of bronze sheet metal (Figure 36); separation and splitting of the bronze sheet metal (Figure 37); splitting and denting near the door hinges (Figure 38). At the one location of exposed core, the wood contained visible deterioration.

Figure 38. Dented bronze sheet metal near door hinge and surface corrosion.

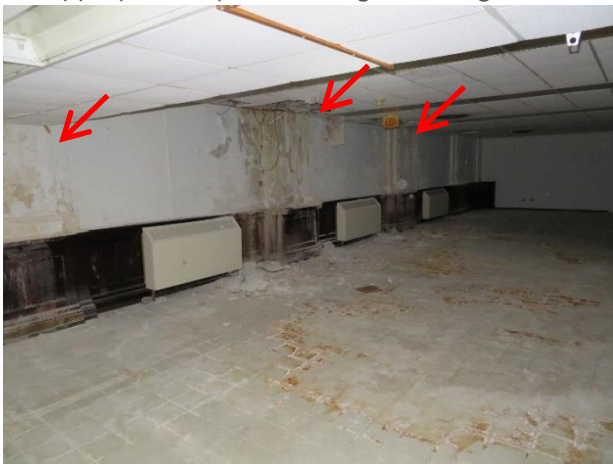
- **Observation:** Water damaged plaster and peeling paint is widespread throughout the ceiling and walls of the fourth floor. Most of this damage is located along the exterior walls and underneath Roof Areas 2 and 3 of the building (Figure 39). Damage is also present at isolated areas on interior walls, most notably near the southeast corner of the atrium (Figure 40)

**Discussion:** The perimeter walls, where much of the plaster damage was noted, roughly align with the base of Roof Area 2 and Roof Area 3. Similar damage was noted in the 2009 Ratio Facility Study report and thus likely predates the 2012-2013 roof replacement. However, the report does not indicate the extent of damage present in 2009, and the reviewed information does not indicate the scope of the 2012-2013 roof replacement. The Indiana Building Authority reported ongoing leakage has occurred at one location during the winter of 2020. If water leakage is ongoing, further investigation and diagnostic water testing would be necessary to identify the sources of the leakage to develop appropriate repairs to mitigate leakage.

Figure 39. Water damage along the south wall at the fourth floor.

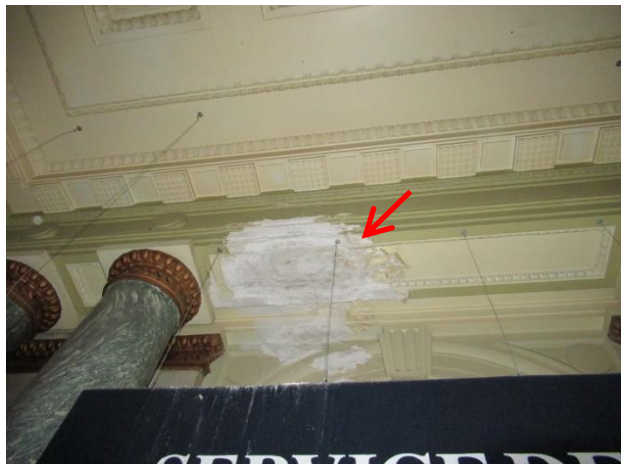
Figure 40. Water damage near the eastern edge of the atrium at the fourth floor.

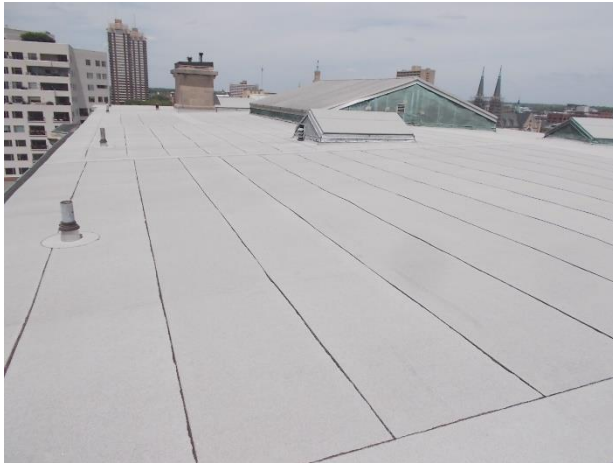
- Observation:** Roof Area 1 contains good slope throughout the roof to the perimeter without signs of ponding water (Figure 41). The GSMB roof membrane turns down at the perimeter edges and is terminated with a termination bar, which is mechanically fastened at 6 inches on center (Figure 42). Very little granule loss has occurred on the membrane, and no blisters were observed throughout the field of the roof. Detailing of the modified-bitumen roof transitions does not contain any visible deficiencies. Historic Google.com aerial imagery shows a distinct change in the appearance of Roof Area 1 between August 2012 and October 2013 (Figure 43 and Figure 44), indicating the installation of the present roof membrane within that timeframe.

**Discussion:** Roof Area 1 is generally in good condition and does not contain significant visible deficiencies. Aerial images indicate that Roof Area 1 may have been replaced between 2012 and 2013 and thus is approximately 8 years old. If properly installed and maintained, the typical useful life of GSMB roof systems is 25-30 years.

Figure 41. Overall view of Roof Area 1 showing atrium skylight and two small skylights.

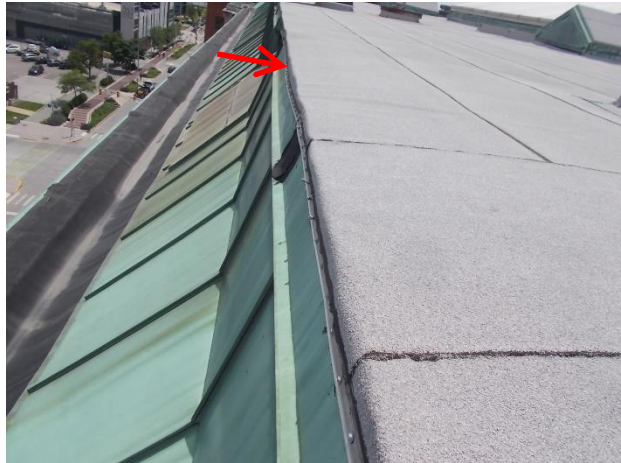
Figure 42. Edge metal termination of the mod-bit roof system.

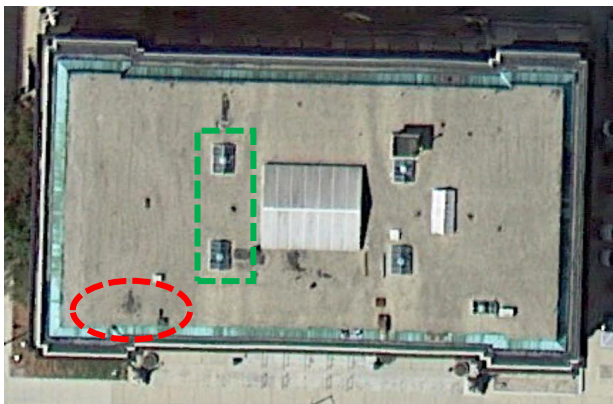
Figure 43. Aerial image taken August 2012. Courtesy of Google.com. Changes in the appearance of several roof elements are shown by dashed ellipses and rectangles.

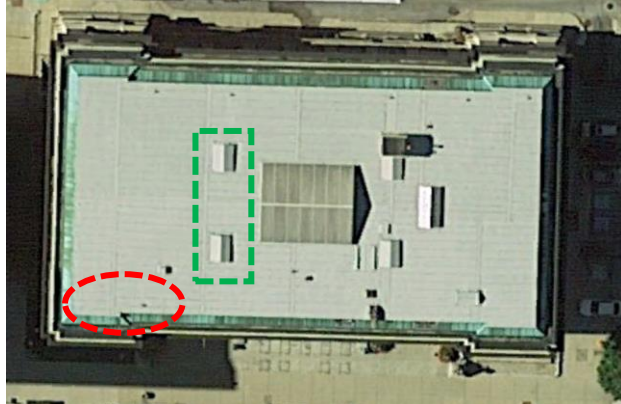
Figure 44. Aerial image taken in October 2013. Courtesy of Google.com. Changes in the appearance of several roof elements are shown by dashed ellipses and rectangles.

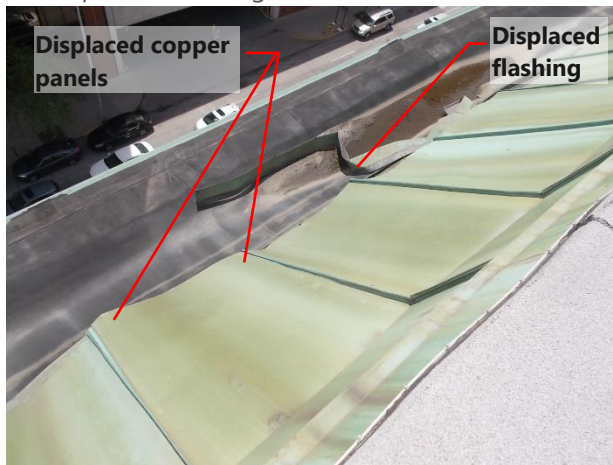
- **Observation:** Multiple copper panels are displaced and bowing outwards along the south portion of Roof Area 2 (Figure 45). Copper base flashings are also displaced along a 20-foot length of roofing on the south edge. At this location, the securement of the EPDM membrane on Roof Area 2 is also detached and fasteners have pulled out of the substrate at the base of the copper panels (Figure 46).

**Discussion:** The existing copper roof assembly is not original, although the date of its installation is not known. Based on available photographs, it appears to predate the 1974 National Register nomination and is therefore likely more than 50 years old. Displaced metal panels indicate that panels are no longer secured to the roof substrate. This failure in attachment may have been caused by wind or thermal expansion and contraction over time. Displaced copper flashings have exposed the leading edge of the EPDM membrane on Roof Area 3 below and may be a source of water infiltration into the roof system and interior of the building at this location. Water damage was noted in the 2009 Ratio Report and during the current assessment below this location.

Figure 45. Displacement of detached roof panels and displaced metal base flashing along the south edge of Roof Area 2.

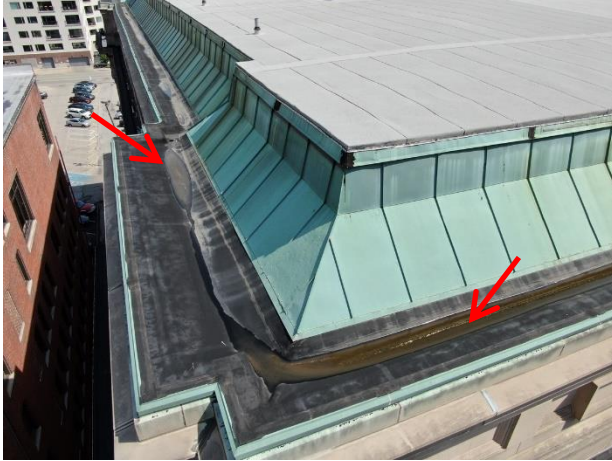
- **Observation:** At Roof Area 3 the EPDM membrane contains many patches. The edges of multiple patches are not well adhered and curled upward. Multiple areas of ponding water and organic debris also exist throughout this roof area. Three of the four drains are missing strainers (Figure 47 and Figure 48).

**Discussion:** Ponding water is the term used for standing water which remains on a roof surface for at least 48 hours. Water which remains on a roof surface for an extended period can prematurely deteriorate roof membranes. Formation of ice crystals during freezing cycles can degrade the surface of the roof membrane and standing water can harbor biological growth which can further damage the membrane, especially at lap seams in the membrane. The size and depth of areas of standing water on Roof Area 3 are indicative of ponding water from precipitation many days prior to the inspection. This ponding water is most likely caused by inadequate sloping of the roof toward internal drains due to its long geometry and limited number of area drains.

If properly installed and maintained, the typical useful life of an EPDM membrane roof can range from 15 to 20 years. The age of Roof Area 3 is unknown; however, the roof membrane exhibits signs of an

advanced age. WJE was provided with two proposals dated July of 2011 for roof replacement and repairs but no repair documents were provided, and it is unclear if the work specified in the proposals was completed. The poor physical condition suggests this roof area may predate the 2012-2013 project and may be at or approaching its expected service life.

Figure 47. Ponding water along south and west portions of Roof Area 3.

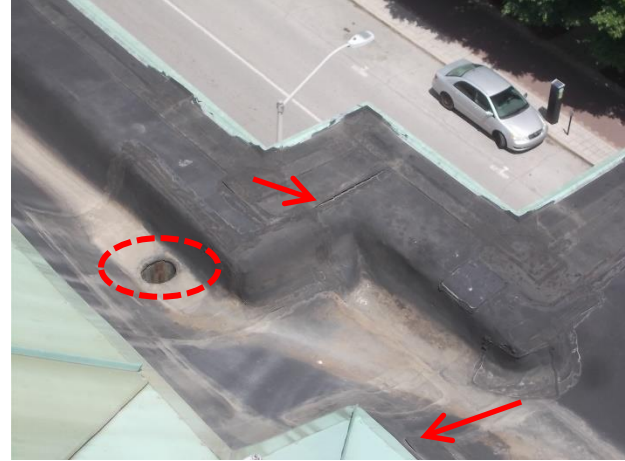
Figure 48. Un-adhered patches and missing strainer near southeast roof drain.

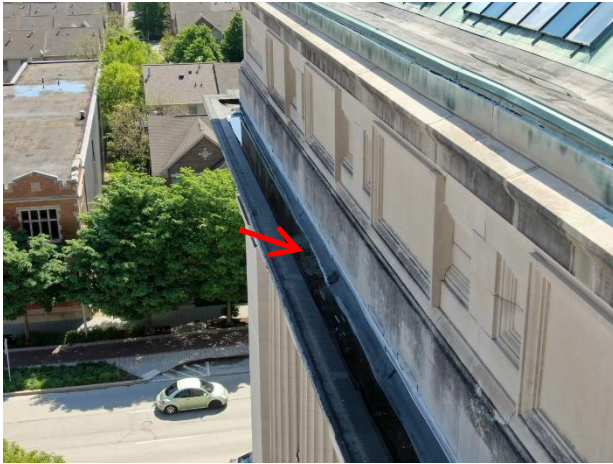
- **Observation:** Ponding water and organic debris are present at many areas of Roof Area 4. (Figure 49). All four roof drains strainers are partially obstructed by this debris (Figure 50).

Biological growth in standing water on Roof Area 4 indicates that water likely remains on the surface of the roof for extended periods and is therefore considered ponding water. See discussion of the deleterious effects of ponding water above. Similar to Roof Area 3, the EPDM rubber membrane in Roof Area 4 may predate the 2012-2013 roof project and may be at or approaching its expected service life.

Figure 49. Ponding water along north portion of Roof Area 4.

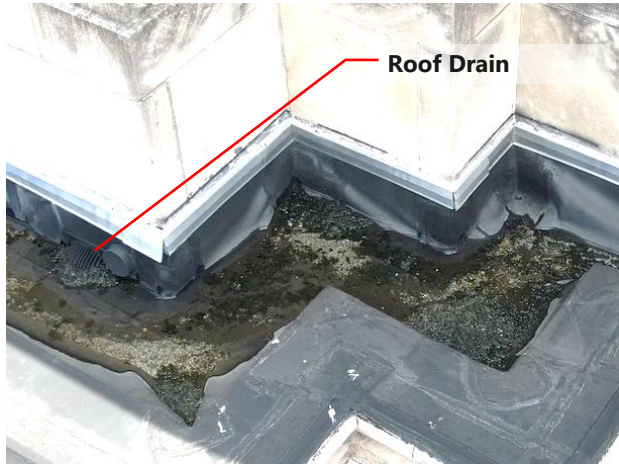
Figure 50. Ponding water and debris near northwest roof drain in Roof Area 4.

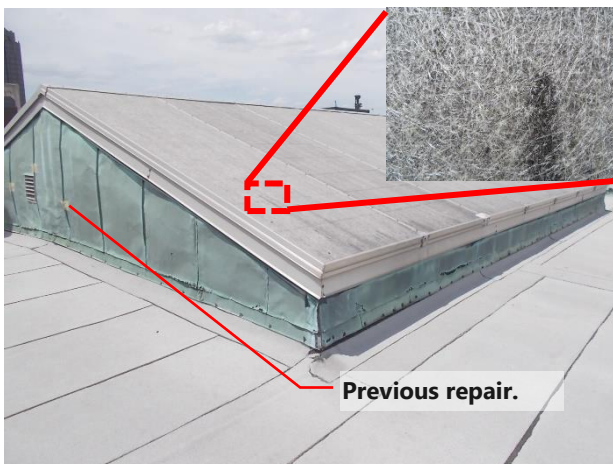
- Observation:** The fiber-reinforced polymer panels which cover the main atrium skylight have weathered significantly, and fibers are exposed on all upward facing surfaces (Figure 51). The existing copper flashings and panels on the walls of the atrium skylight are not securely fastened to the vertical surfaces. In addition, many panels contain cracks and previous fluid-applied repairs (Figure 52).

**Discussion:** The fiber-reinforced polymer panels on the atrium skylight were installed in or near 1978 and thus are approximately 43-years old. The date of installation of the existing copper flashings is not known, but they are older than the skylight. The 1970s polymer panels have degraded, likely from UV exposure, which makes future maintenance options, such as application of sealants, unlikely to be successful. Based on its vintage, the skylight system likely does not incorporate thermal breaks, which may lead to excessive condensation on the bottom side of the skylight panels.

Figure 51. Atrium skylight with weathered fiberglass panels.

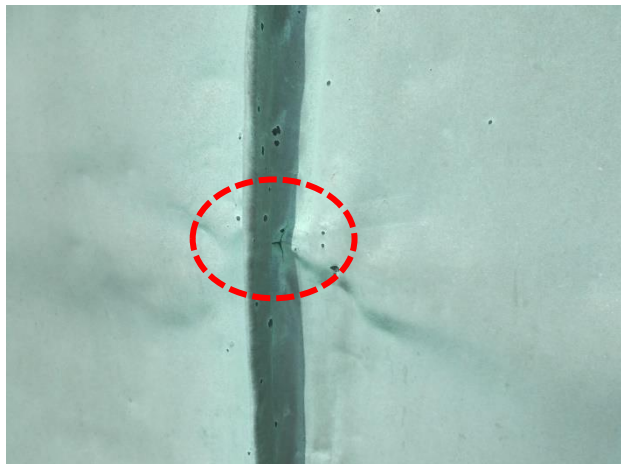
Figure 52. Crack in copper panel at atrium Skylight.

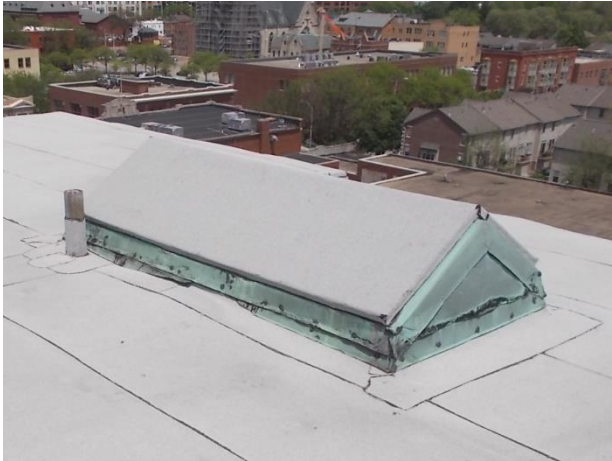
- **Observation:** Five of the six small skylights on Roof Area 1 are covered with GSMB membrane, and many of the copper flashings on the vertical walls of these skylights remain in place (Figure 53). The copper flashings contain multiple liquid-applied surface repairs (Figure 54). When viewed from below, it appears that the skylight glazing has been removed, and OSB sheathing has been installed on top of the skylight framing to support the roofing membrane. The one uncovered small skylight contains fiber-reinforced polymer panels similar to the atrium skylight.

**Discussion:** The installation of GSMB membrane over OSB on top of skylight framing is not a conventional use for the roofing material. The discontinuity in the roof membrane at the transition between copper wall panels and skylights may be a source of possible water infiltration into the roof system. Additionally, the copper flashings which remain exposed contain multiple repairs, cracks and tears which may be paths for additional water infiltration.

Figure 53. Skylight which has been covered with GSMB membrane.

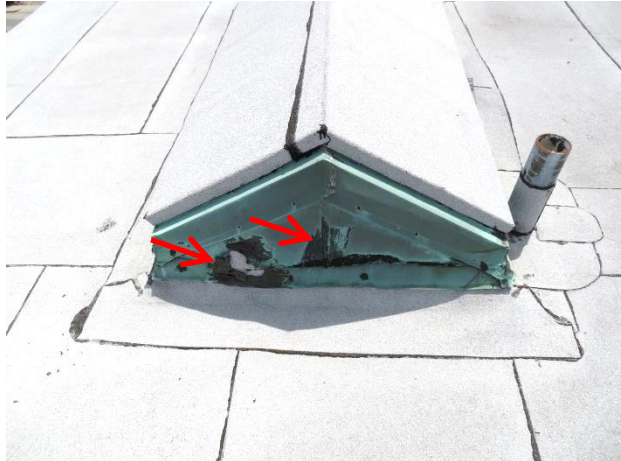
Figure 54. Liquid-applied repairs to copper flashings at small skylight on Roof Area 1.

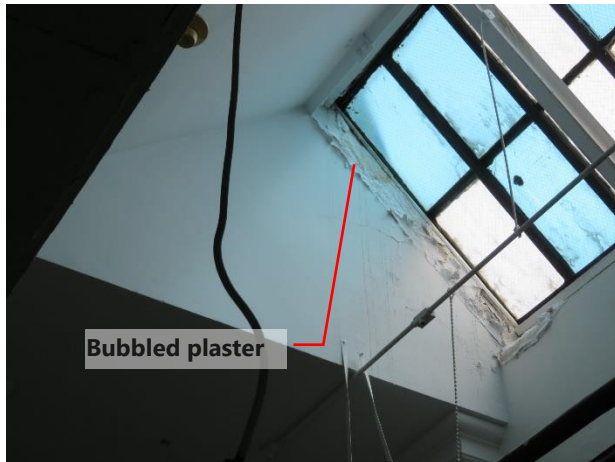
- **Observation:** Water damage to interior finishes is prominent around the six skylights set into Roof Area 2 (Figure 55). The skylights contain multiple vintages of glass lights, of which many are cracked. Some glass panes are covered with additional translucent panels. The window glazing is deteriorated or displaced at several of the skylights (Figure 56).

**Discussion:** The skylights at Roof Area 2 likely date to the original construction. Severe deterioration and evidence water infiltration around the skylights indicate that skylights have been a source of water infiltration at some point in the past, but the extent of active water infiltration at these skylights is unknown because OCH is not currently occupied.

Figure 55. Bubbling plaster around mansard skylight on east edge of Roof Area 2.

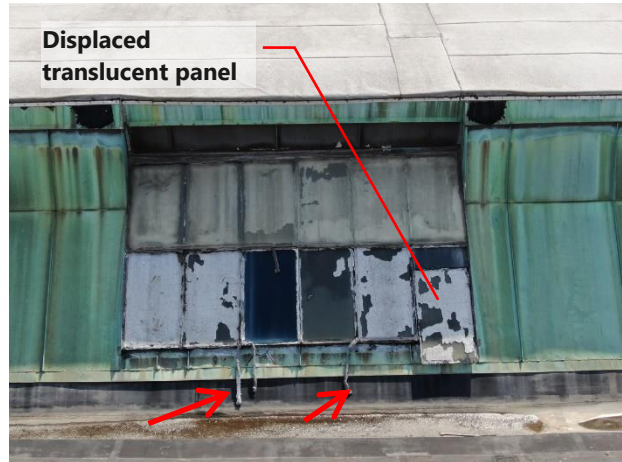
Figure 56. Deteriorated glazing at skylight along west edge of Roof Area 2.

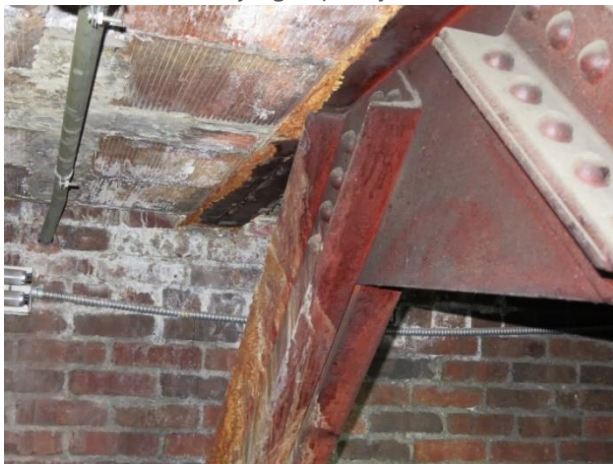
- **Observation:** Steel roof trusses comprise riveted, built-up sections. Surface corrosion exists at isolated locations on roof framing, but no water was observed on the surface of the steel trusses at the time of our site visit (Figure 57).

**Discussion:** Corrosion is an electrochemical reaction when unprotected mild steel is exposed to water and oxygen. While surface corrosion of mild steel is often expected on steel surfaces of historic buildings similar to OCH, if the unprotected mild steel is consistently exposed to water, overtime corrosion can lead to section loss of the steel elements.

Surface corrosion on the steel trusses is likely the result of water infiltration through the roof assembly. It is unknown if the water infiltration has been addressed or is ongoing. The corrosion was superficial and does not appear to have compromised the structural integrity of the steel truss, but if water infiltration is ongoing, corrosion and section loss will occur. Significant section loss of steel elements reduces the carrying capacity of steel elements and when severe can result in structural issues.

Figure 57. Surface corrosion on the top chord and diagonal bracing of roof truss.

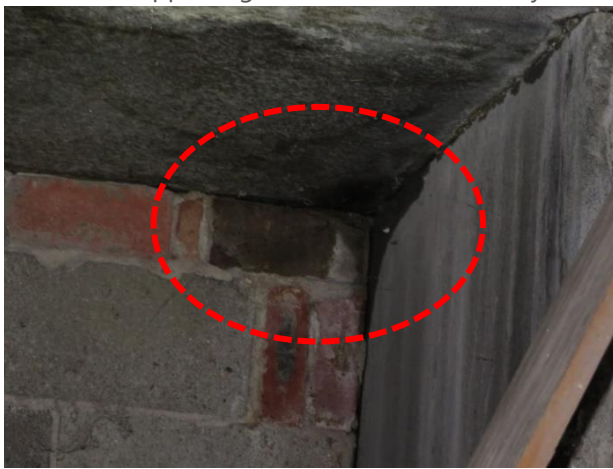
- **Observation:** Water infiltration is ongoing under the vaulted sidewalk below the landing in front of the east entrance doors (Figure 58). Surface corrosion exists on steel framing which supports the entrance landing (Figure 59).

**Discussion:** The reviewed documents do not indicate the age of steel framing below the vaulted sidewalk, or the waterproofing installed at the vaulted sidewalk if any. Steel shapes are contemporary hot-rolled sections and are likely not original to the building. However, the 1964 renovation drawings do not indicate installation of steel at this location.

The various instances of water infiltration into the space below the vaulted sidewalk indicates any waterproofing system which may exist at the sidewalk level is deficient at multiple locations. Corrosion of the supporting steel elements will likely continue until this water infiltration is addressed.

Figure 58. Water infiltration at northeast corner of vaulted sidewalk

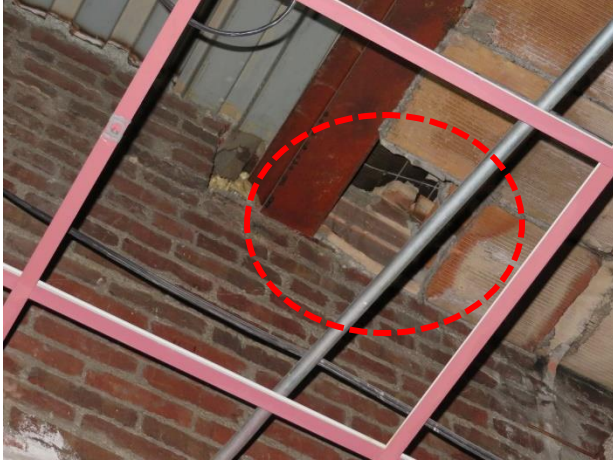
- **Observation:** Multiple penetrations are present through the flat-tile arch floor system. Many are small penetrations made to anchor suspended ceiling systems. At some locations, however, entire clay tiles are missing, or entire bays of flat-tile arches have been removed and replaced with a new floor system, of which only metal deck is visible (Figure 60 and Figure 61). In some instances, it appears the original interior partition wall was partially demolished and unsupported clay tiles remain.

**Discussion:** Most of the visible flat tile arch floor systems of OCH are in overall serviceable condition with limited visible indications of distress. However, further assessment of the flat tile arch systems is warranted prior to re-occupying the building. Flat tile arch flooring systems were commonly utilized in the early twentieth century as a fire resistive floor system. Flat tile arch floors develop capacity to carry demands through true masonry arch action of the individual clay tiles between structural framing members. While it is possible to modify and install penetrations through flat tile arch floors, it should be completed only under the direction of a structural engineer with relevant experience in the design and repair of flat tile arch floor systems. Modification or penetration of the flat tile arch floor systems if not properly designed can pose a significant risk of failure due to the reliance of the system on arch action and compression to resolve demands.

Figure 60. Missing floor tile at the corner of one flat-tile arch.

WJE did observe localized modifications to the flat-tile arches in many locations which should be further evaluated to ensure the flat tile arch floor system has not been structural compromised.

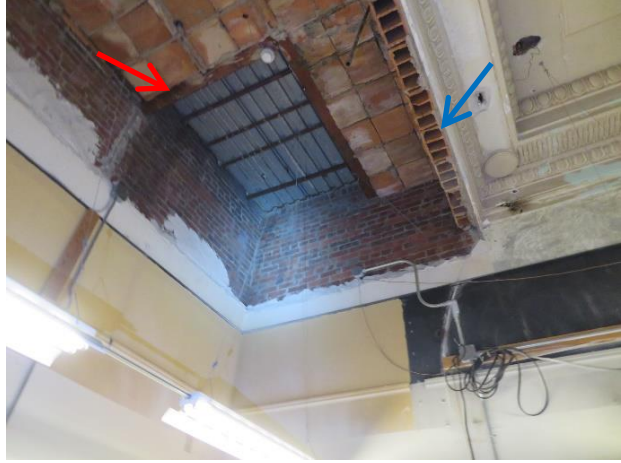
Figure 61. Metal deck visible at area of removed flat-tile arch sub-floor (red arrow). Also note unsupported clay tiles (blue arrow). These appear to be remnants of an original interior partition wall, subsequently partially demolished.

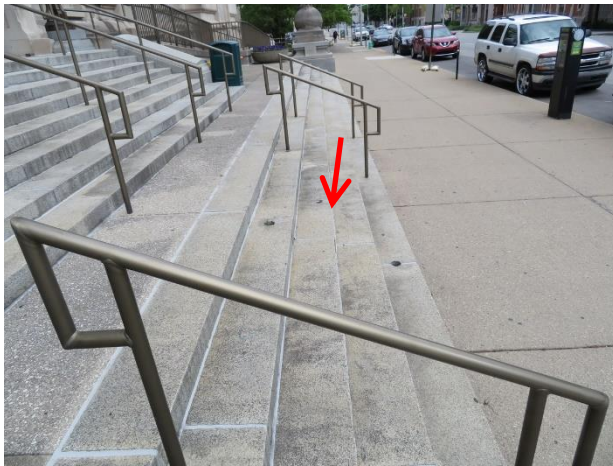
- Observation: One handrail at the east entrance steps is missing (Figure 63). Ramp handrail posts are embedded into the concrete slab of the ramp and surrounded by cementitious material. Concrete at the base of many handrail posts is cracked or spalled (Figure 64). Some of these cracks have been previously sealed but have continued to propagate in length and width.

Discussion: During our limited ADA assessment in 2020, WJE noted that the existing stair handrails at the exterior entrance stairs contained insufficient extension lengths at the top and bottom of the bottom flight of steps. The existing handrails are non-historic elements.

Figure 63. Missing handrail at east entrance steps.

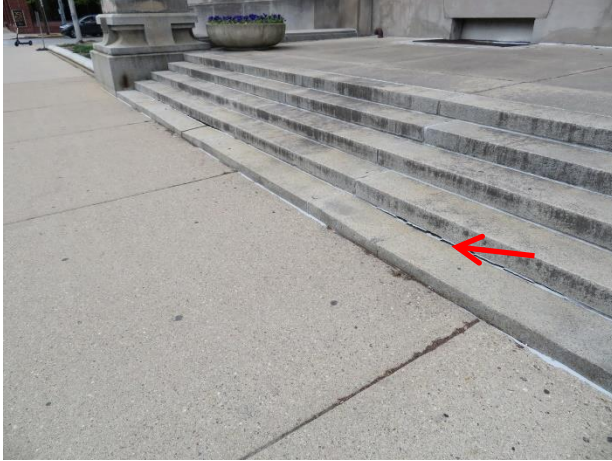
- Observation: Joint sealants in the exterior granite entrance steps and throughout the on-grade pavements near the east entrance were failed in cohesion and adhesion (Figure 65 and Figure 66).

Discussion: Sealant is typically installed at the interface between adjacent materials to keep the assembly watertight. Joint sealants in pavement applications have a limited service life of approximately 3 to 5 years. The observed failure of sealants included both adhesive and cohesive failures. Cohesive failures are indicative of exposure and age of the sealant reaching the end of its service life. Adhesive failures could also be the result of sealant reaching the end of its service life or unanticipated or excessive movement between adjacent materials, inadequate or improper surface preparation, or material incompatibility. The debonded sealant can create an uneven walking surface

and allow water to infiltrate below the walking surfaces potentially compromising the underlying subbase or concealed elements.

Figure 65. Deteriorated sealant at east entrance steps.

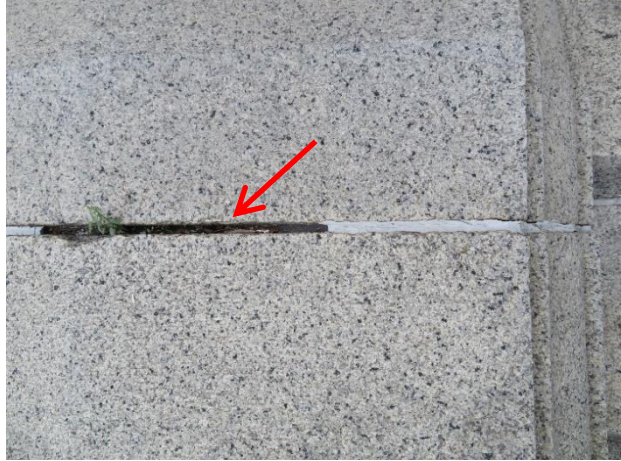
Figure 66. Missing and failed sealant at granite paver.

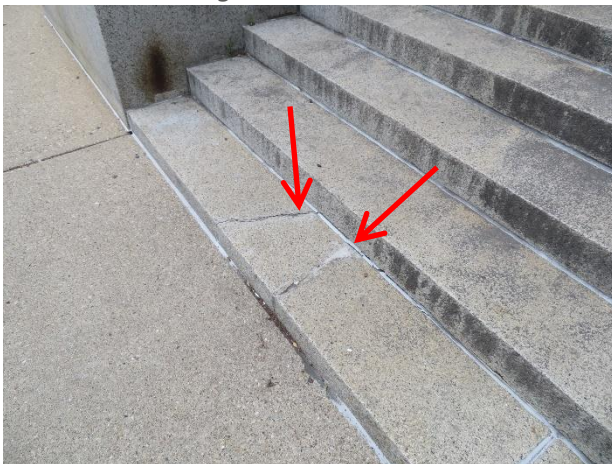
- **Observation:** Several granite steps at the east entrance are cracked (Figure 67). One step is cracked through the geometry while several others are cracked at the corner of the step near previous or existing handrail embedments (Figure 68).

**Discussion:** Cracks which extend through the geometry may be caused by differential settlement of the support below the step. Cracking at the corner of steps near handrails is likely caused by corrosion of the handrail post embedment or expansion of the cementitious anchorage material as described above. Where these handrail posts are embedded near the end of the step units, the expansive forces resulting from accumulation of corrosion scale or expansion of the anchorage material likely exceeded the tensile capacity of the stone resulting in diagonal cracks through the end of the unit.

Figure 67. Cracked granite step near east entrance.

Cracked and displaced granite pieces may be a tripping hazard at the entrance of the building and should be mitigated.

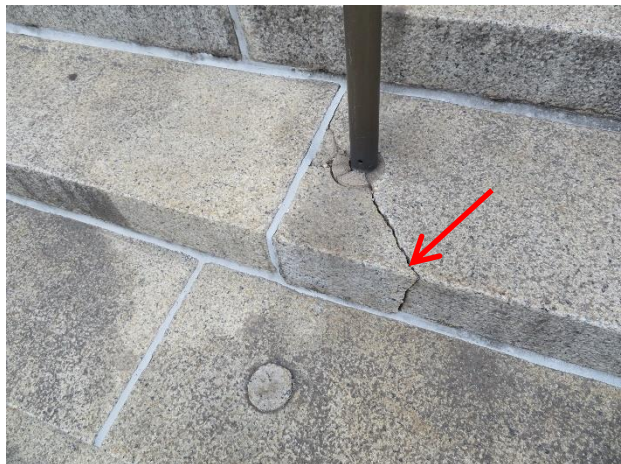
Figure 68. Corner crack at granite step near handrail post.

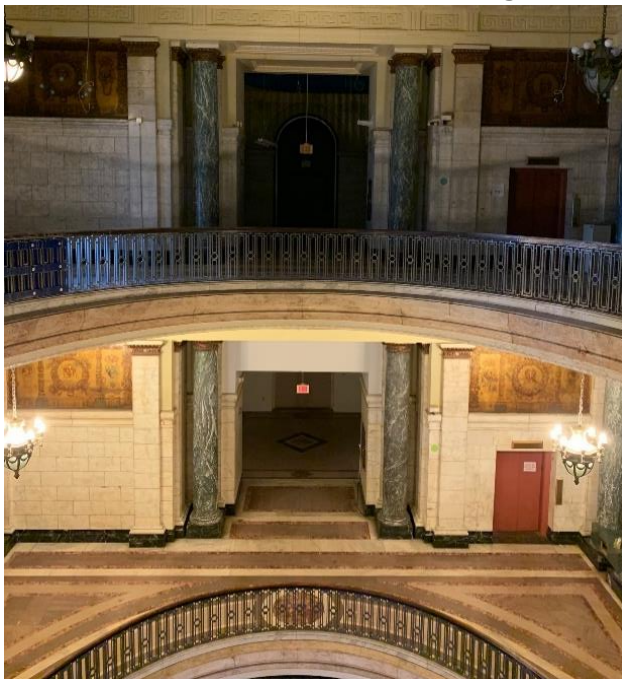
- **Observation:** There is large central floor opening (atrium) in the center of the building (Figure 69 and Figure 70) connecting the first level to the fourth level. There are no fire rated corridors as the building is designed and configured as an open office plan. This floor opening is arranged as an atrium without smoke control.

Figure 69. Central atrium space

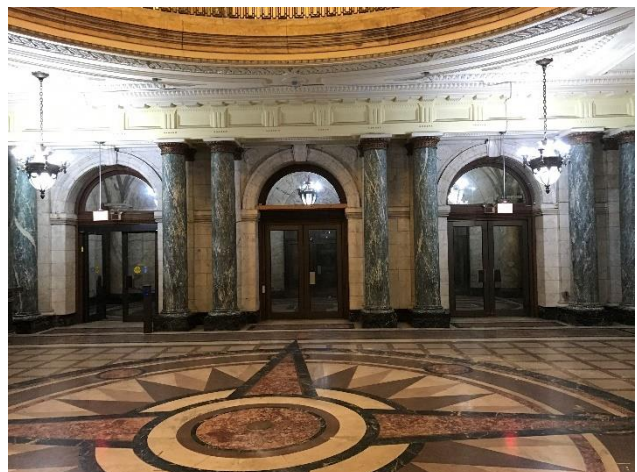
Figure 70. First floor central atrium space (looking east)

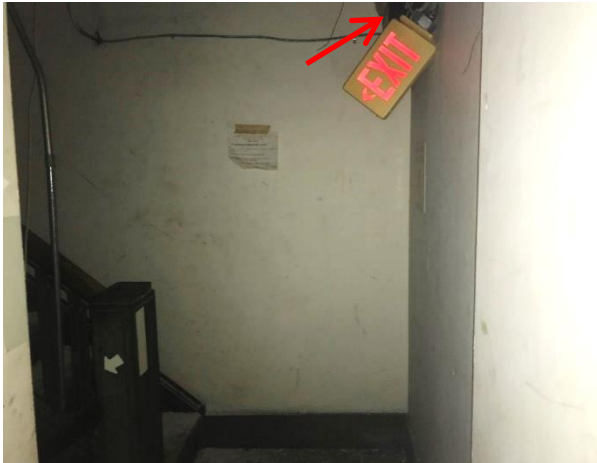
- Observation: There are two stairway enclosures in the building. The stairway enclosures consist primarily of clay-tile construction and plaster finishes and appear to provide a 2-hour fire resistance rating.
  - Stairway doors are provided with glazing that does not provide a fire-resistance rating.
  - Penetrations and holes were observed in stairway enclosing walls requiring a fire-resistance rating. There is approximately one penetration every floor level per stairway (Figure 71).

Discussion: The enclosed exit stairways are not provided with fire resistive doors that self-close and latch. As an existing condition no changes are necessary for the current building status (vacant) and occupancy (business). The historic nature of the building and potential adaptive reuse is discussed further in this report below.

Figure 71. Penetration in stairway enclosure.

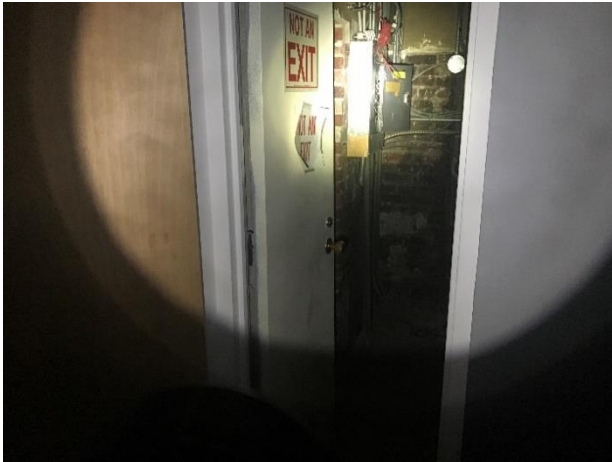
Discussion: If changes occur to these rooms during renovation, including the use of these rooms or the equipment is changed, the enclosure requirements for these rooms will require a fire resistance rating depending on the equipment installed within.

Figure 72. Typical electrical room

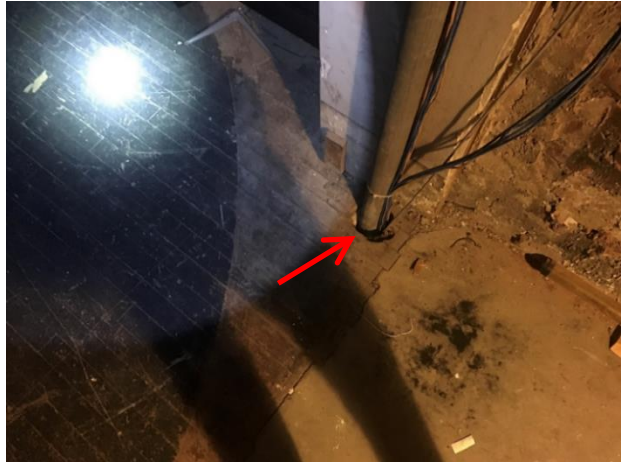
Figure 73. Floor penetration

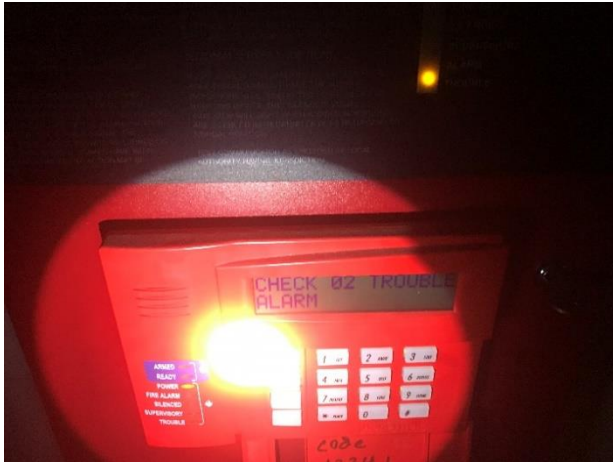
- **Observation:** The building has a fire alarm system (EST IRC-3) with a Honeywell DACT fire alarm communicator. The main panel is located in the basement (Figure 80). Manual pull stations are located at the intermediate levels of the main open stairway. Smoke detection is located within the building. Beam detection for security is installed across the atrium floor opening. Occupant notification (strobe and horn) is located within the atrium space on every level (Figure 81). The fire alarm panel indicated a trouble alarm in area 02.

**Discussion:** The expected useful life for a fire alarm control panel is approximately 20 years with proper maintenance as detailed in NFPA 72 but may be extended with continued maintenance per the manufacturer's requirements. It is unknown when the fire alarm control panel was installed or last upgraded, the devices are of various vintages and the identified panel is obsolete and no longer produced by the manufacturer. As a result, parts may get progressively more difficult to obtain and new devices that might be added in the field may not be compatible with the existing hardware.

Figure 80. Fire alarm control panel in basement boiler room indicating a trouble alarm.

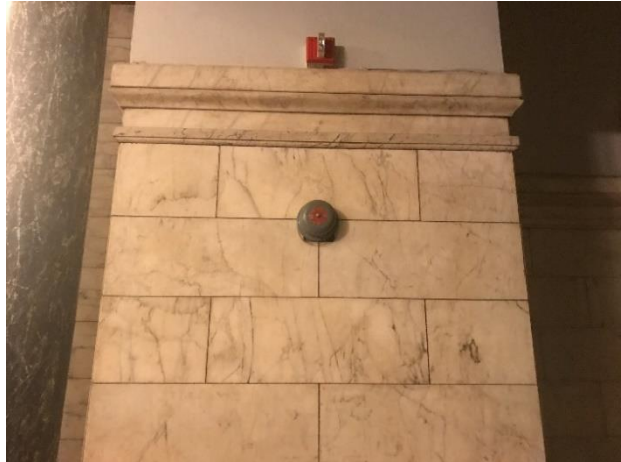
Figure 81. Strobe and alarm bell in the main atrium space

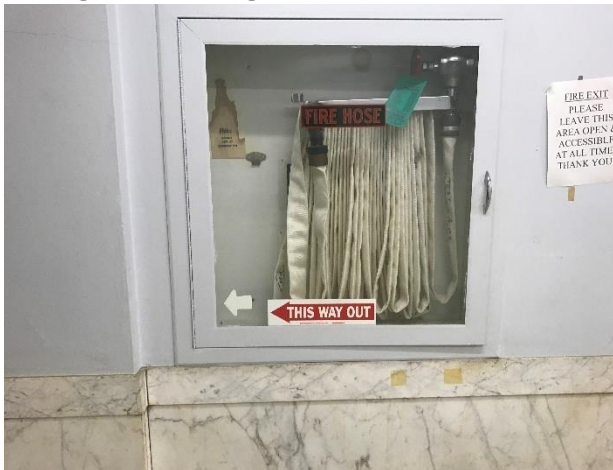
- **Observation:** The building does not have an automatic fire sprinkler system. There are two fire department connections with 1-1/2 inch hose lines on each floor on either side of the atrium (Figure 82 and Figure 83).

Figure 82. Fire hose cabinet with fire department connection

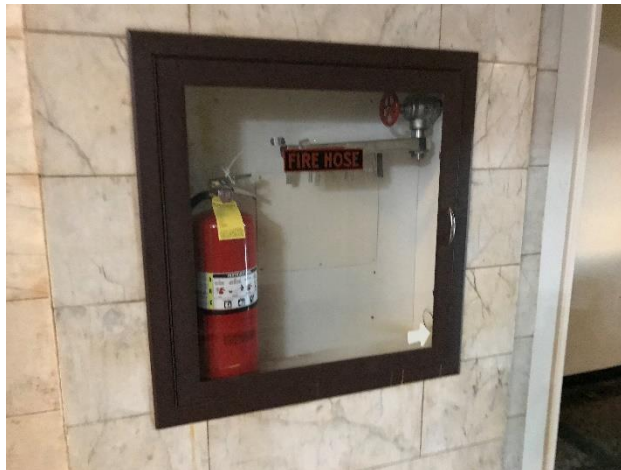
Figure 83. Fire hose cabinet with hose removed and fire extinguisher located in the cabinet.

- **Observation:** Manual fire extinguishers are installed around the building but have not been inspected (See Figure 83 above).

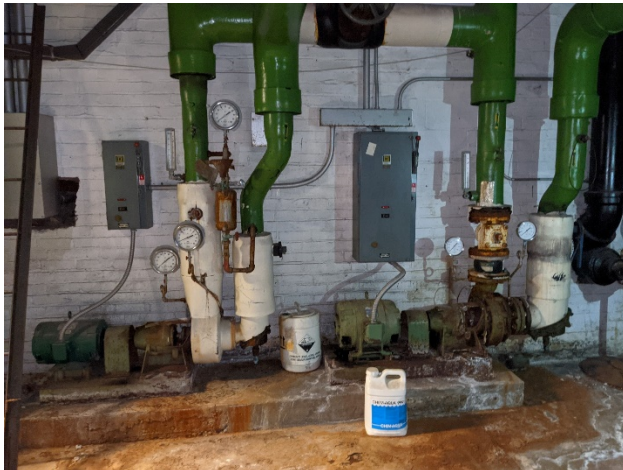
Cooling is provided from two reciprocating water-cooled chillers which are also located in the basement mechanical room. These chillers are connected to a site mounted cooling tower located north of the building. Pumping for the system is also located in the basement mechanical room (Figure 2).

*Figure 2 Chilled Water Pumps – location basement mechanical room*
